APPENDIX A

Appendix A: Condition Survey of Pavements and Coring Information

Part 1: Survey Data

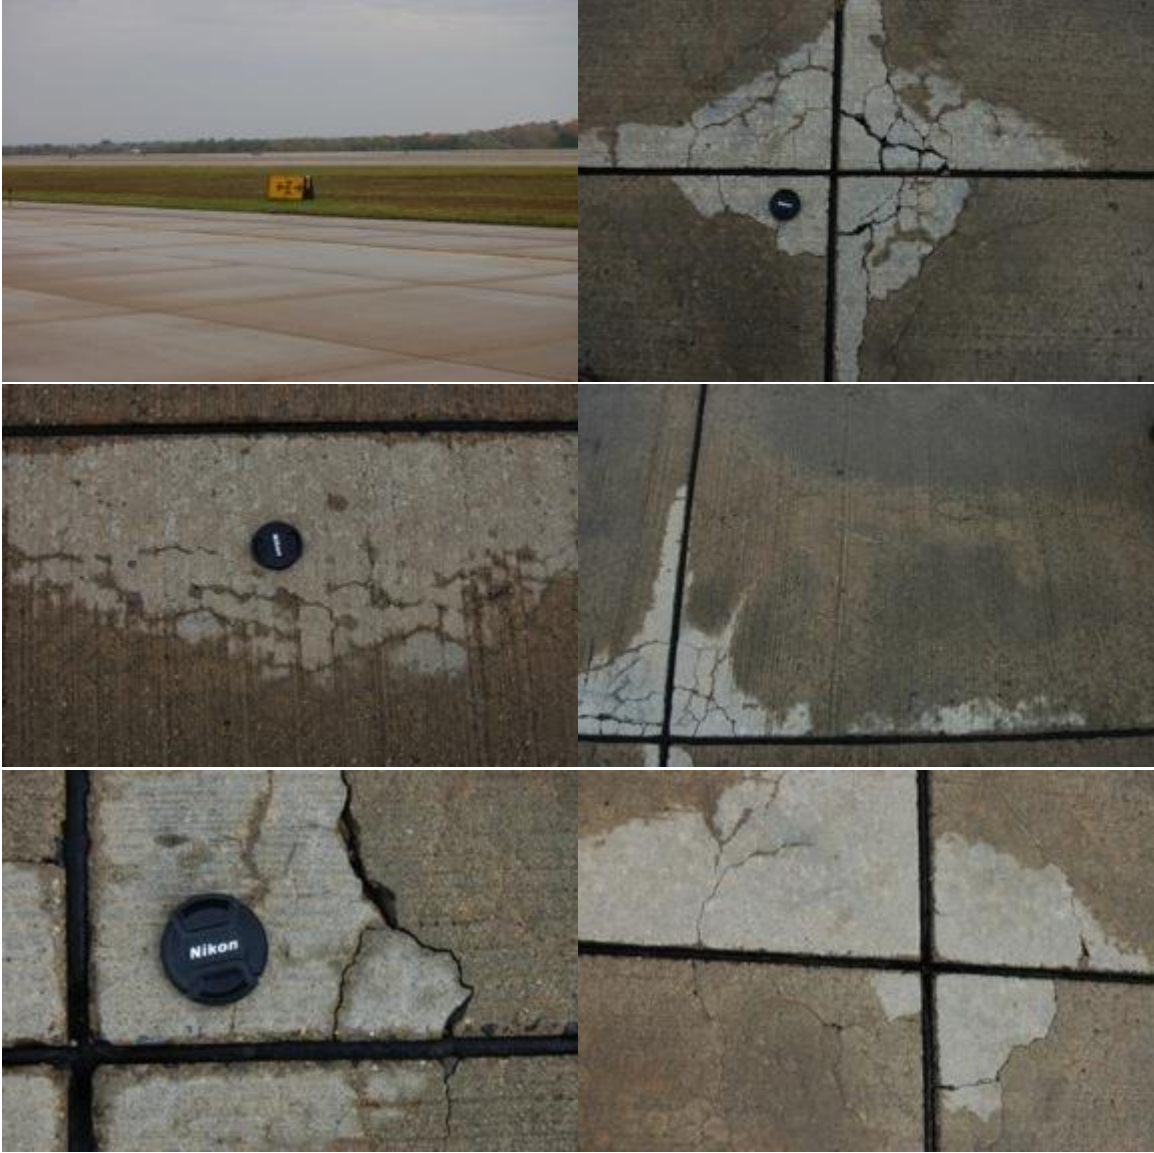
Figure 1: Airport I Visual Survey of Taxiway Echo

Taxiway Echo had high severity map cracking along the joints and moderate to low severity map-cracking in the mid-panels. Visual examples from Taxiway Echo can be seen in Figure 1. Taxiway Victor was in decent condition so only three cores were selected. Two of the cores were taken from areas with the limited cracking and the other one was from an undamaged area. Taxiway Tango was in better condition than Taxiway Echo but not as good as Taxiway Victor. Visual examples from Taxiway Tango can be seen in Figure 2. Taxiway Victor was in decent condition so only three cores were selected. Two of the cores were taken from areas with the limited cracking and the other one was from a decent area. Visual examples from Taxiway Victor can be seen in Figure 3.

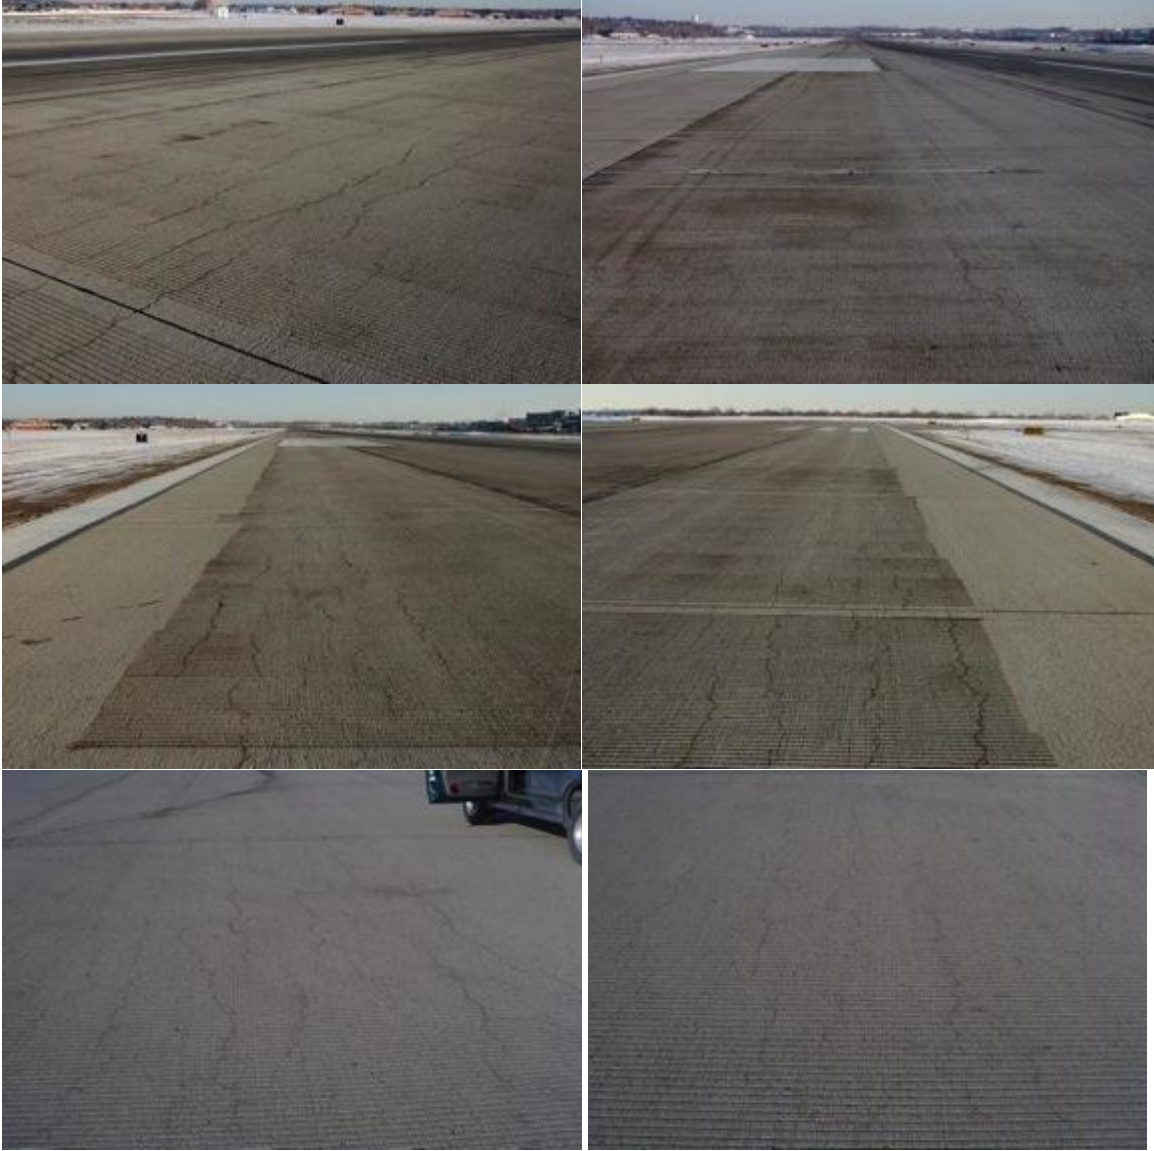
Figure 4: Airport II Visual Survey of Runway 30R/12L

The distress was significant random cracking. Visual examples can be seen in Figure 4.

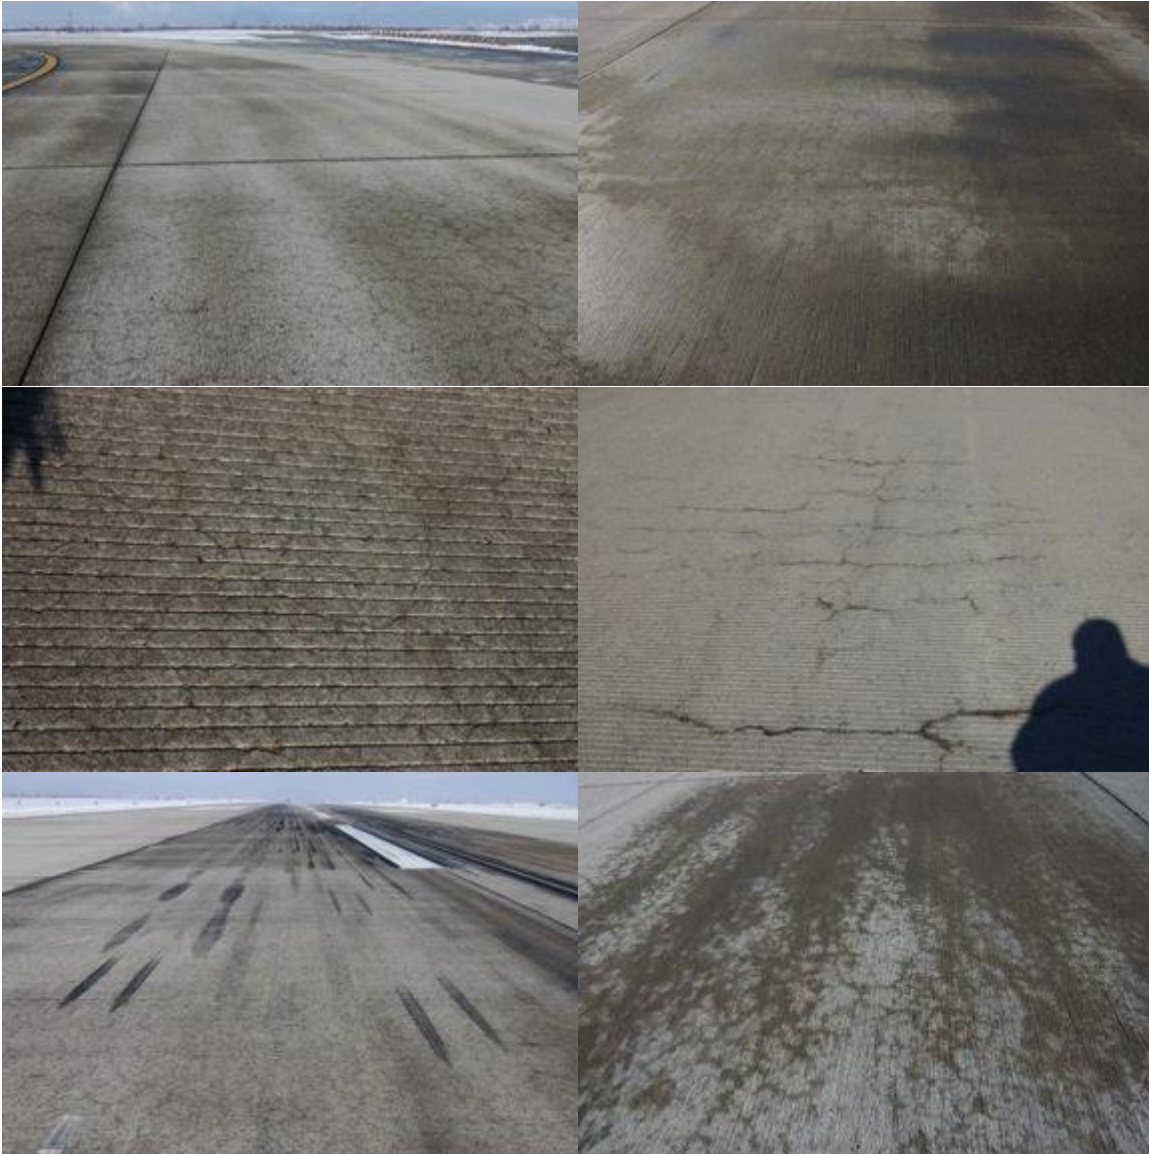
Figure 5: Airport III Visual Survey of Runway 16R/34L

The distress was moderate to low severity map cracking along joints and mid-panels. Visual examples can be seen in Figure 5.

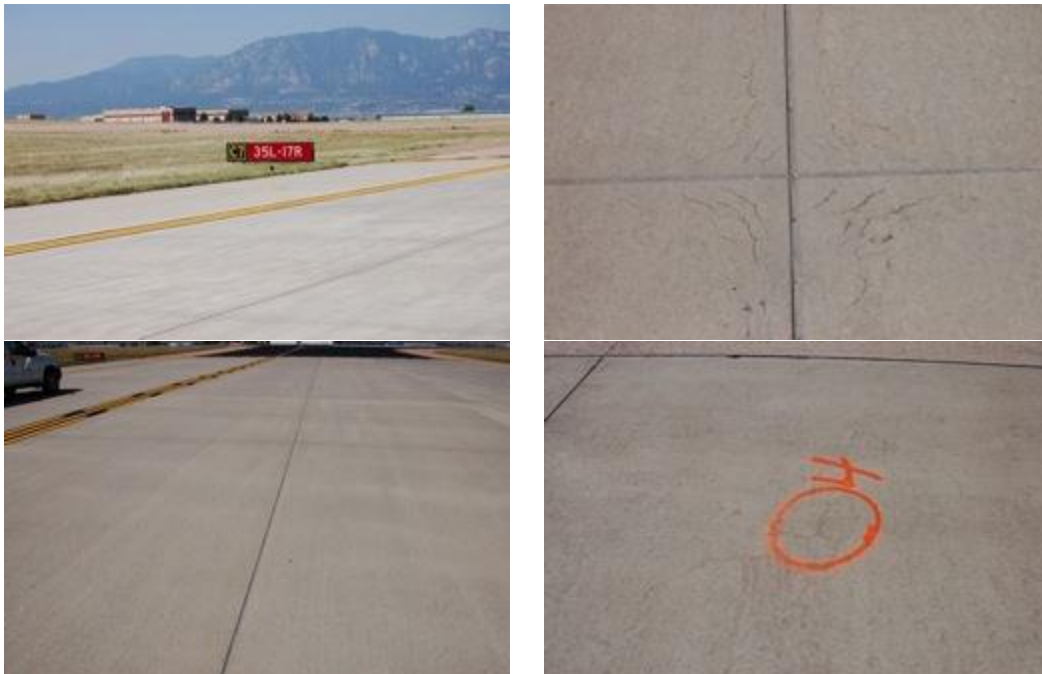
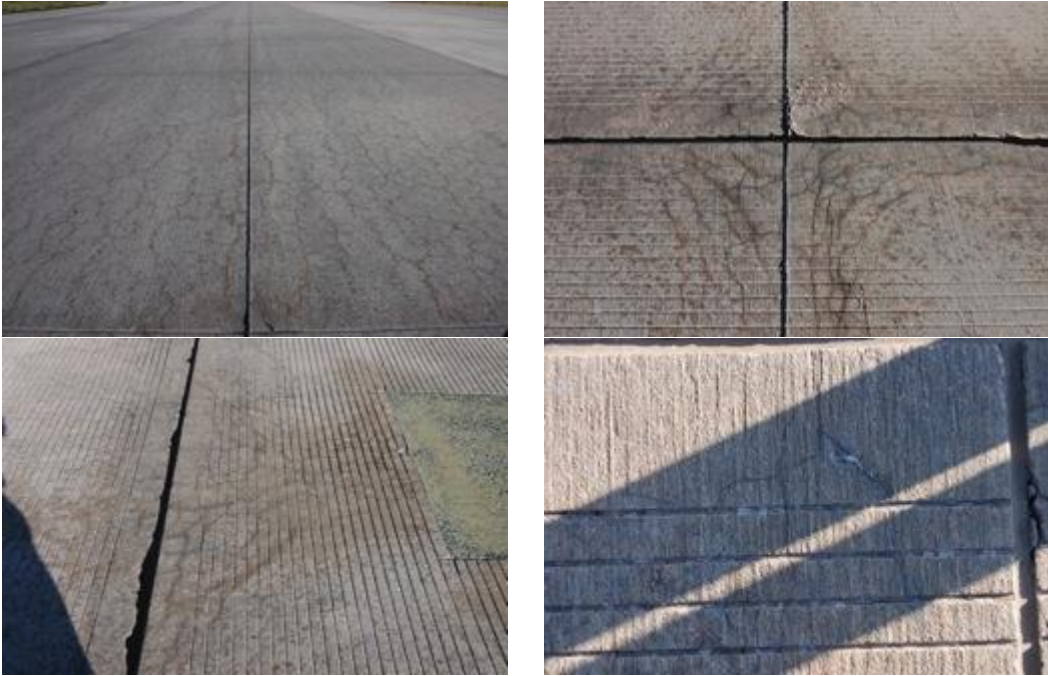
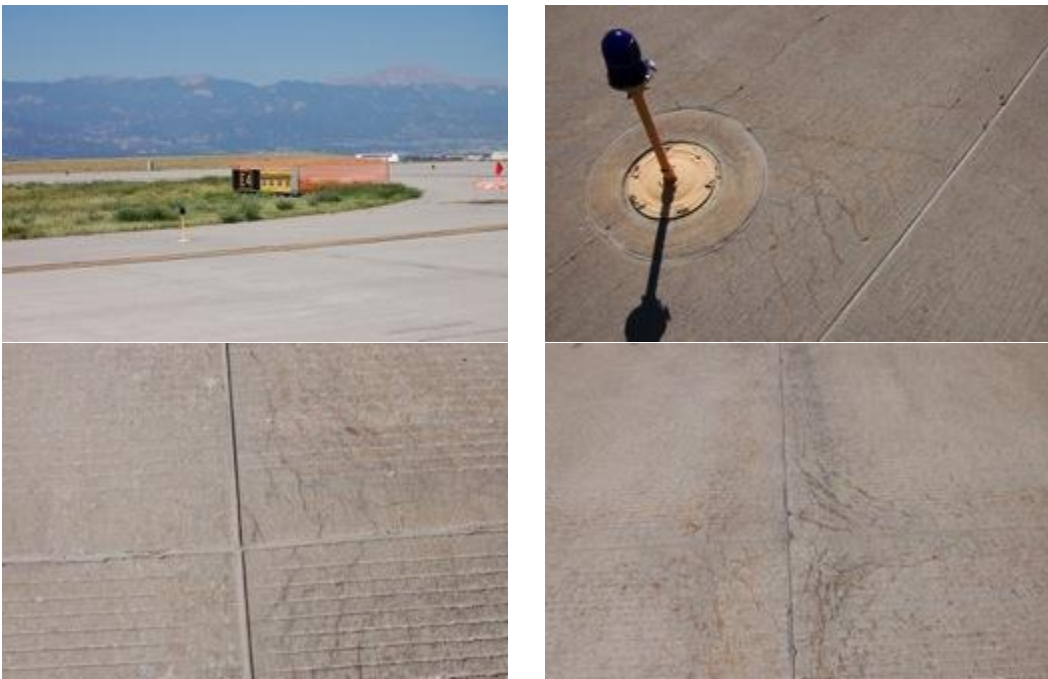
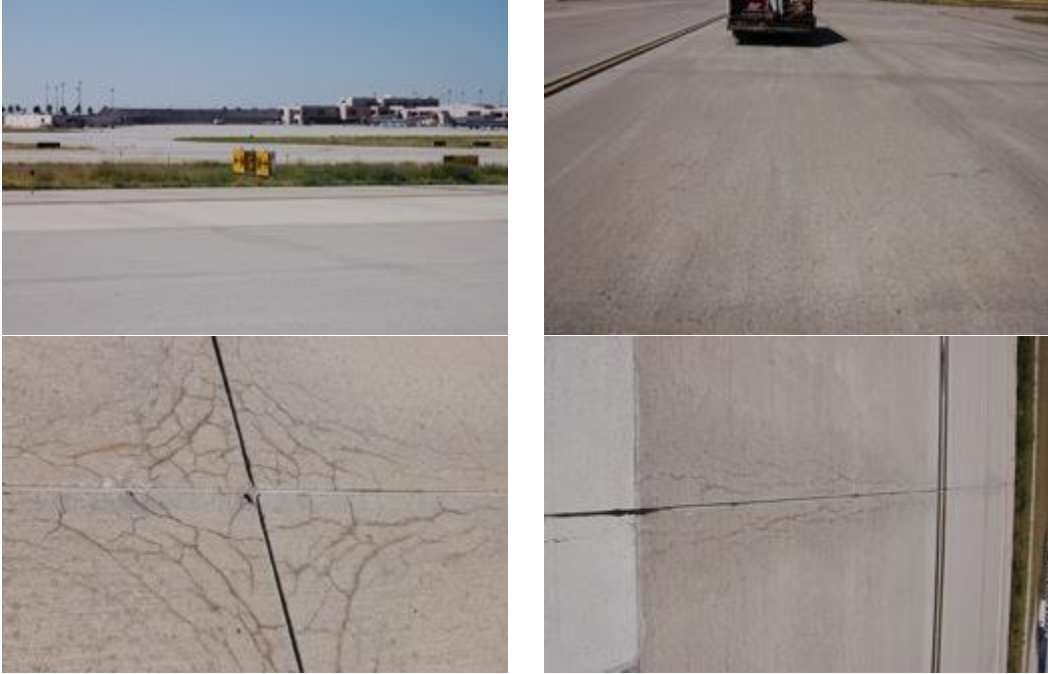
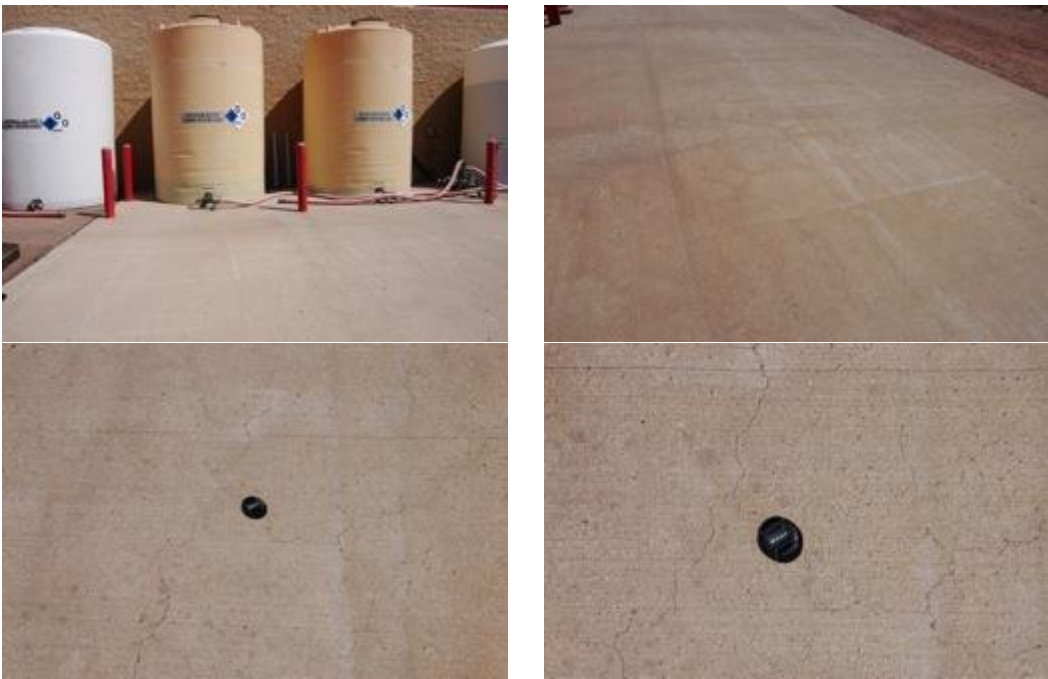
All of the pavements surveyed at Airport IV had extensive map cracking in mid panels and D-cracking near the joints. The deicing pad had the most extensive damage. Examples of the damage in each taxiway can be seen in Figure 6, Figure 7, Figure 8, Figure 9, and Figure 10.

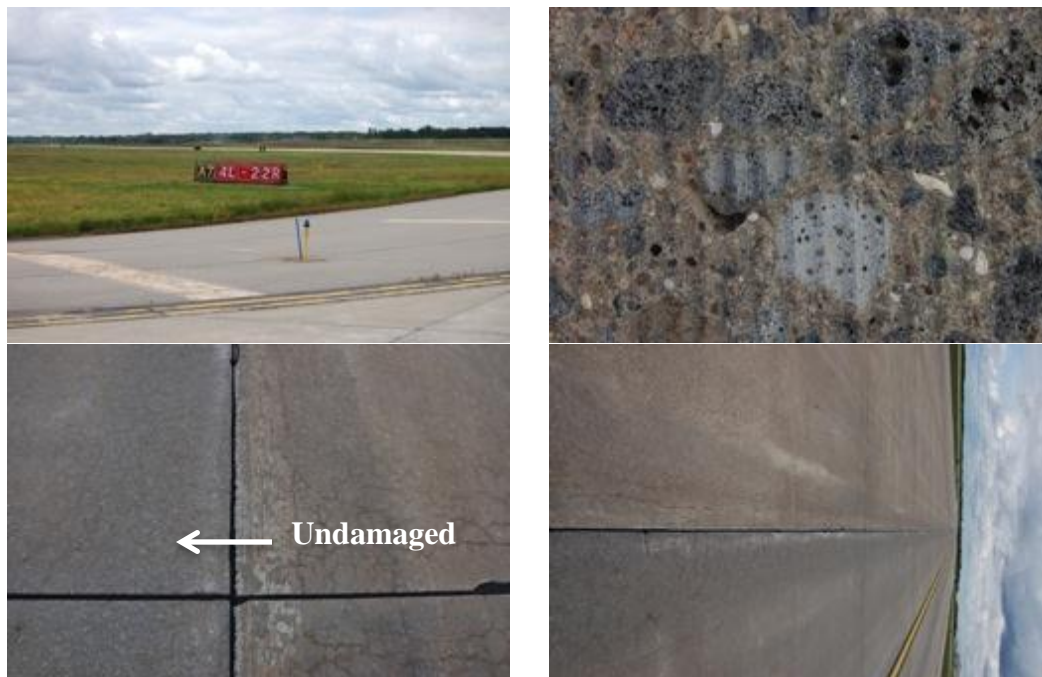
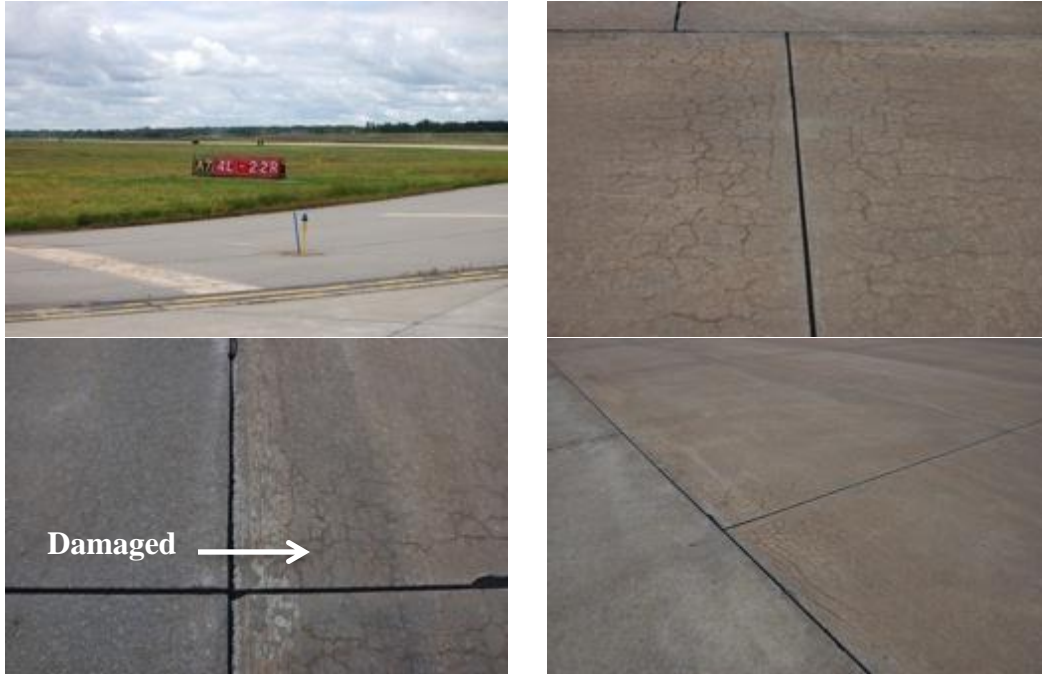
Cores were taken from damaged and undamaged sections of runway 22R/4L. Cores 1, 2, 3, and 7 were taken from the undamaged sections with cores 4, 5, 6, 8, and 10 being taken from the damaged sections. The undamaged cores had moderate to no cracking on the surface, with the damaged sections having severe cracking. The cracks were in the form of map cracking both in the mid panel and along the joints. Cores 11 and 12 were taken from Taxiway Alpha 4. Core 11 was taken from a damaged section and core 12 was taken from an undamaged section. Examples of the damage in runway 22R/4L can be seen **Error! Reference source not found.** and Figure 12.

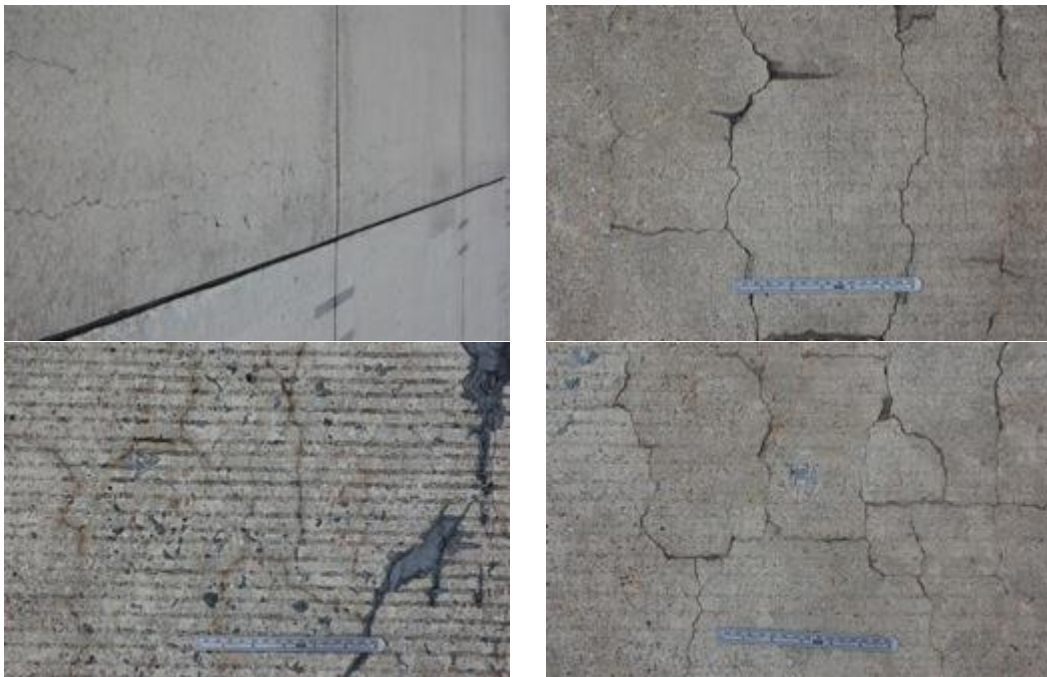
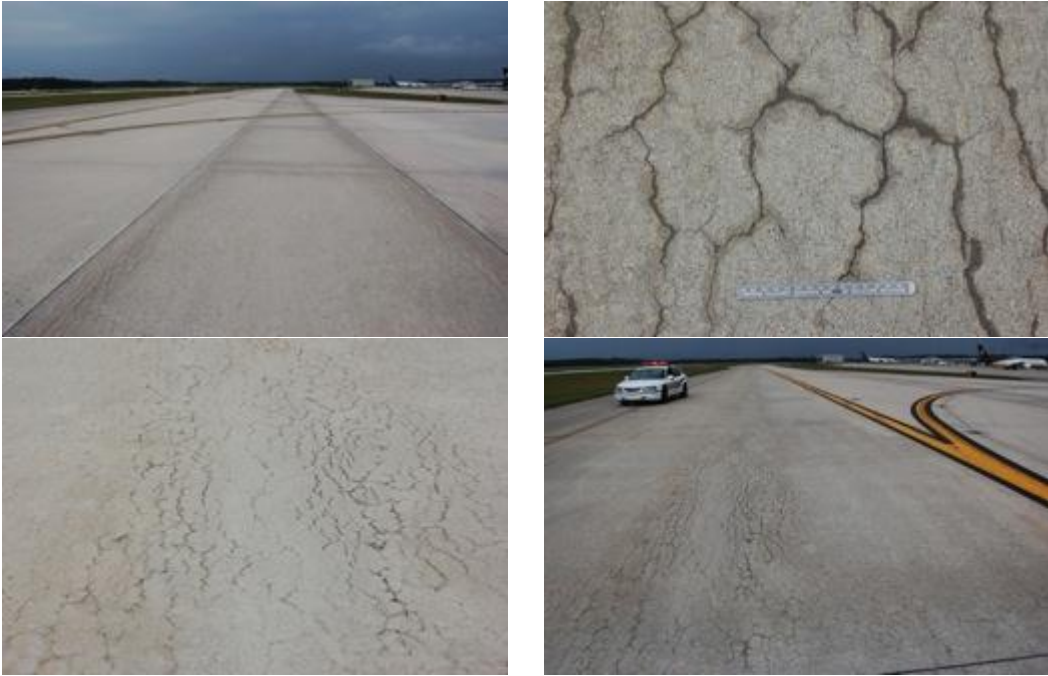
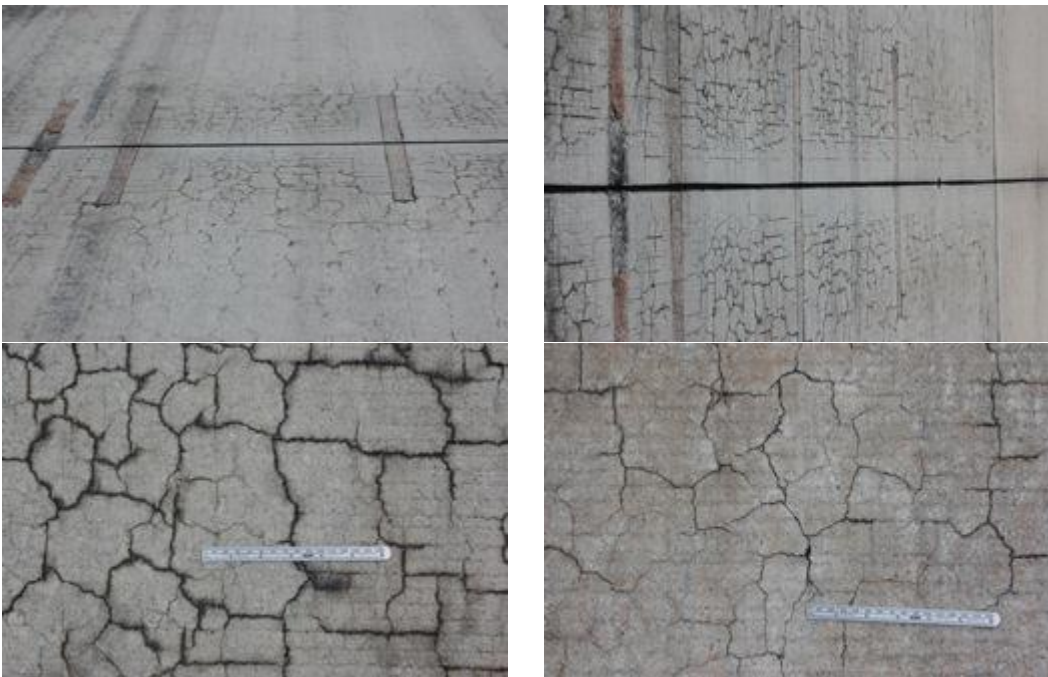
For Airport VI, two taxiways and a runway were examined. Taxiway Bravo had severe cracking in the form of map cracking along with some structural cracking, which take the form of large singular cracks running parallel to longitudinal joints. Taxiway Foxtrot had some severe map cracking in the mid panels. Runway 23R/5L had map cracking which ran parallel to the longitudinal joints. Examples of the damage in the taxiways and runway can be seen in Figure 13, Figure 14, and Figure 15.
