Report IPRF-01-G-002-03-3

**Design and Construction of
Concrete Pavement for
Aircraft De-icing Facilities**

April 2006

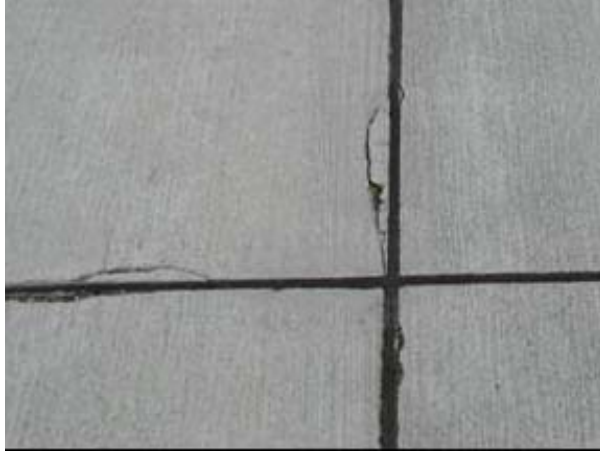
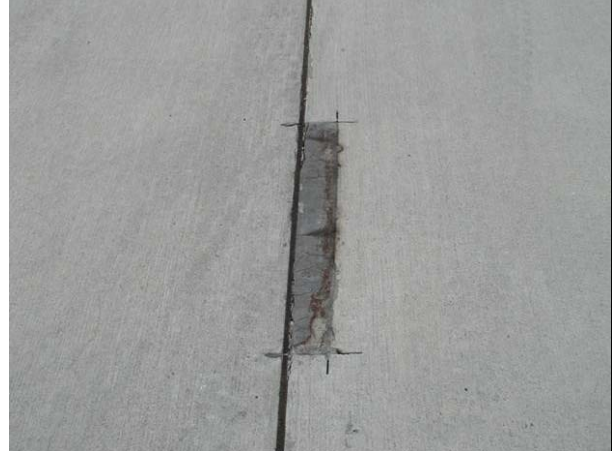
FIGURE 3. LOW-SEVERITY SPALLING (LEFT) AND LOW-SEVERITY PATCH (RIGHT)
ON SAMPLE UNIT 1 AT AIRPORT ALPHA

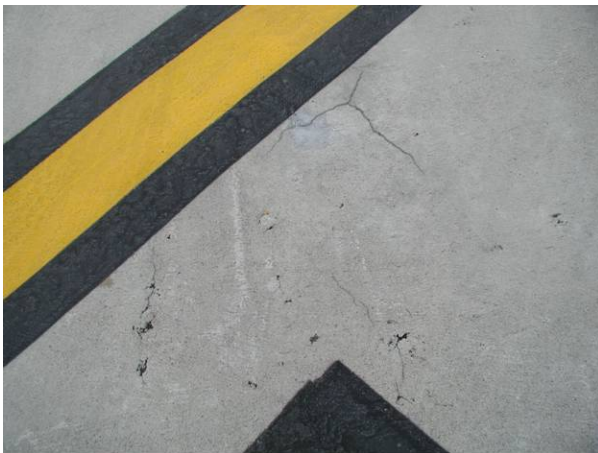
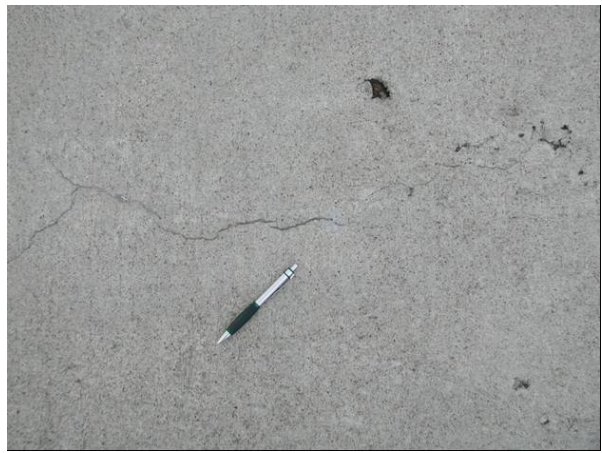
FIGURE 4. FINE HAIRLINE CRACKING OBSERVED IN SAMPLE UNIT 1 AT AIRPORT
ALPHA

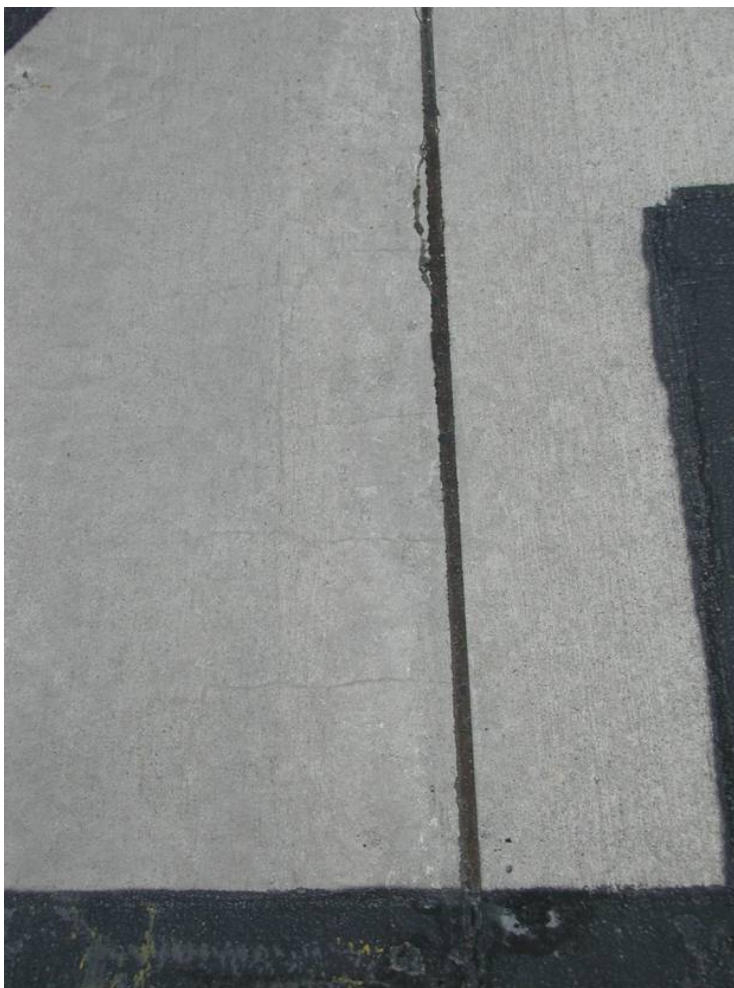
The only distress in the second sample unit, located in an area subjected to lower applications of deicing fluids, was one slab exhibiting a very small amount of map cracking near a joint (see figure 5).

FIGURE 5. FINE HAIRLINE CRACKS NEAR A JOINT IN SAMPLE UNIT 2 AT AIRPORT ALPHA

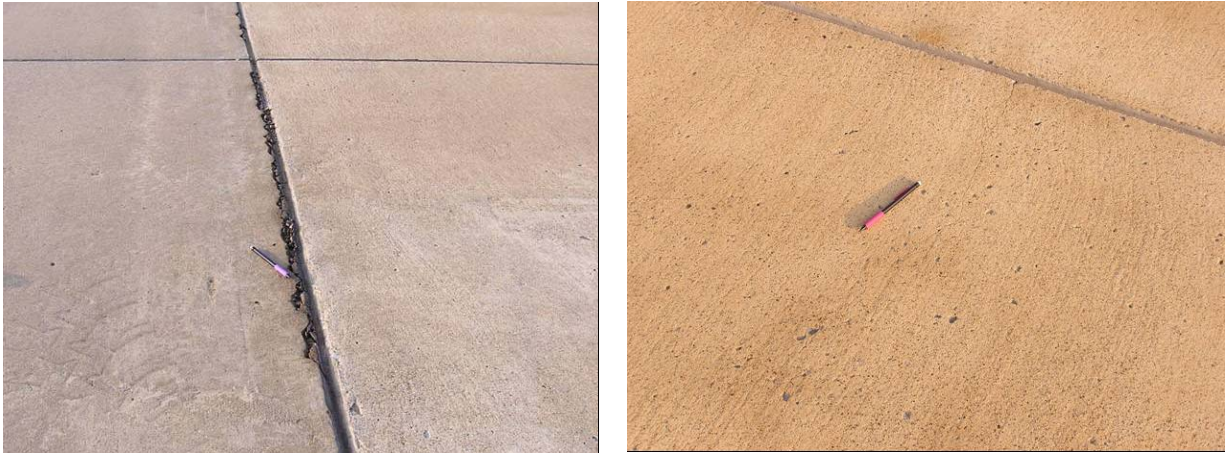
FIGURE 8. LOW-SEVERITY SPALLING (LEFT) AND HAIRLINE CRACK (RIGHT) IN SAMPLE UNIT 1 AT AIRPORT BETA

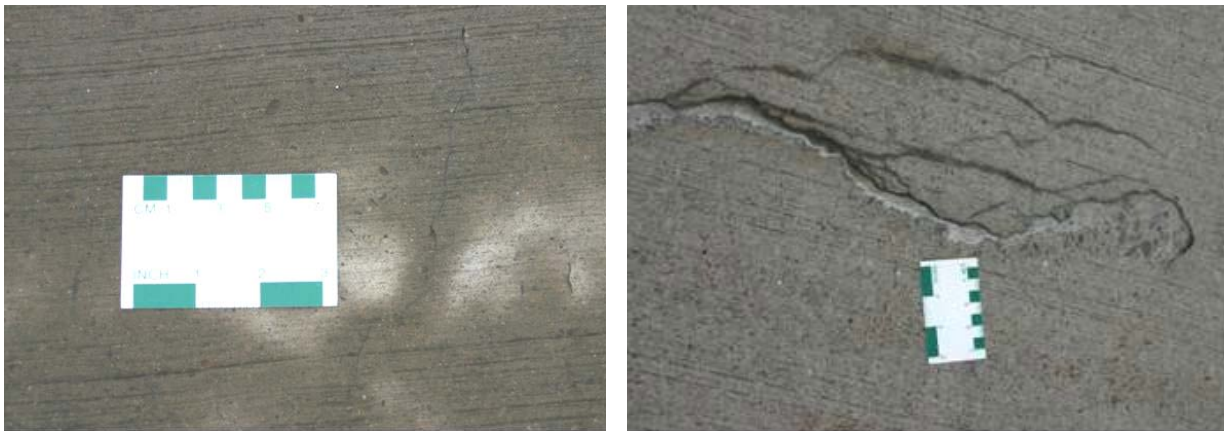
FIGURE 10. HAIRLINE CRACKING OBSERVED IN SAMPLE UNIT 1 AT AIRPORT CHARLIE

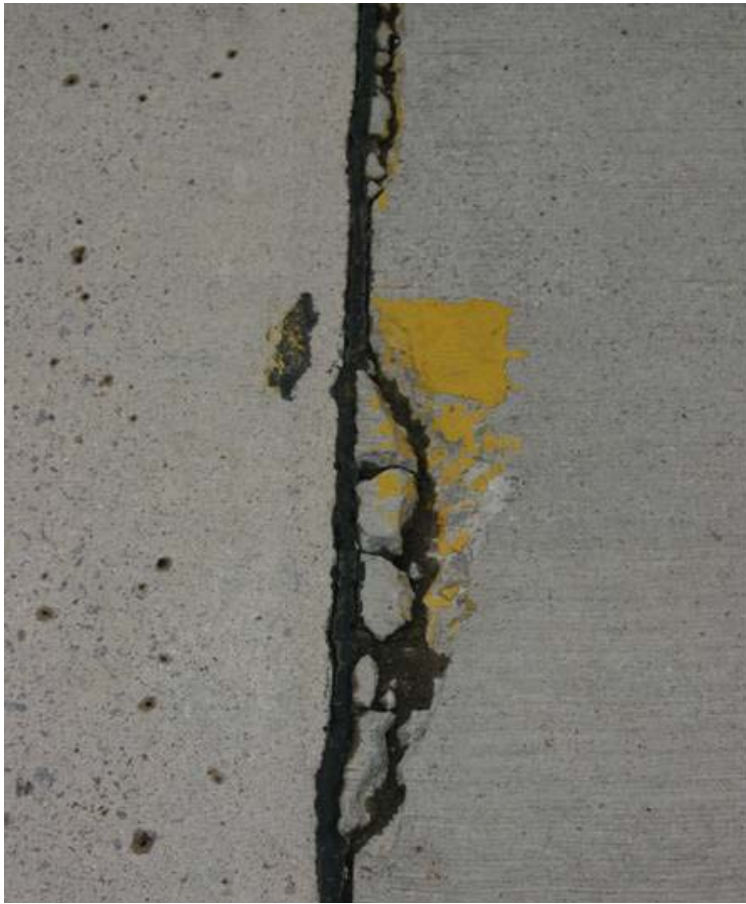
FIGURE 11. JOINT SPALLING IN SAMPLE UNIT 1 AT AIRPORT CHARLIE

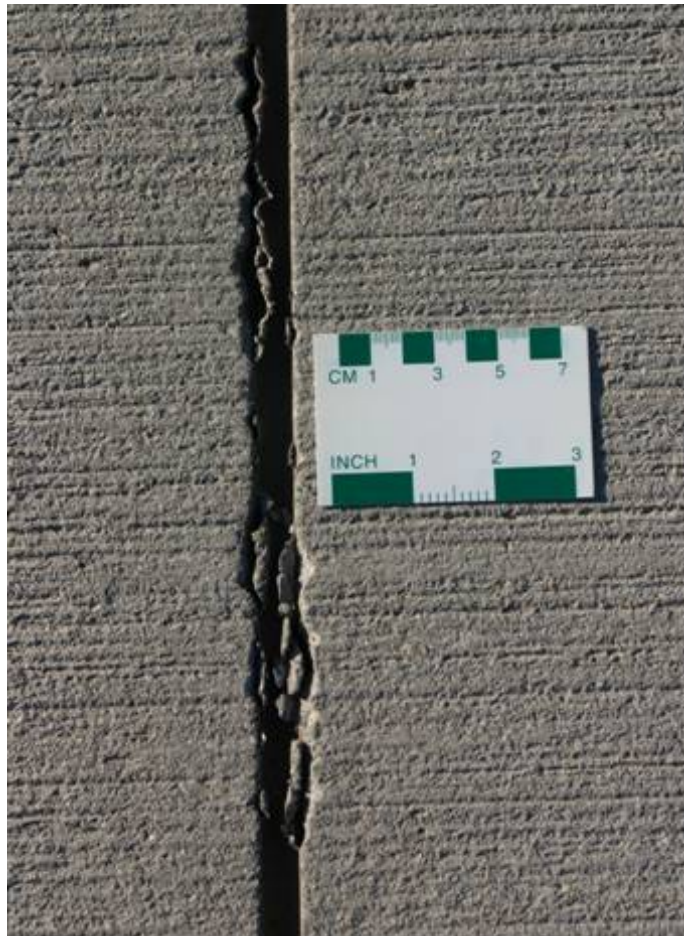
FIGURE 13. SEALANT ADHESIVE FAILURE ON SAMPLE UNIT 1 AT AIRPORT DELTA

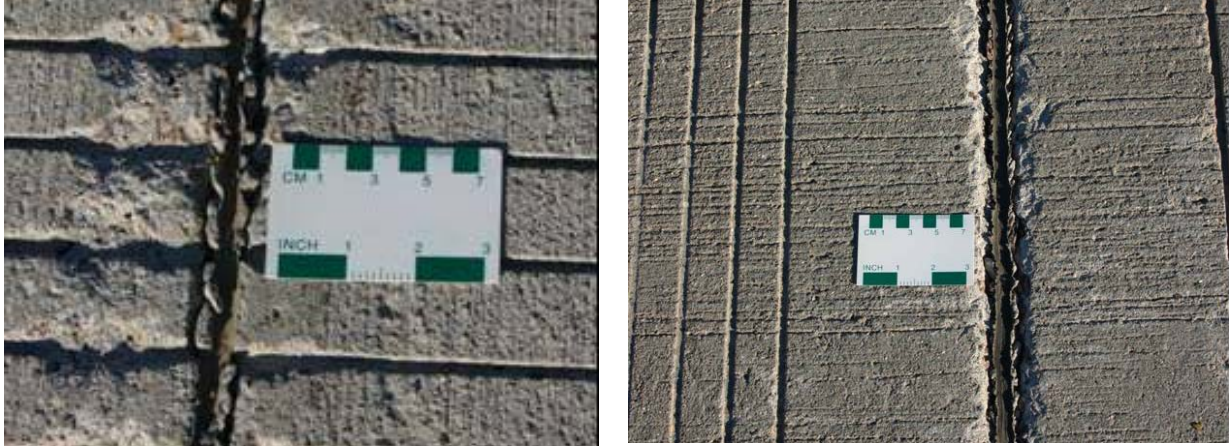
The second sample unit is located in an area of the 12L Hold Pad that should receive little if any deicing application. One slab exhibited a low-severity corner spall and there were some sliver spalls, but it appears as if most damage is due to the scraping of snowplow blades rather than some type of pavement performance problem (see figure 14). The sealant was again noted in good condition.

FIGURE 14. SNOWPLOW DAMAGE ON SAMPLE UNIT 2 AT AIRPORT DELTA

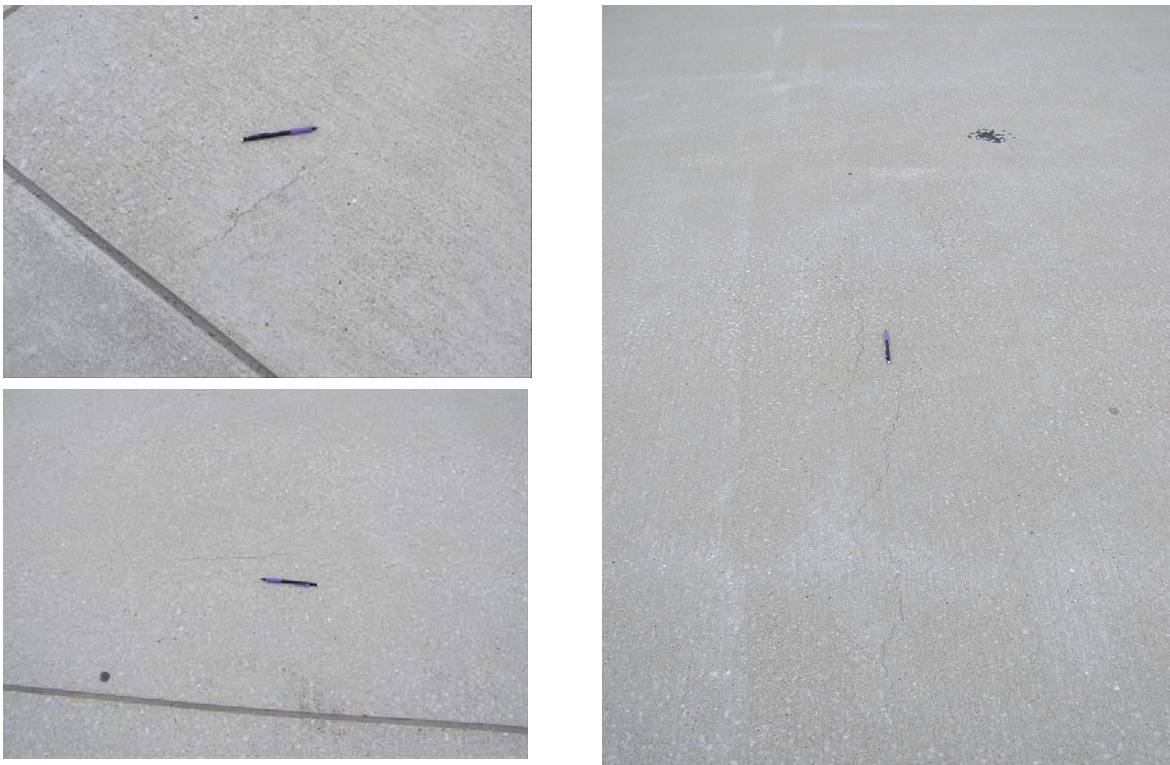
FIGURE 16. HAIRLINE CRACKING OBSERVED IN SAMPLE UNIT 1 AT AIRPORT ECHO

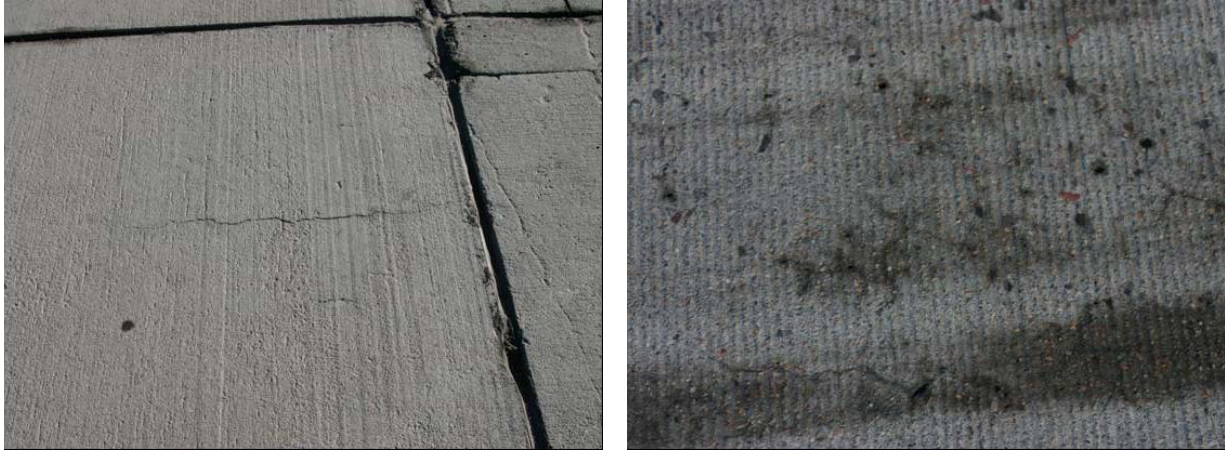
FIGURE 18. MAP AND HAIRLINE CRACKING OBSERVED ON SAMPLE UNIT 1 AT AIRPORT FOXTROT

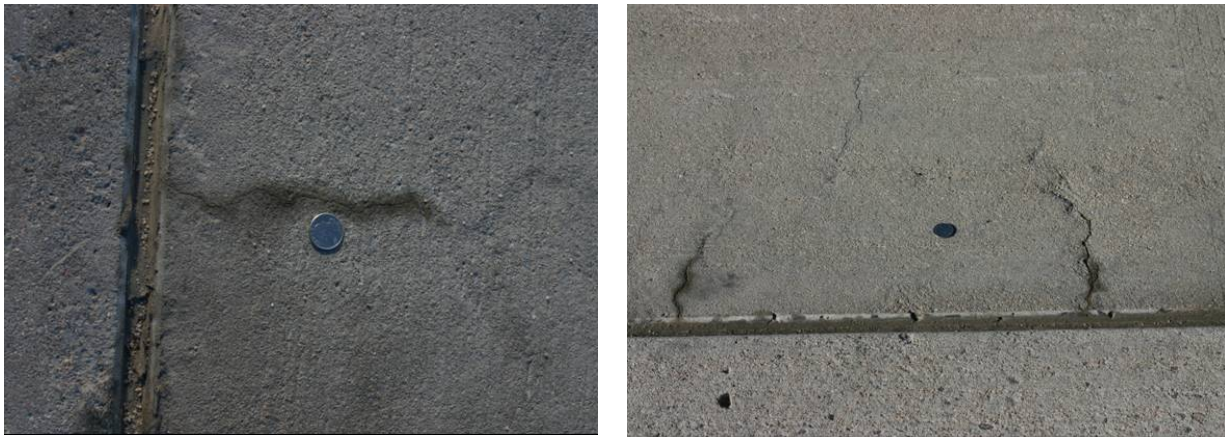
Sample unit 2 is located directly to the east of the deicing pad, so it has much less exposure to deicing fluids. The slabs in this section exhibited occasional popouts, map cracking (on four slabs, see figure 19), and surface scaling (on one slab, see figure 20).

FIGURE 19. MAP AND HAIRLINE CRACKING OBSERVED ON SAMPLE UNIT 2 AT AIRPORT FOXTROT

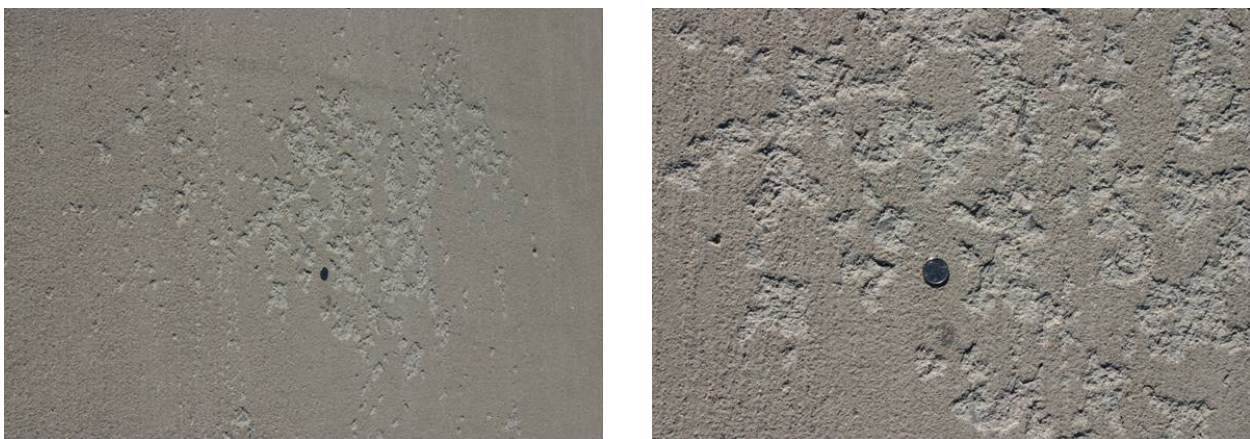
FIGURE 20. SURFACE SCALING OBSERVED ON SAMPLE UNIT 2 AT AIRPORT FOXTROT

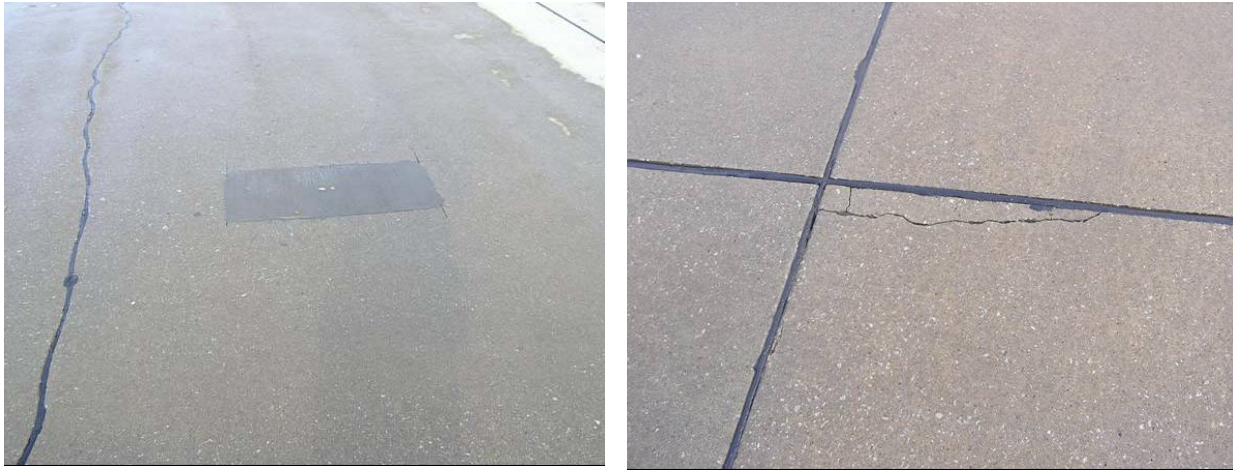
FIGURE 22. CRACKING, PATCHING, AND SPALLING OBSERVED ON SAMPLE UNIT 1 OF DEICING PAD E AT AIRPORT GOLF

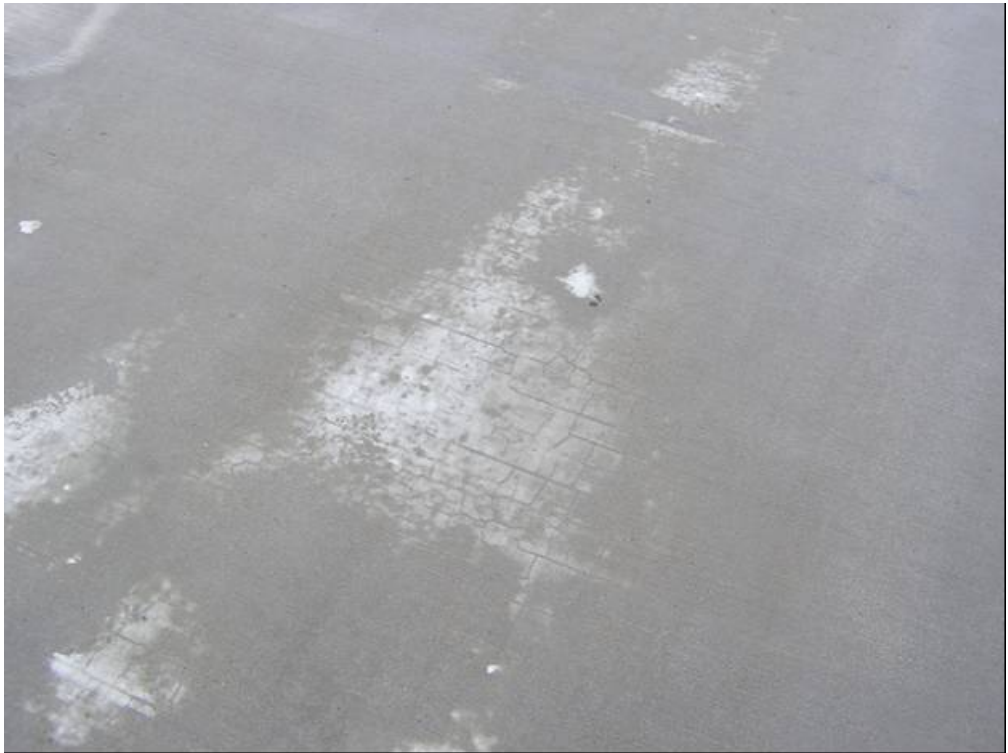
FIGURE 23. MAP CRACKING OBSERVED ON SAMPLE UNIT 1 OF DEICING PAD E AT AIRPORT GOLF

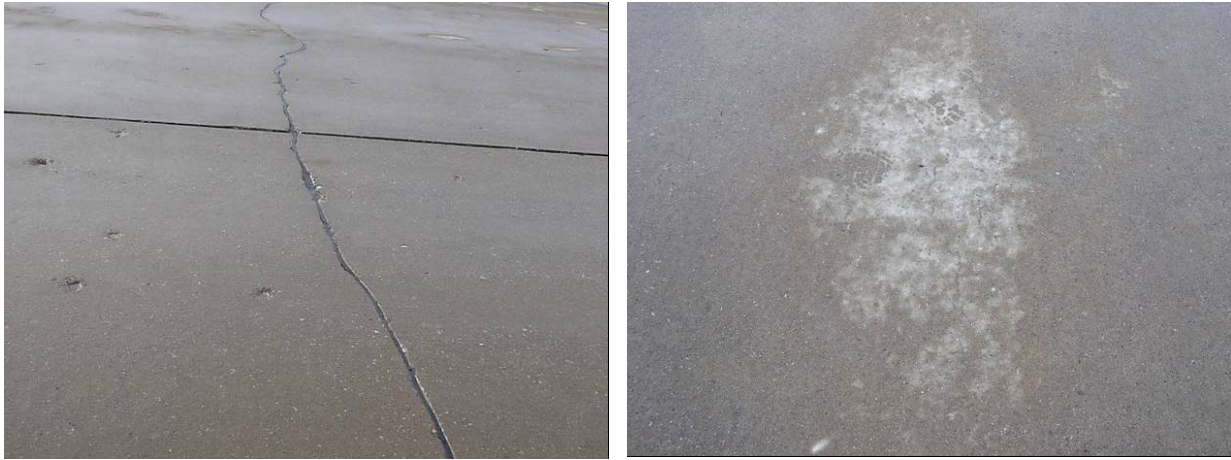
The second sample unit, located in an area of lower deicing concentration, was very similar in condition to that of the first sample unit, exhibiting low-severity cracking, low-severity patching, popouts, and low-severity joint and corner spalling. Again, some very fine map cracking was observed on a few of the slabs, and the joint sealant was noted to be in fair to poor condition. Some of the observed conditions are shown in figure 24.

FIGURE 24. CRACKING, POPOUTS, AND MAP CRACKING OBSERVED ON SAMPLE UNIT 2 OF DEICING PAD E AT AIRPORT GOLF

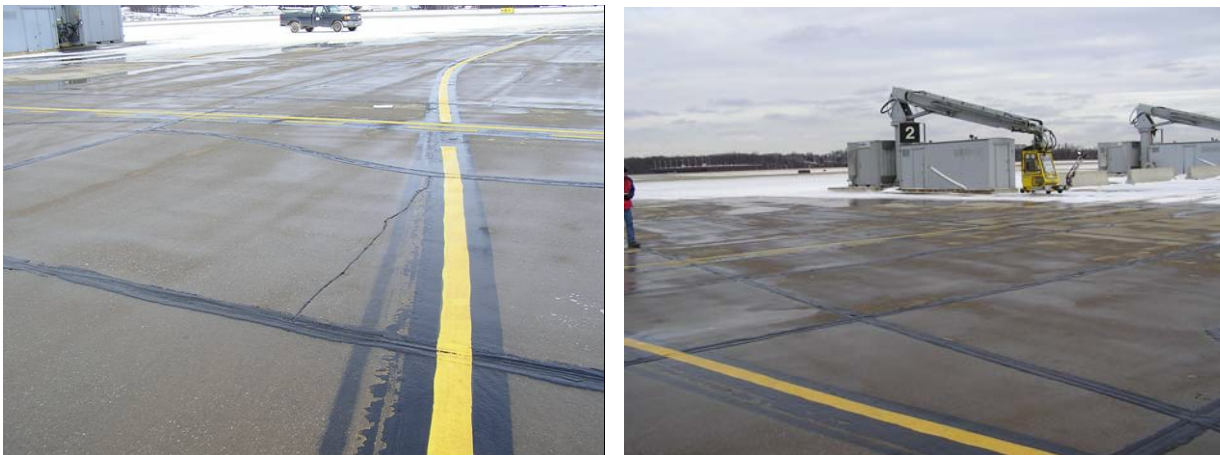
FIGURE 25. CRACKING (LEFT) AND OVERBANDED SEALANT (RIGHT) ON SAMPLE UNIT 1 OF DEICING PAD C AT AIRPORT GOLF

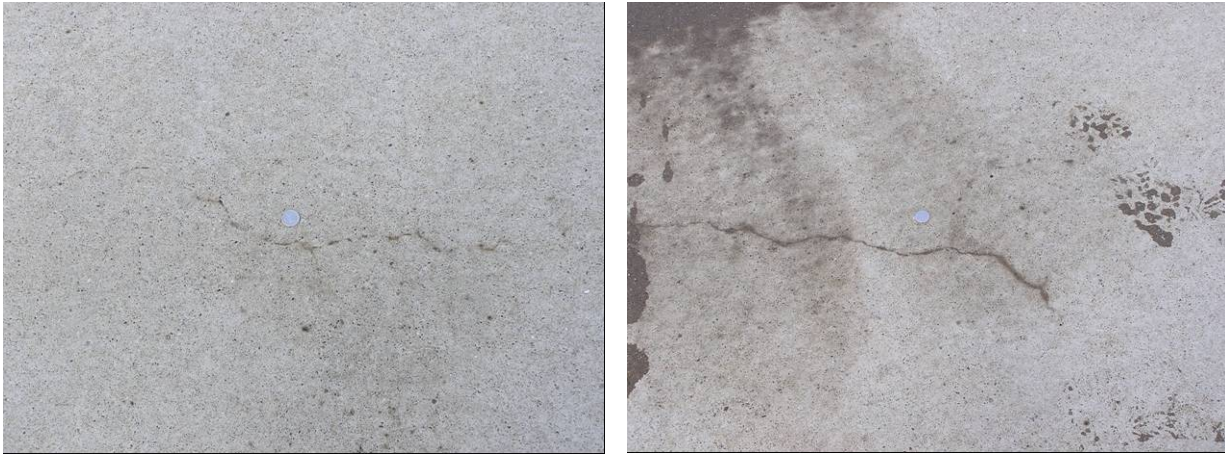
FIGURE 26. HAIRLINE CRACKING OBSERVED ON SAMPLE UNIT 1 OF DEICING PAD C AT AIRPORT GOLF

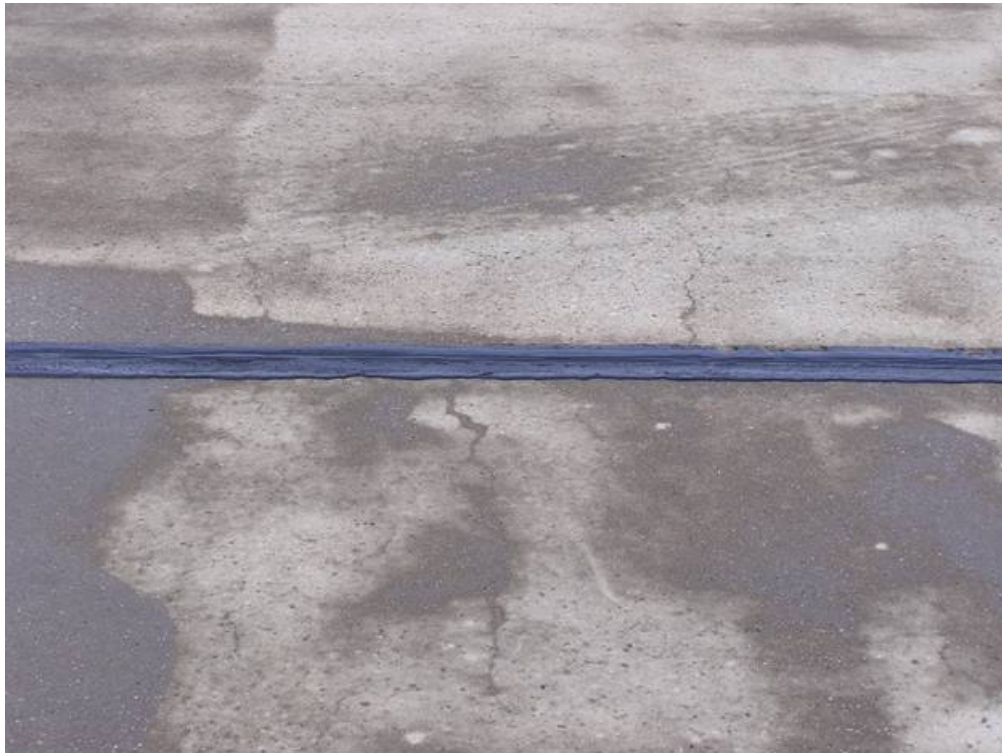
FIGURE 27. HAIRLINE CRACKING OBSERVED ON SAMPLE UNIT 2 OF DEICING PAD C AT AIRPORT GOLF

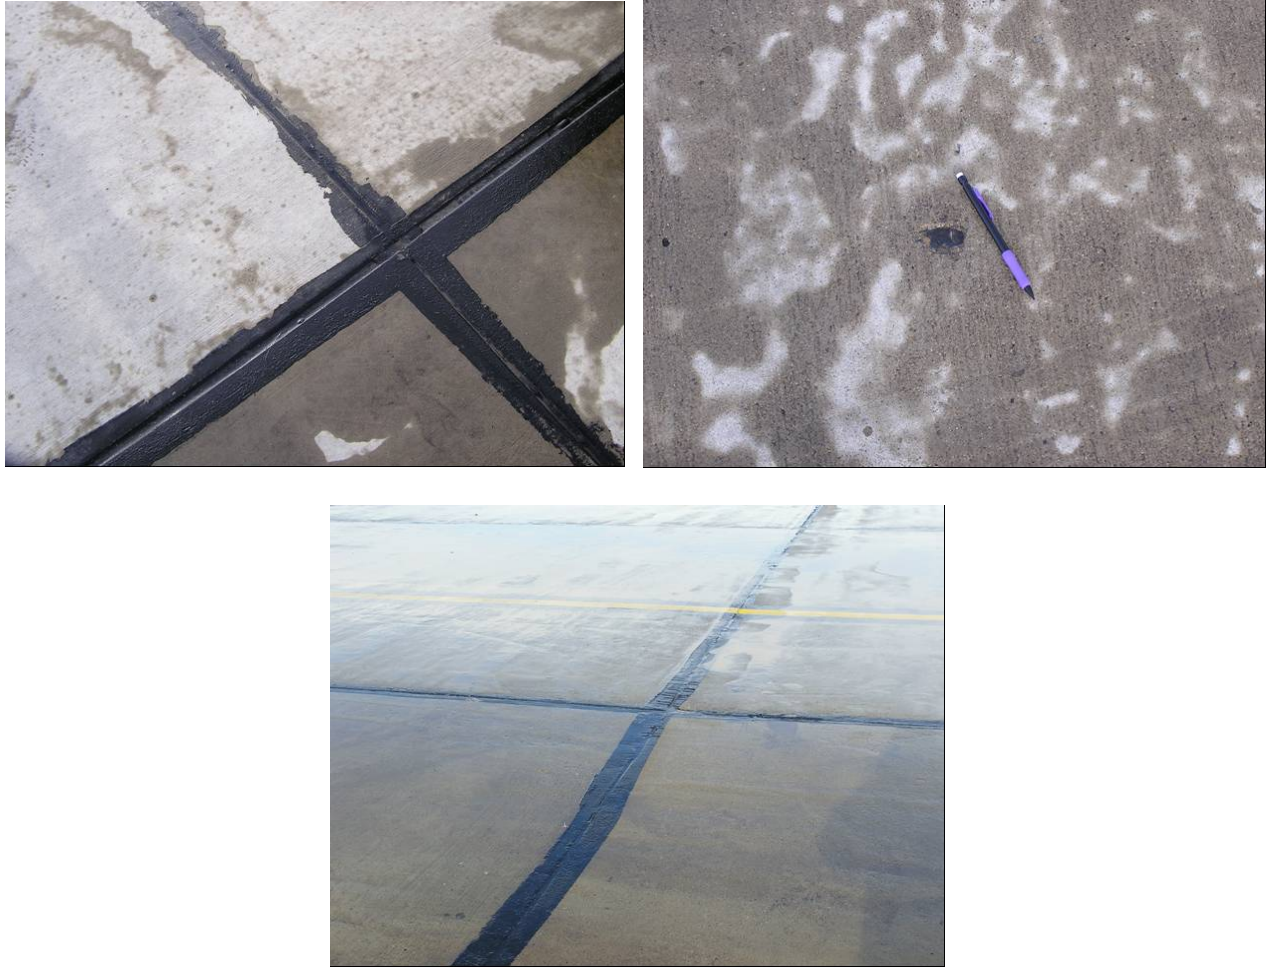
FIGURE 29. JOINT SEALANT (UPPER LEFT, SAMPLE UNIT 1), POPOUT (UPPER RIGHT, SAMPLE UNIT 2), AND OVERALL SLAB CONDITION (BOTTOM, SAMPLE UNIT 2) AT AIRPORT HOTEL

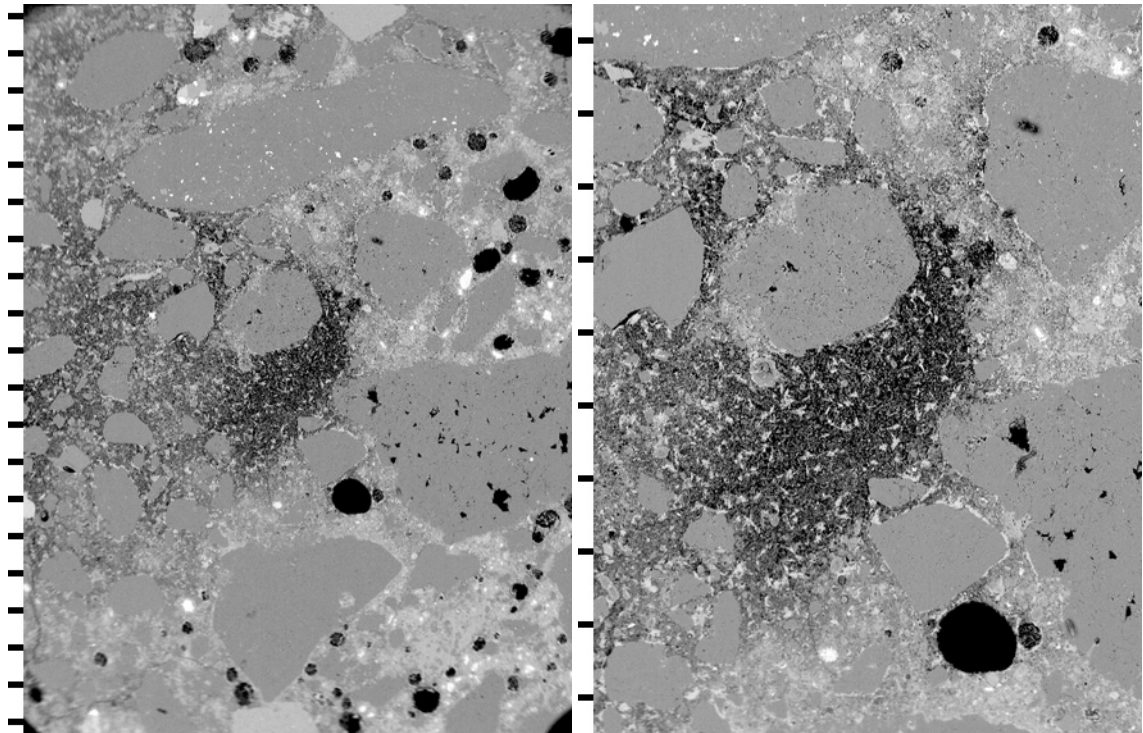
FIGURE 38. BSE IMAGES OF LOCALIZED REGION IN CEMENT PASTE OF EXTREMELY HIGH POROSITY ON POLISHED THIN SECTION FROM CORE C, AIRPORT ALPHA. TICK MARKS EVERY 250 MICROMETERS

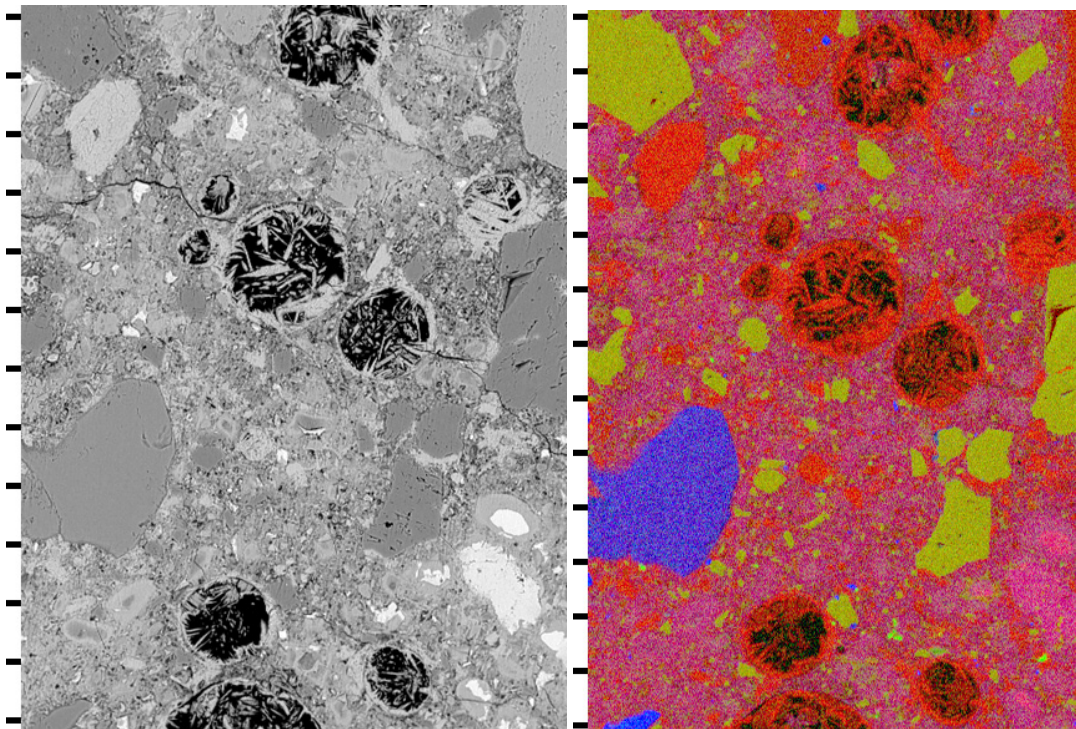
FIGURE 40. BSE IMAGE (LEFT) AND ELEMENTAL MAP (RIGHT) OF CALCIUM HYDROXIDE DEPOSITS IN ENTRAINED AIR VOIDS FROM POLISHED THIN SECTION FROM CORE C, AIRPORT ALPHA. DOLOMITE POWDER FILLER IS ALSO CLEARLY VISIBLE IN THE ELEMENTAL MAP, CA = RED CHANNEL, MG = GREEN CHANNEL, AND SI = BLUE CHANNEL. TICK MARKS EVERY 50 MICROMETERS

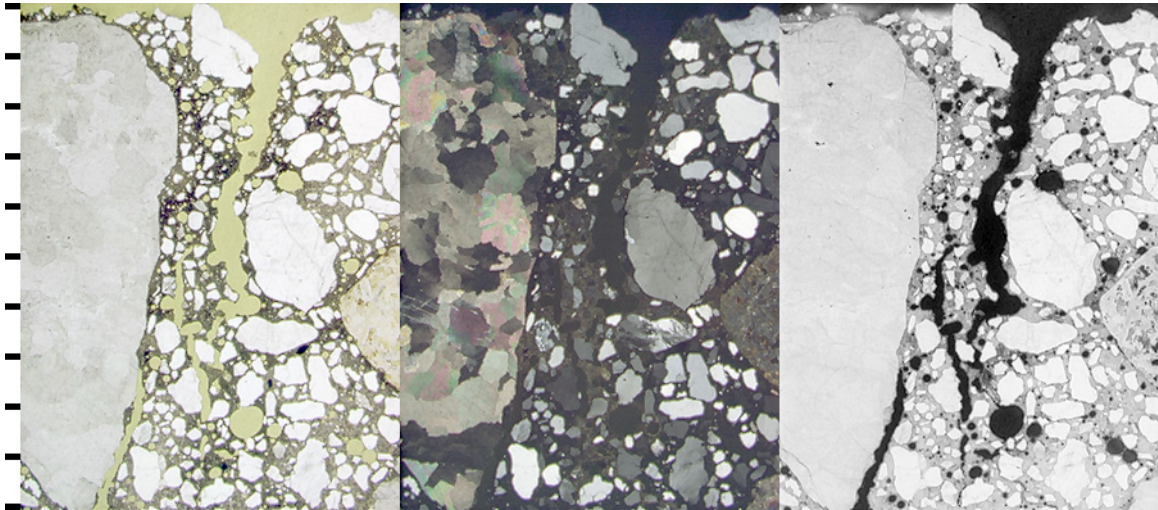
FIGURE 56. PETROGRAPHIC MICROSCOPE IMAGES TO SHOW CROSS-SECTION THROUGH PLASTIC SHRINKAGE CRACK AT PAVEMENT SURFACE FROM CORE C, AIRPORT ECHO. FROM LEFT TO RIGHT: PLANE POLARIZED LIGHT, CROSSED POLARS, AND EPIFLUORESCENT MODE. TICK MARKS EVERY MM

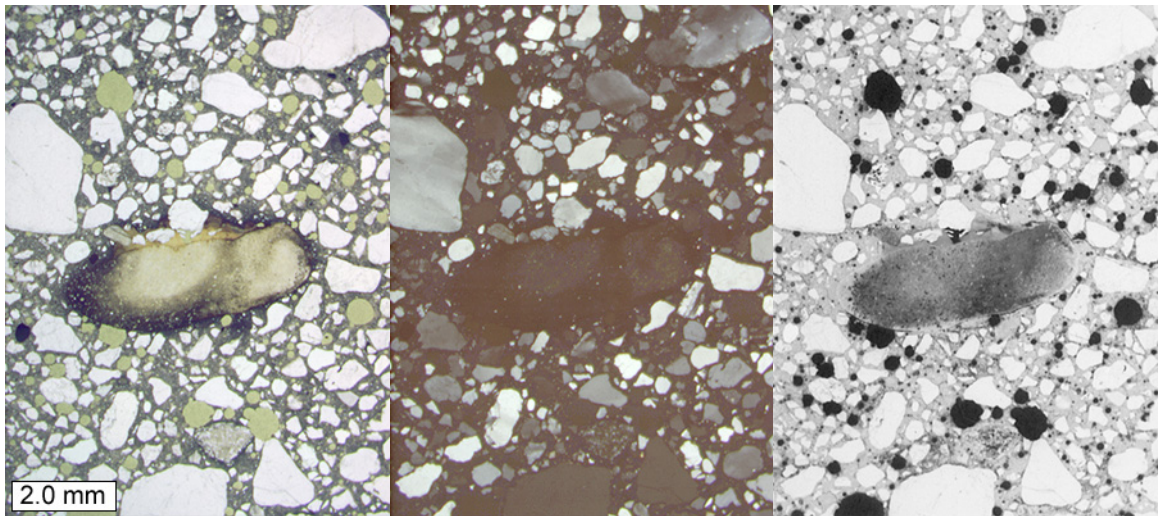
FIGURE 57. PETROGRAPHIC MICROSCOPE IMAGES TO SHOW REACTIVE FINE AGGREGATE PARTICLE IN POLISHED THIN SECTION FROM CORE C, AIRPORT ECHO. FROM LEFT TO RIGHT: PLANE POLARIZED LIGHT, CROSSED POLARS, AND EPIFLUORESCENT MODE

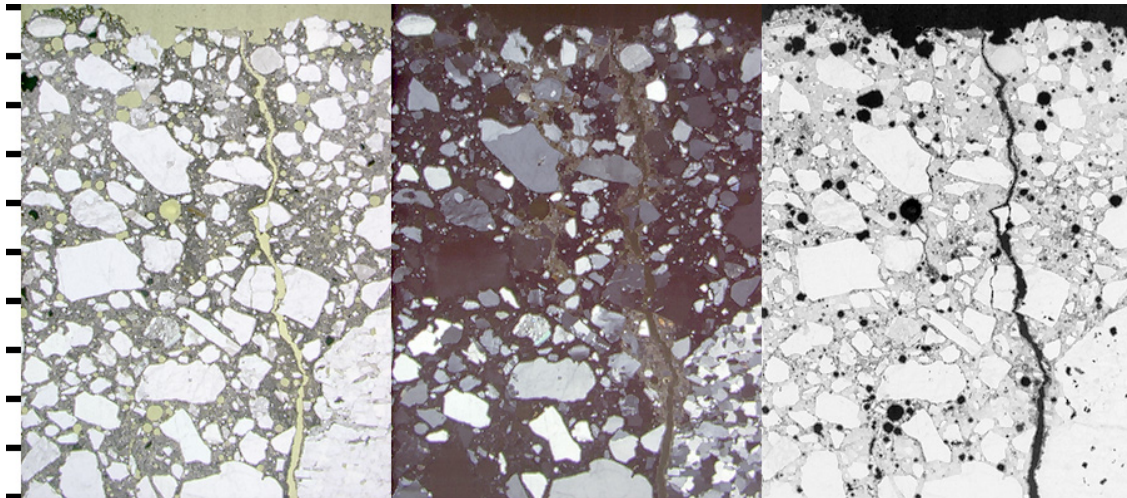
FIGURE 65. PETROGRAPHIC MICROSCOPE IMAGES OF POLISHED THIN SECTION FROM CORE C, AIRPORT FOXTROT, SHOWING CROSS SECTION THROUGH PAVEMENT SURFACE AND CARBONATION ALONG CRACK. FROM LEFT TO RIGHT: PLANE POLARIZED, CROSSED POLARS, AND EPIFLUORESCENT MODE. TICK MARKS EVERY MM

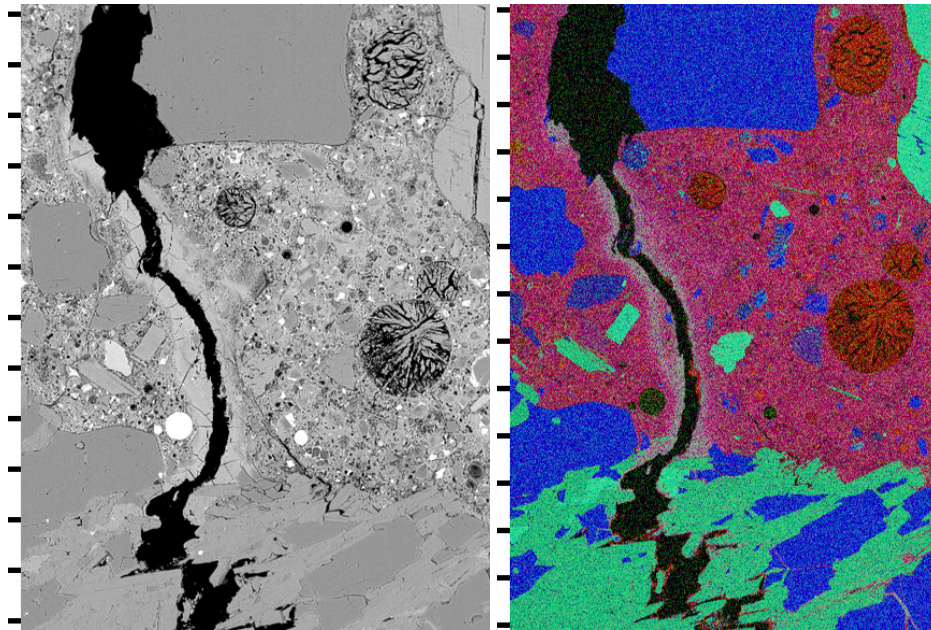
FIGURE 68. BSE IMAGE (LEFT) AND ELEMENTAL MAP (RIGHT) OF CRACK LINED WITH ALKALI SILICA REACTION PRODUCT AND ENTRAINED AIR VOIDS FILLED WITH SECONDARY ETTRINGITE DEPOSITS IN POLISHED THIN SECTION PREPARED FROM CORE C, AIRPORT FOXTROT. IN ELEMENTAL MAP, CA = RED CHANNEL, K = GREEN CHANNEL, AND SI = BLUE CHANNEL. TICK MARKS EVERY 100 MICROMETERS

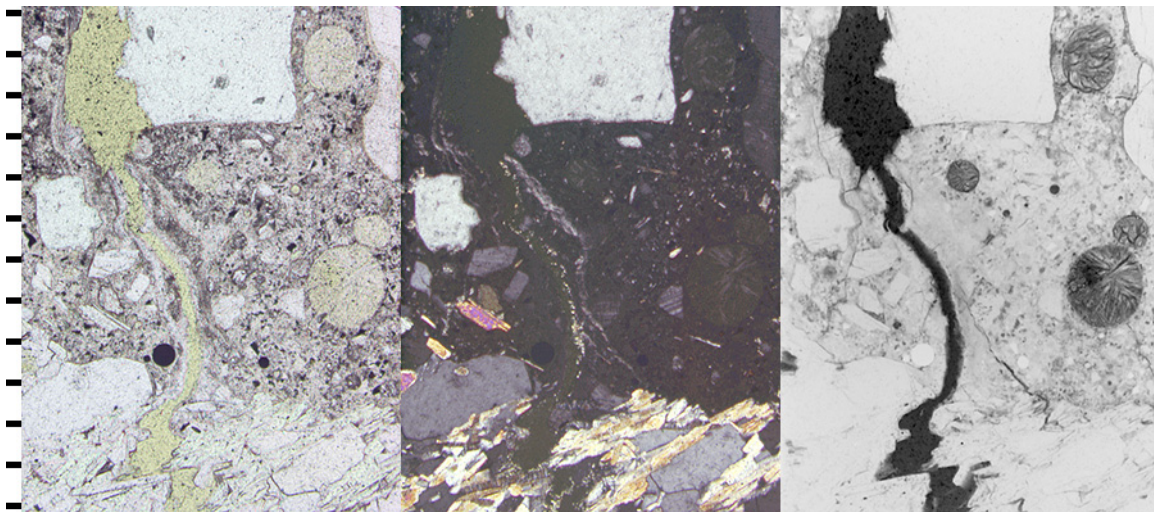
FIGURE 69. PETROGRAPHIC MICROSCOPE IMAGES OF CRACK LINED WITH ALKALI SILICA REACTION PRODUCT, AND ENTRAINED AIR VOIDS FILLED WITH SECONDARY ETTRINGITE DEPOSITS IN POLISHED THIN SECTION PREPARED FROM CORE C, AIRPORT FOXTROT. FROM LEFT TO RIGHT: PLANE POLARIZED, CROSSED POLARS, AND EPIFLUORESCENT MODE. TICK MARKS EVERY 100 MICROMETERS

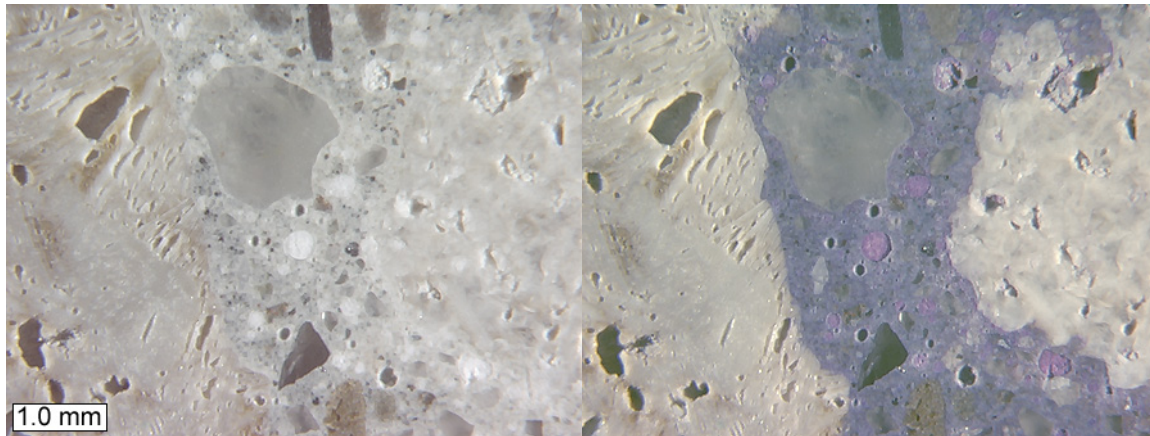
FIGURE 74. STEREO-MICROSCOPE IMAGES OF POLISHED SLAB FROM MIDDLE THIRD OF CORE C SHOWING ETTRINGITE FILLED ENTRAINED AIR VOIDS BOTH BEFORE (LEFT) AND AFTER (RIGHT) STAINING WITH BARIUM CHLORIDE AND POTASSIUM PERMANGANATE SOLUTION

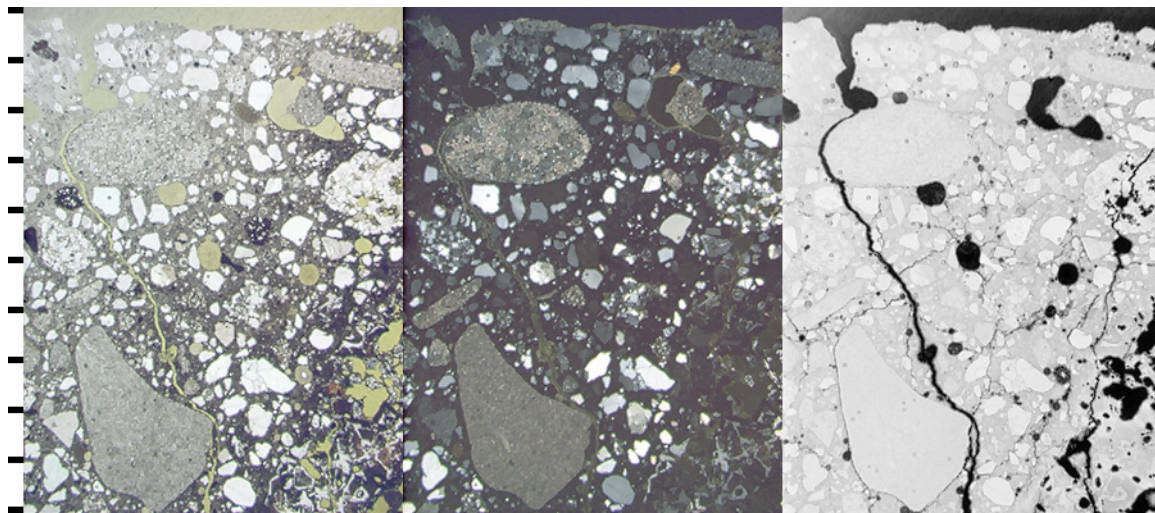
FIGURE 76. PETROGRAPHIC MICROSCOPE IMAGES OF POLISHED THIN SECTION FROM CORE C, AIRPORT GOLF, SHOWING CROSS SECTION THROUGH PAVEMENT SURFACE AND CARBONATION ALONG CRACK. FROM LEFT TO RIGHT: PLANE POLARIZED, CROSSED POLARS, AND EPIFLUORESCENT MODE. TICK MARKS EVERY MM

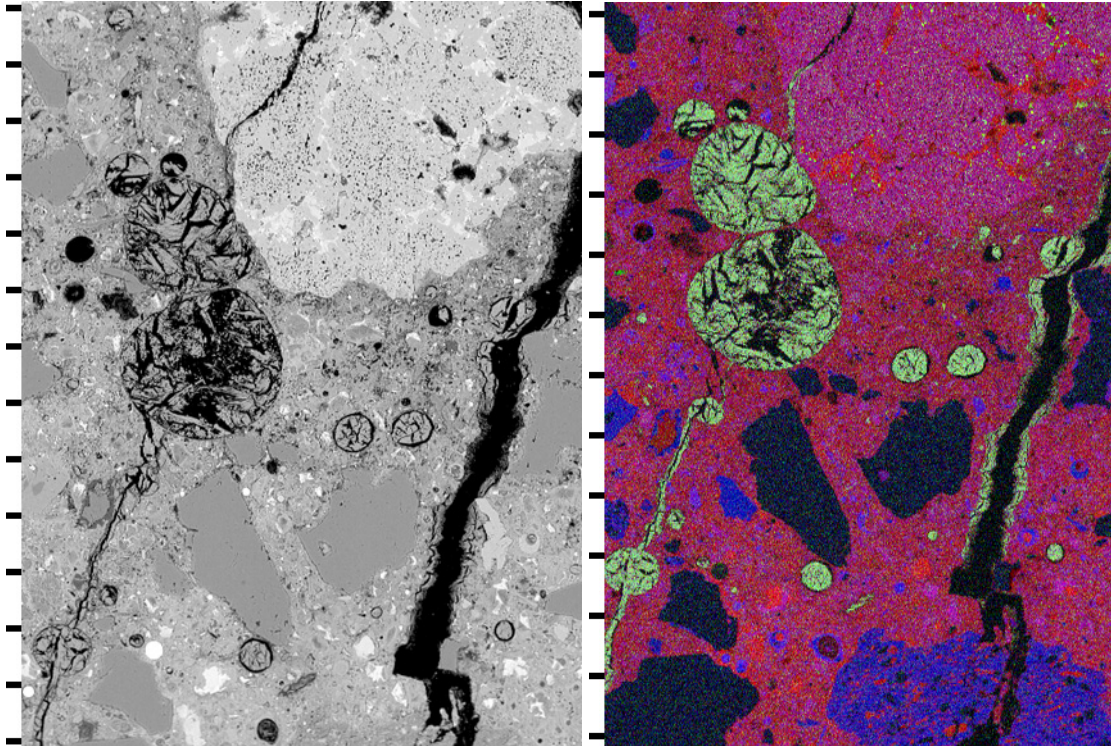
FIGURE 77. BSE IMAGE (LEFT) AND ELEMENTAL MAP (RIGHT) OF CRACK LINED WITH ETTRINGITE DEPOSITS IN POLISHED THIN SECTION PREPARED FROM CORE C, AIRPORT GOLF. IN ELEMENTAL MAP, CA = RED CHANNEL, S = GREEN CHANNEL, AND AL = BLUE CHANNEL. TICK MARKS EVERY 100 MICROMETERS

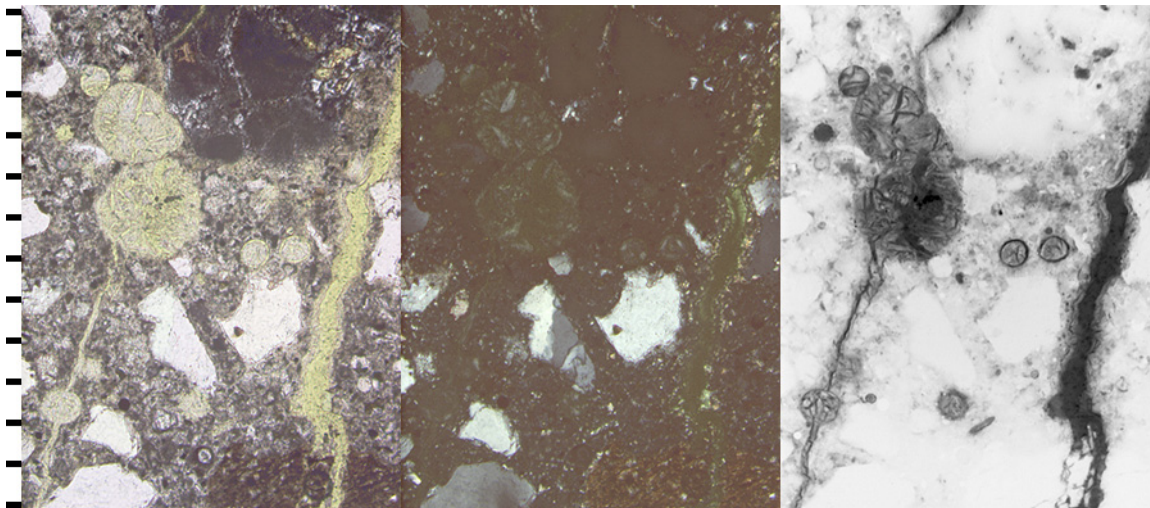
FIGURE 78. PETROGRAPHIC MICROSCOPE IMAGES OF CRACK LINED WITH ETTRINGITE DEPOSIT IN POLISHED THIN SECTION PREPARED FROM CORE C, AIRPORT GOLF. FROM LEFT TO RIGHT: PLANE POLARIZED, CROSSED POLARS, AND EPIFLUORESCENT MODE. TICK MARKS EVERY 100 MICROMETERS
