Report IPRF-01-G-002-3

Innovative Rehabilitation of Pavement for Light Load Aircraft

September 2004

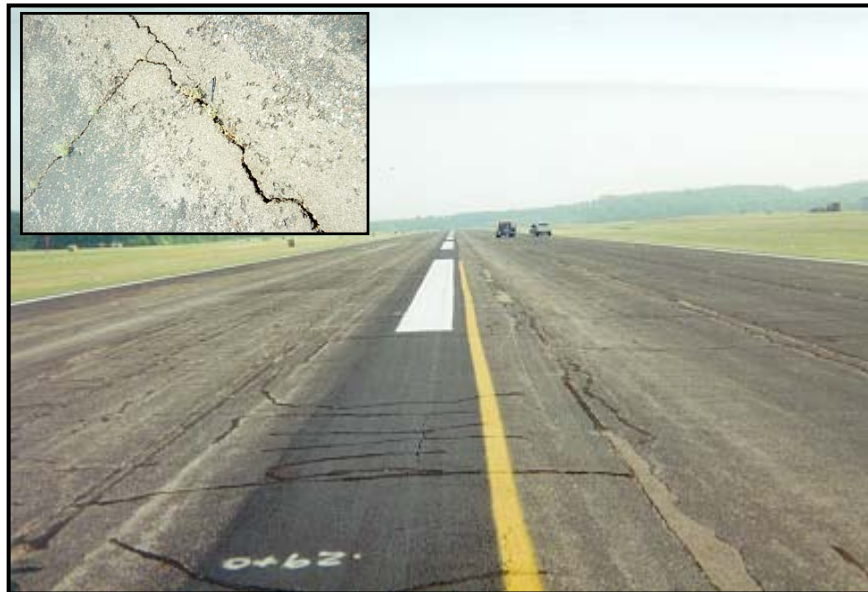
The surface of Runway 18-36 was generally in fair to good condition. Figure 2.2 shows low- and medium-severity block cracking observed along the entire length of the runway; the inset shows a close-up of typical crack intersections. Low-severity longitudinal and transverse cracks were also noted (Figure 2.3).

Figure 2.2. Block cracking observed on both sides of the runway centerline at SNH.

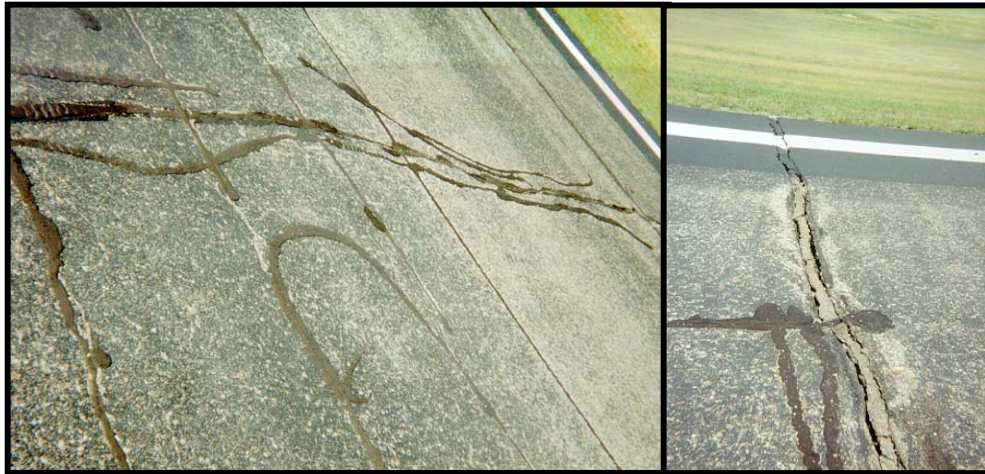
Figure 2.3. Longitudinal and transverse cracking observed at SNH.

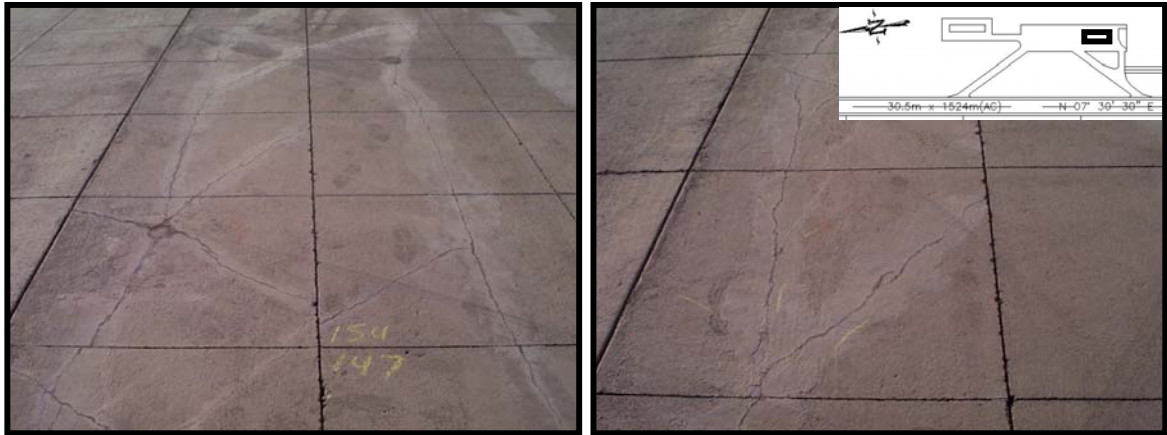
All pavement areas on Runway 18-36 had a high PCI rating. The runway was the original UTW rehabilitation project and a thorough evaluation of the existing AC pavement and in-depth design analysis was made prior to the UTW construction. Because the runway UTW construction was such a success, the contract was amended to include UTW construction on the taxiways and the apron without any pre-construction testing or any further design analysis. The same design section (4-inch [100-mm] PCC) was used for this additional construction. Several areas on the apron and taxiway contained localized weak spots and deterioration of the AC. Shortly after completion of the UTW construction, these areas exhibited extensive cracking, with the majority of the slabs cracked into two or more pieces, as shown in Figure 2.8.

Figure 2.8. Cracking in SNH apron UTW slabs.

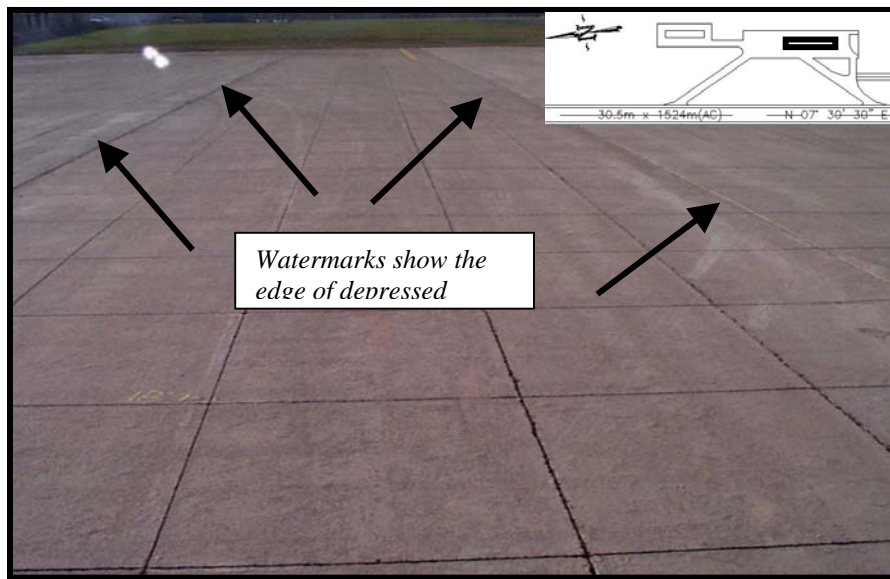
Another problem encountered in the same area was depressed slabs in the general vicinity of the cracked slabs; these are shown in Figure 2.9. Improper joint spacing and slab shapes also caused slabs to crack, especially at the intersection of taxiways and the apron, and taxiways and the runway (Figure 2.10).

Figure 2.9. Poor subgrade support caused depressions in SNH apron pavement.

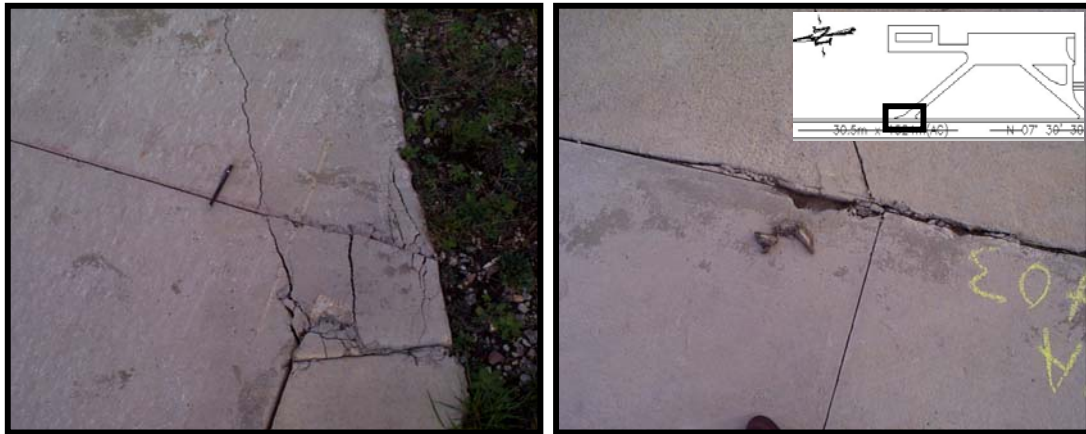
Figure 2.10. Improper joint spacing and slab shapes caused SNH slabs to crack.

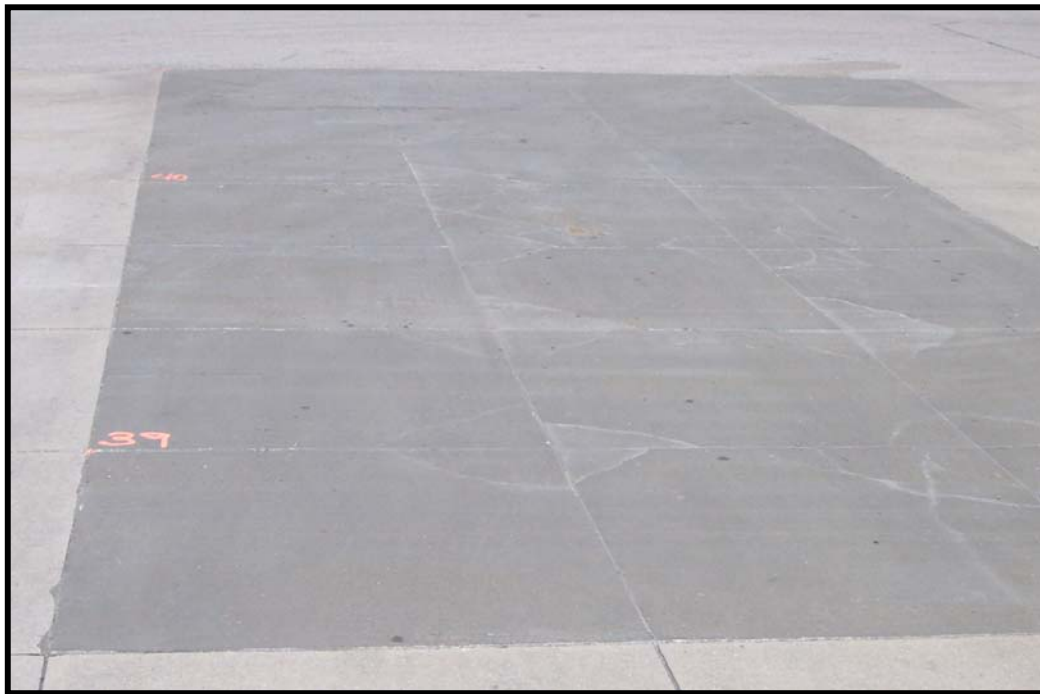
After entering the apron area, trucks make a left turn on the UTW pavement (Figure 2.13-A). All PCC slabs along the path of the trucks, shown in Figure 2.14, have corner cracks. The fuel trucks make the second left turn (Figure 2.13-B) into the parking area. All slabs in this area are shattered or fractured into three or more pieces as shown in Figure 2.15. Corner breaks and shattered slabs are load-related, not climate or durability-related. Another problem noticed at SUS was cracking of slabs containing aircraft tie downs, shown in Figure 2.16. These slabs were retrofitted with tie down anchors, which are PCC columns extending about 18 inches (457 mm) into the ground below the slab. Stress build-up due to temperature swings have resulted in the cracking shown in Figure 2.16.

Figure 2.14. All slabs at the first left turn have corner cracks along interior joints.

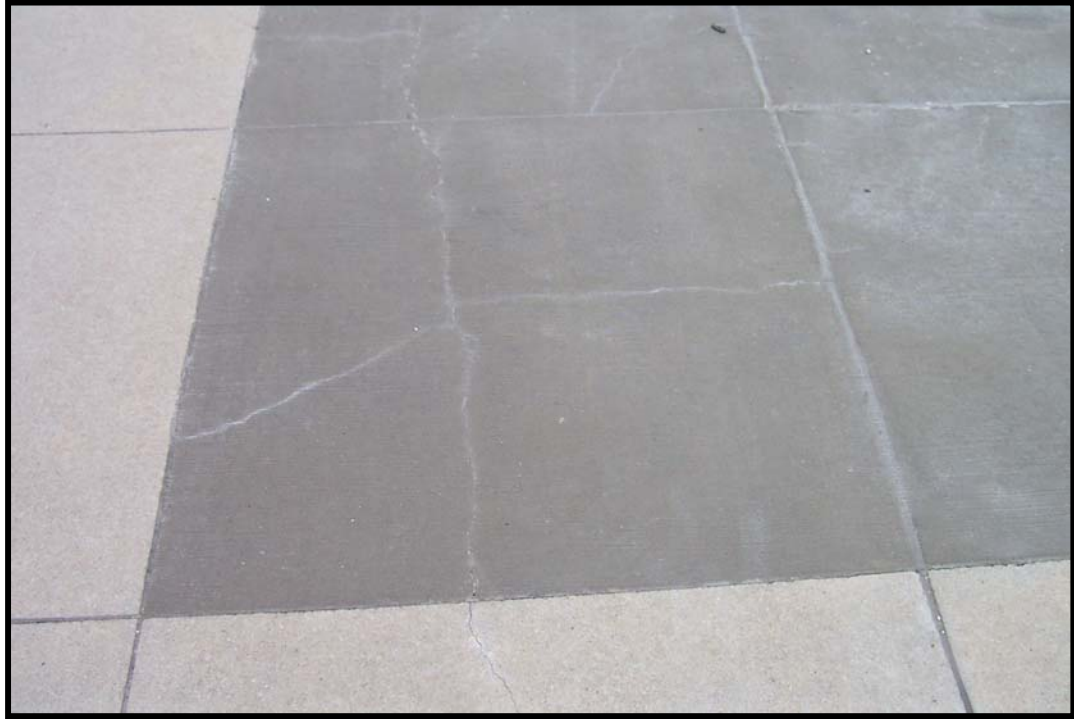
Figure 2.15. All slabs after the second left turn are shattered into three or more pieces.

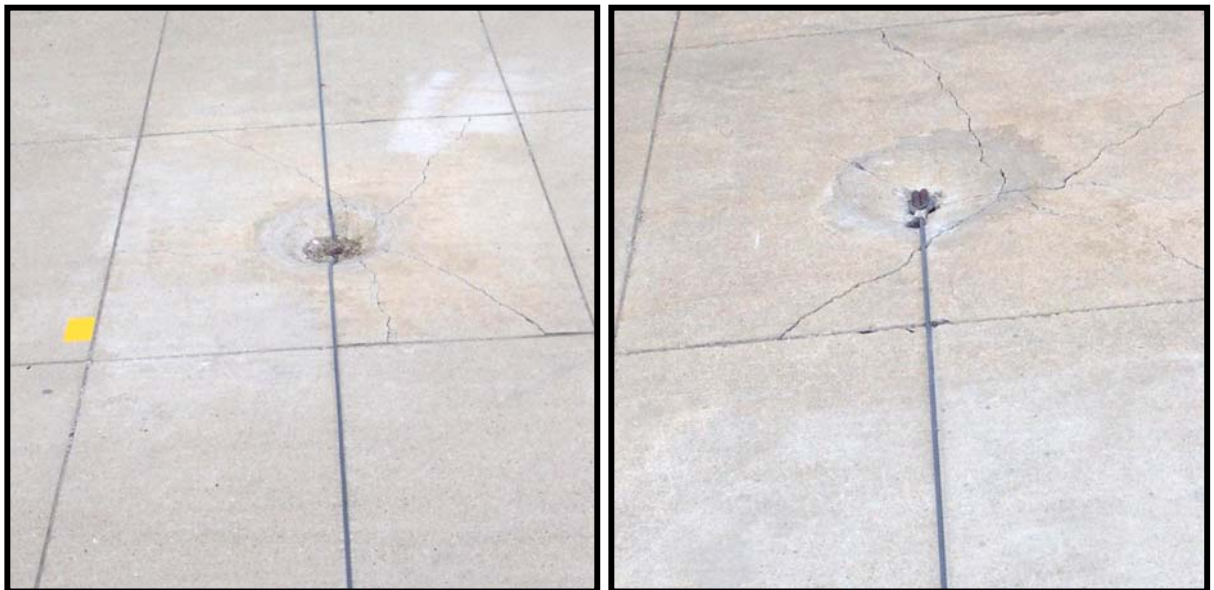
Figure 2.16. All slabs containing aircraft tie downs were shattered.

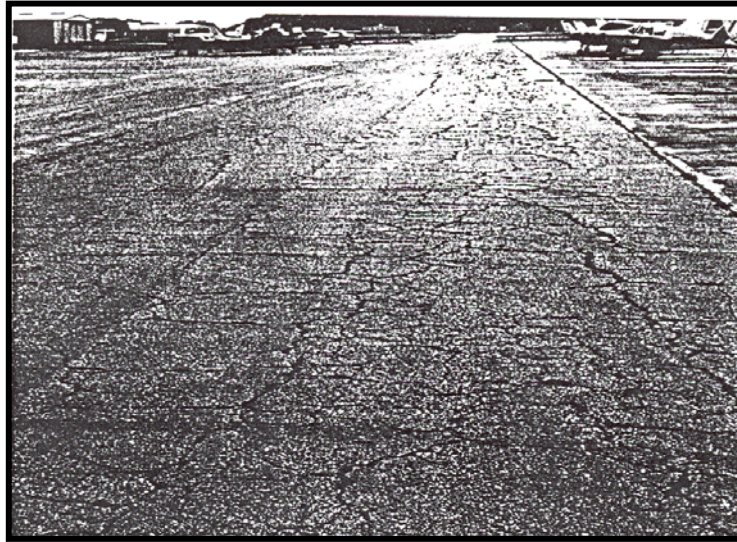
Figure 2.19. Alligator cracking of AC surface at New Smyrna Beach Airport.

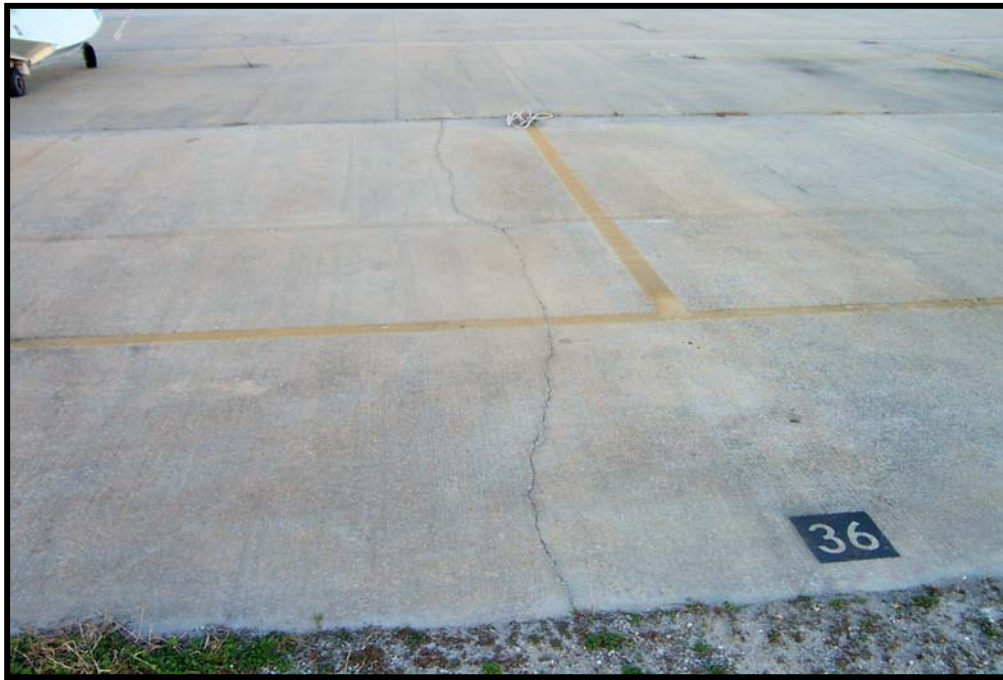
Figure 2.22. Large 26-ft by 13-ft (8-m by 4-m) slabs cracked into two pieces.

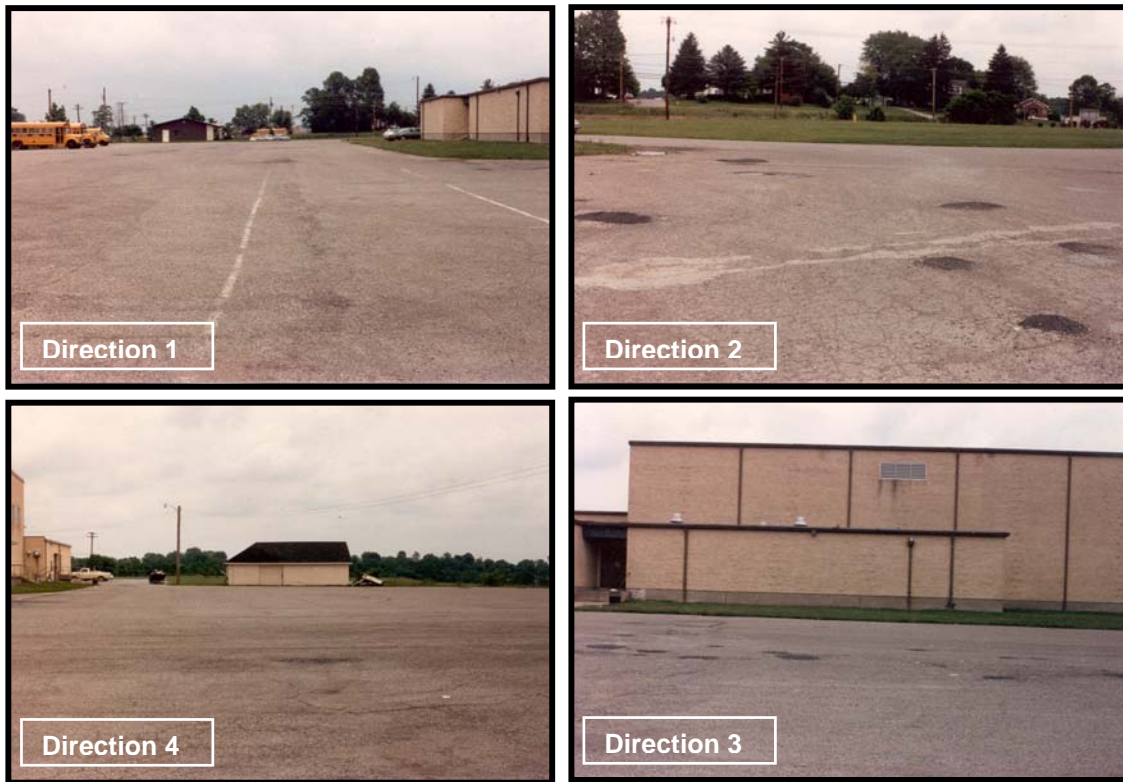
Figure 2.27 shows distresses at various locations in the parking lot (viewing directions are indicated on Figure 2.26). The existing AC had oxidized, and almost all the pavement section had block cracking. Several places had severe alligator cracking and patches where potholes had been repaired.

Figure 2.27. AC pavement at the Williamstown School was severely distressed.

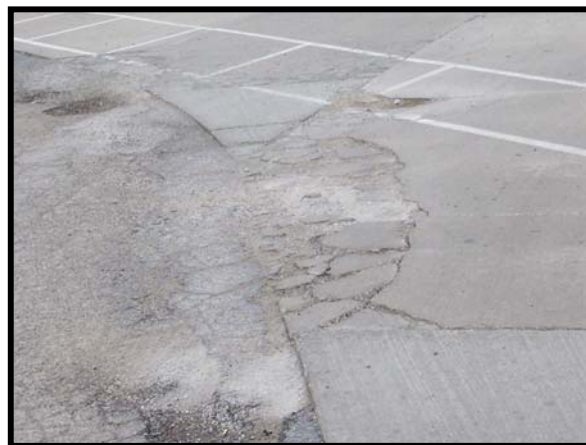
Slabs in Feature 1 (see Table 2.20, Figure 2.29) were badly deteriorated at the transition from AC to PCC pavement. PCC slabs in this area were badly cracked (see Figure 2.30), which led to a low PCI of 43.

Figure 2.30. PCC Slabs on transition from AC to PCC were severely distressed.

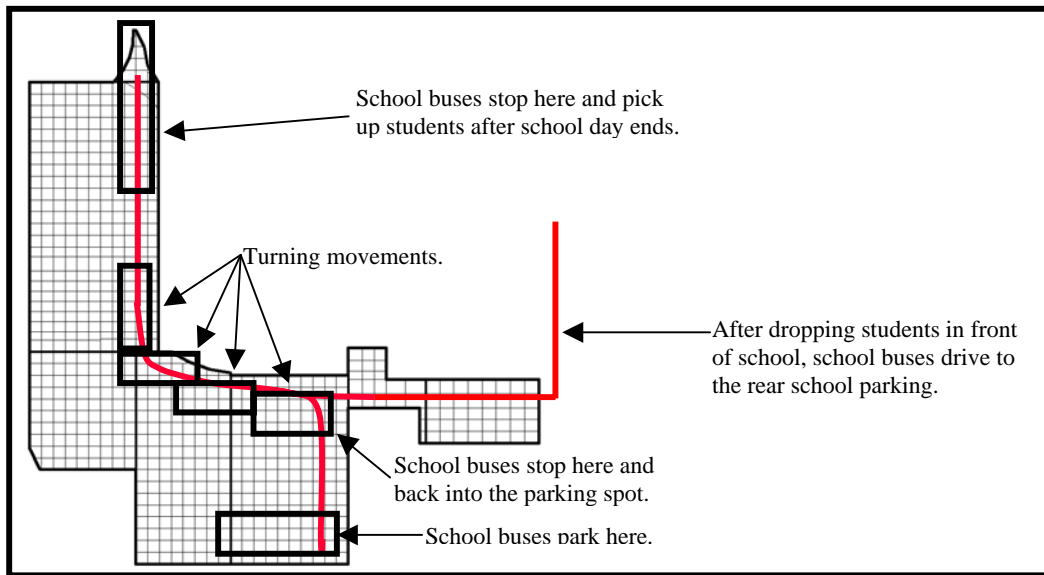
Figure 2.31. The path followed by school buses was severely distressed.

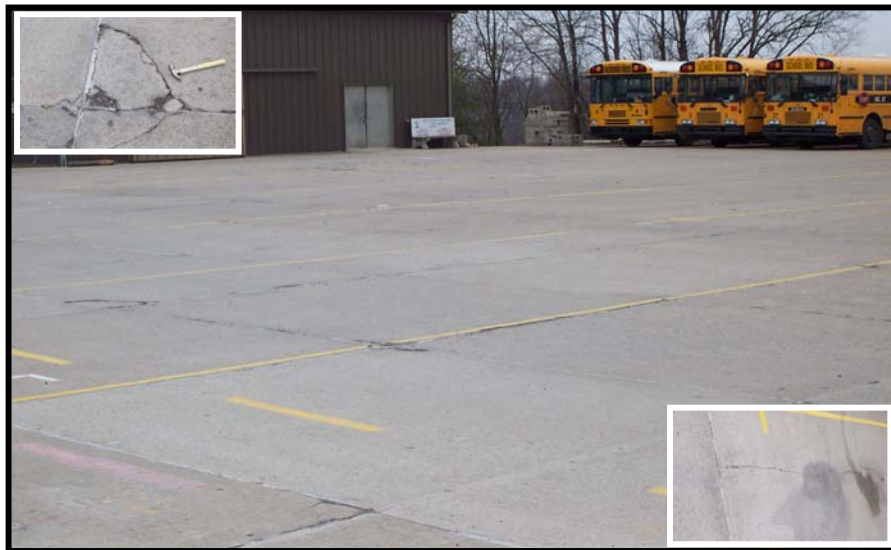
Figure 2.32. Most slabs where buses made turns had broken corners.

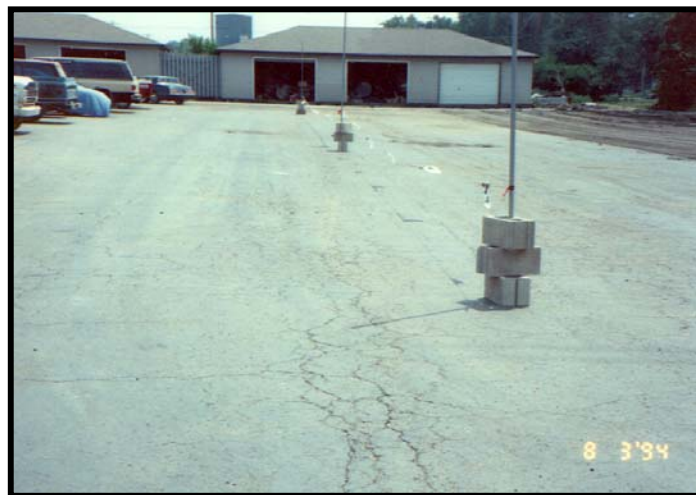
The condition of the parking lot before UTW construction is shown in Figure 2.35. The parking lot had block cracking in all areas and severe alligator cracking, especially in areas with high traffic. The pavement surface was raveled and oxidized.

Figure 2.35. AC pavements at Holiday Inn parking lot exhibited alligator cracking.

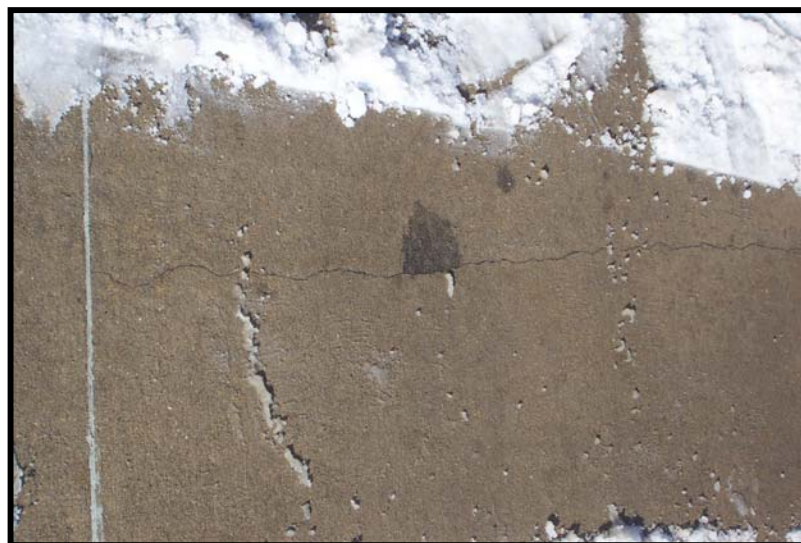
The only crack observed was located with the help of the groundskeeper (see Figure 2.38). A few slabs and this crack were tapped with the hammer, and they all sounded solid. However, due to prevailing freezing temperatures, no statement can be made about the bond.

Figure 2.38. A single crack in front of a rear hotel entrance was observed.

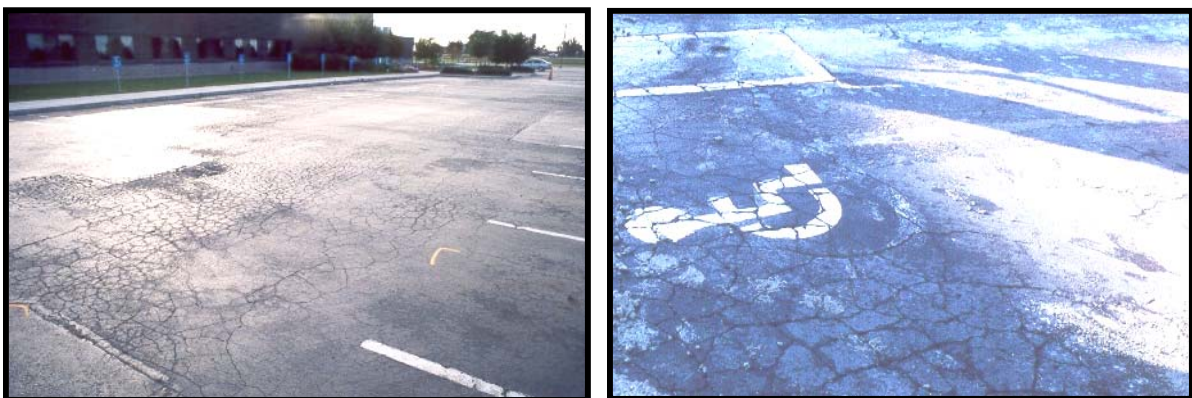
The existing AC parking lot was severely distressed with alligator cracks covering all areas, as shown in Figure 2.40. There were areas of the parking lot where the pavement had rutted after the formation of alligator cracks; these areas were repaired using full-depth patches before UTW placement.

Figure 2.40. Life Bridge Christian Church parking lot was severely cracked.

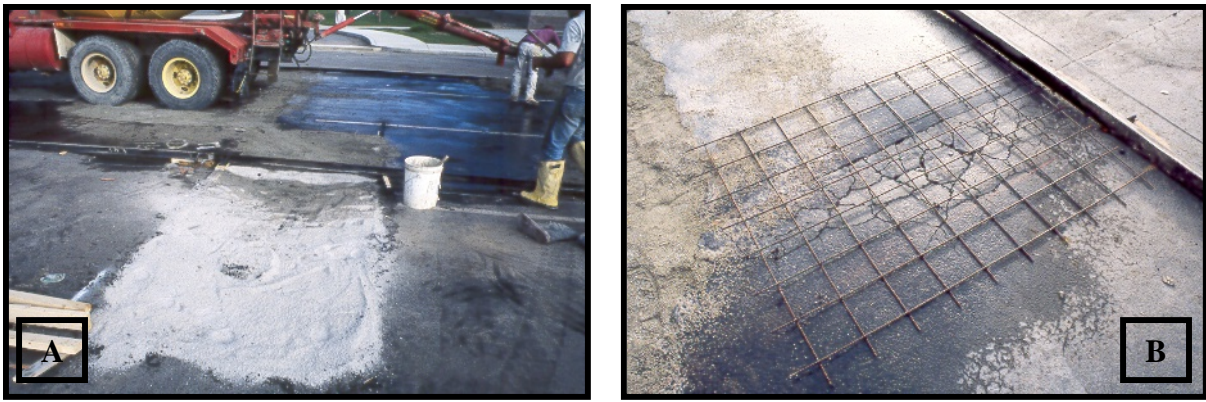
Figure 2.41. Severely distressed areas were repaired before UTW construction.

Potholes in the existing pavement were filled, and large depressed areas were filled with crusher fines (Figure 2.41-A). If the depressed areas showed an indication of fatigue (depressed with severe fatigue cracking), the surface was strengthened using a welded wire mesh (Figure 2.41-B).

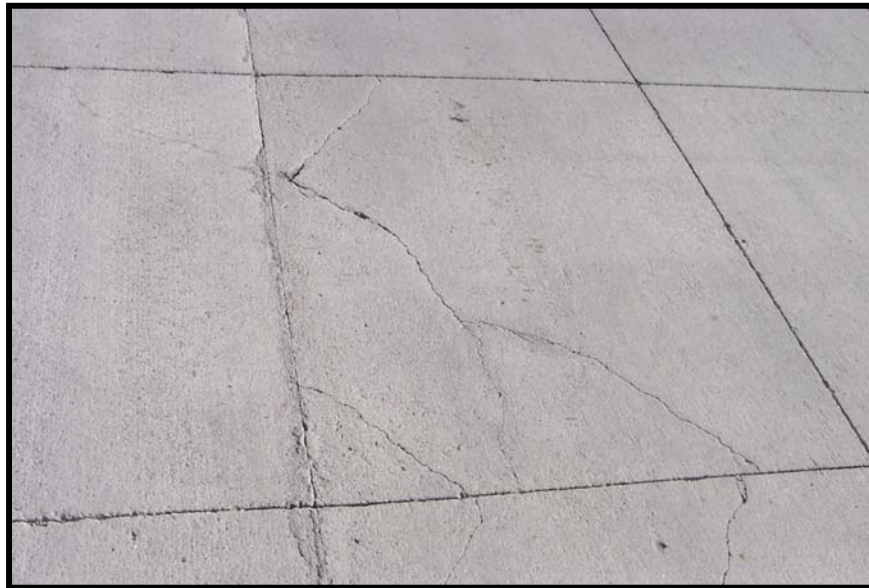
A construction-related problem was noted at the driveway leading to the church. The driveway between the parking lots was placed last and, due to an error in slope calculations, a portion of the driveway had a slab thickness of only 2-inches (50-mm). This area has failed, as shown in Figure 2.44.

Figure 2.44. Thinner slabs led to premature failure.

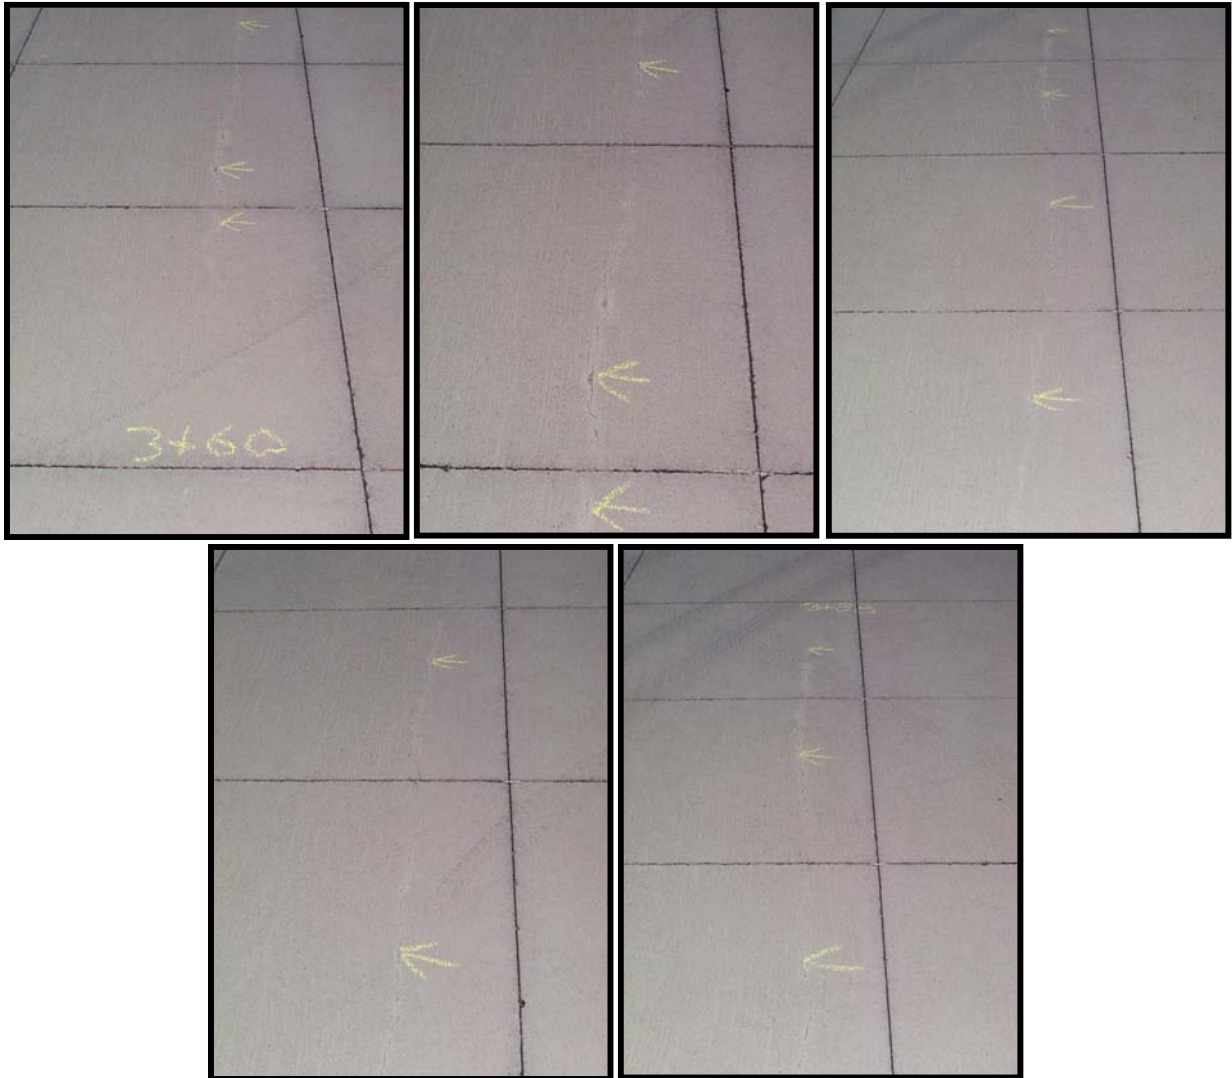
and AC when tapped with a hammer; all slabs sound solid when tapped at mid-slab and along the crack. Once a crack started it progressed on to adjoining slabs.

Figure 3.2. Linear cracks, once started, may continue for several slabs.

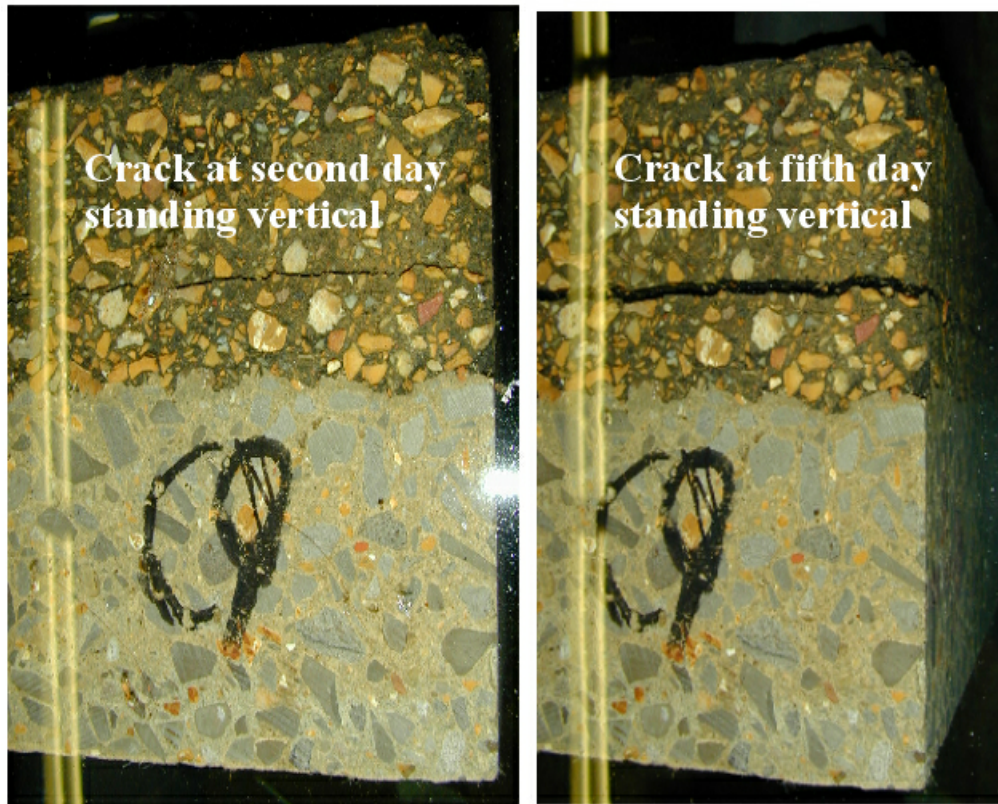
Figure 6.34. Delamination between asphalt layers on F&T specimen C9 at 64 cycles.

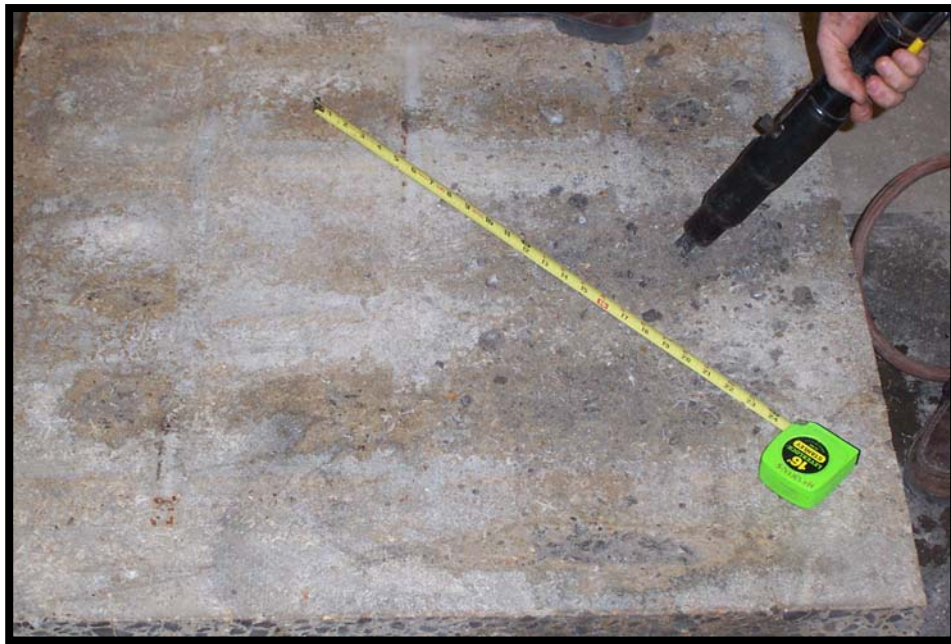
Figure 6.58. Severely deteriorated PCC surface was easily scrapped using a jackhammer.
