An **IPRF** Research Report
Innovative Pavement Research Foundation
Airport Concrete Pavement Technology Program

Report IPRF-01-G-002-03-9

**Potential for Acceleration of ASR
in the Presence of Pavement
Deicing Chemicals**

March 2007

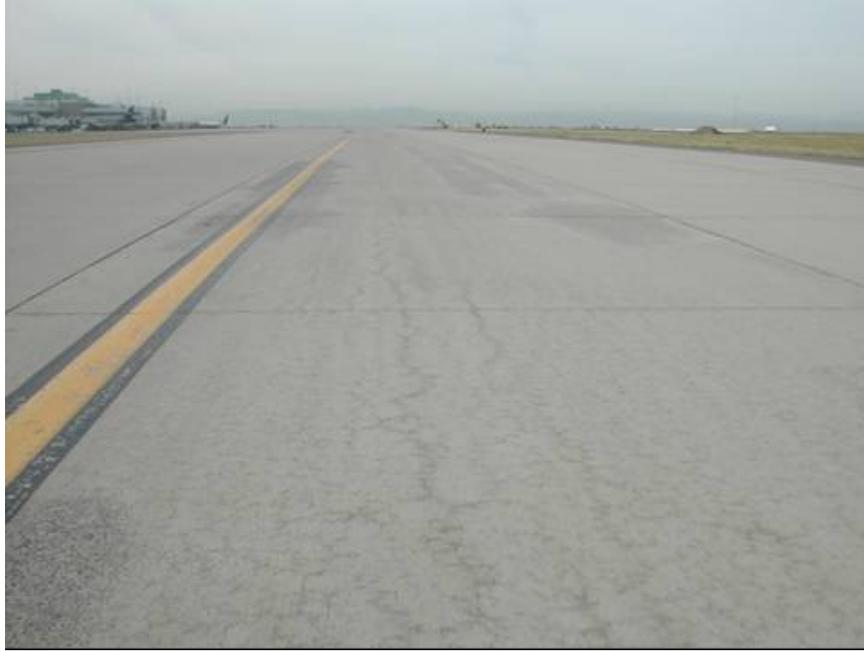
FIGURE 1. ASR DISTRESS IN CONCRETE PAVEMENT AT DENVER INTERNATIONAL AIRPORT

In some of these airports, including COS, DEN, SLC and DTW it has been suspected that the exposure of the concrete pavement to the alkali-acetate and alkali-formate deicers may have played a role in either triggering or accelerating ASR distress. Figures 1 and 2 show the typical ASR distress observed in airfield concrete pavements exposed to deicing chemicals.

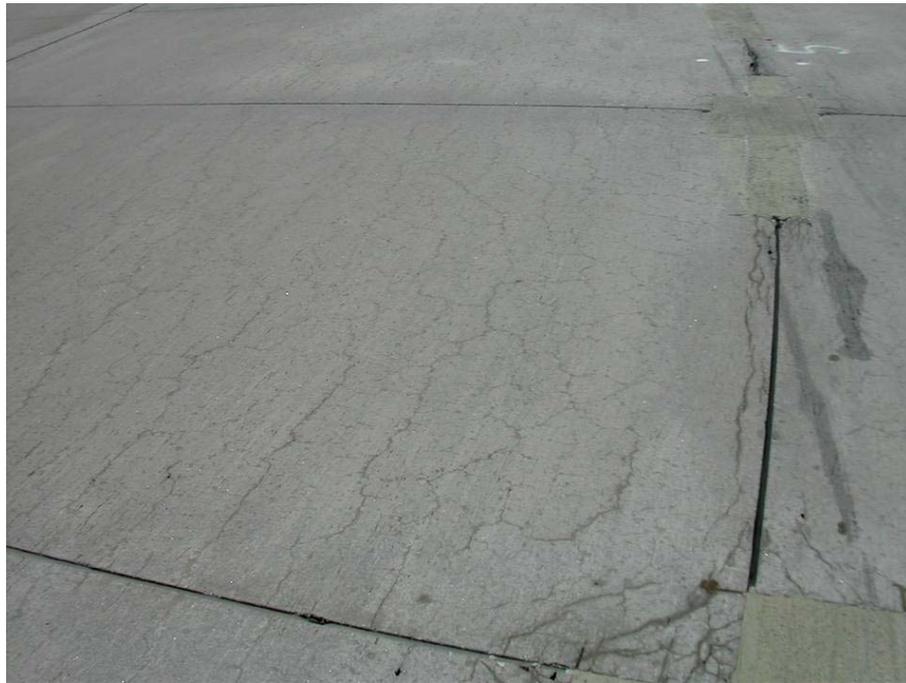
FIGURE 2. ASR DISTRESS IN CONCRETE PAVEMENT AT COLORADO SPRINGS AIRPORT

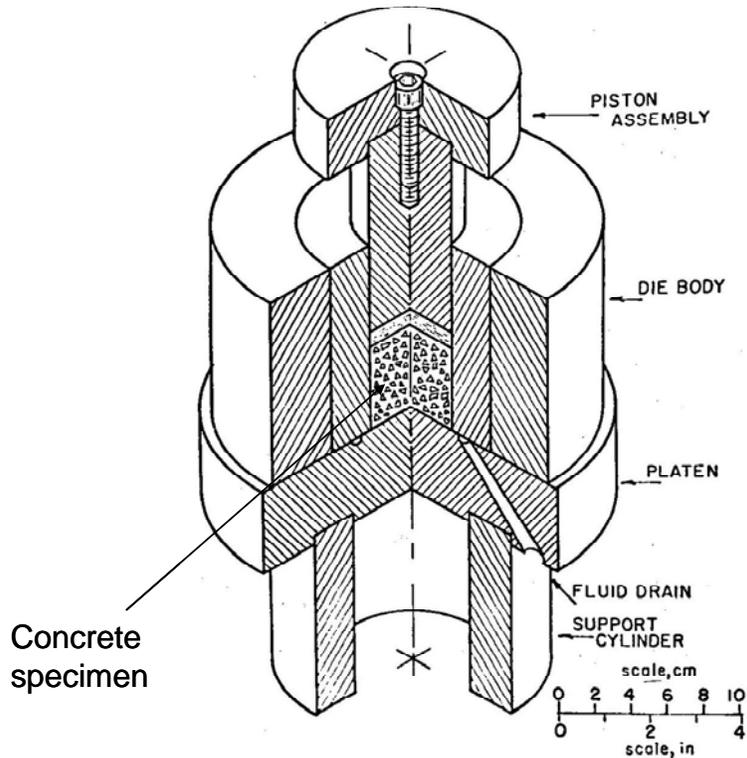
FIGURE 3. ISOMETRIC HALF-SECTION OF PORE FLUID EXPRESSION DEVICE [33]

3-month and 6-months old concrete specimens previously tested for expansion using the modified ASTM C 1293 method were used for expression of pore solution. After slicing sections of concrete prisms from standard and modified ASTM C 1293 tests, the specimens for pore solution expression were tightly sealed with plastic foil after wrapping with wet towels (soaked in deicer solution and then wrung out) to prevent pore solution loss during shipment. Just before the start of the squeezing process the samples were crushed in laboratory crusher. After crushing, some of the loose coarse aggregate grains were removed from the specimens to increase the paste content in the sample. The pore fluid expression device designed by Barneyback and Diamond was used for pore solution expression [33]. The apparatus (shown in Figure 3) has an inner specimen chamber with a diameter of 2 inches.

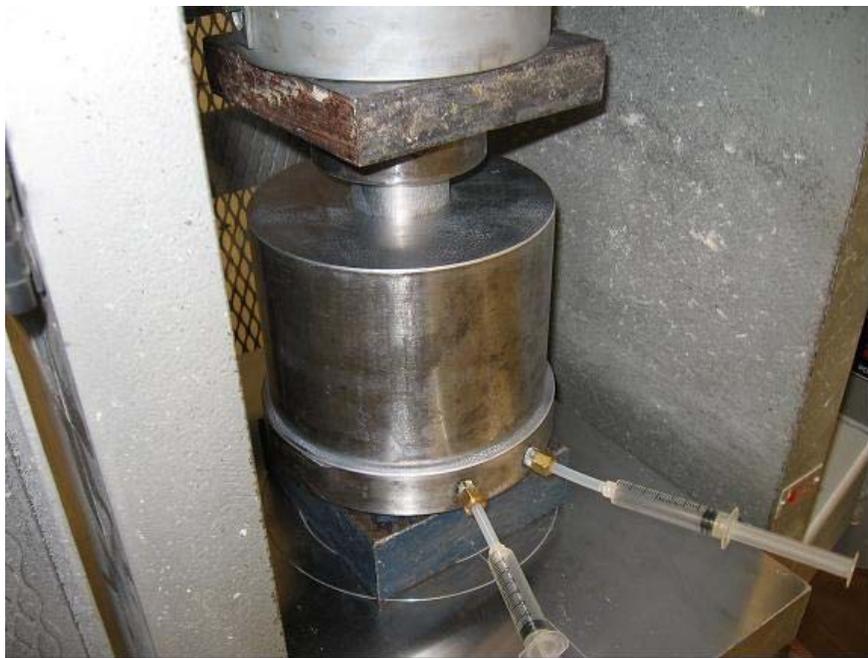
FIGURE 4. DIE ASSEMBLY WITH ATTACHED POLE FLUID COLLECTION SYRINGES.

After completion of the pore solution expression, the syringes were removed from the die and the fluid was immediately transferred to polyethylene bottles which were then tightly sealed. Before, after, and between each squeezing the equipment was cleaned with de-ionized water and paper towels, then dried with acetone to remove any water present within the die.

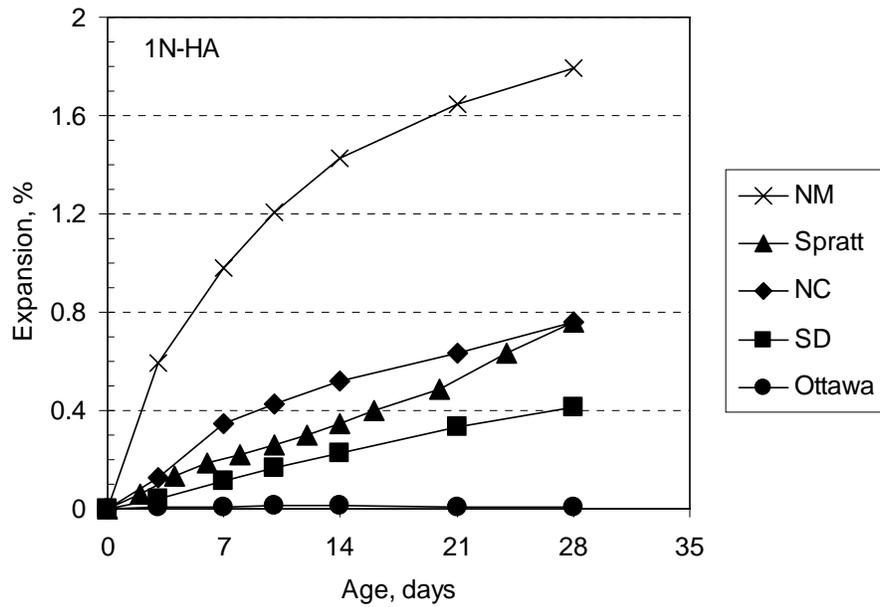
FIGURE 10. EXPANSION OF MORTAR BARS IN STANDARD ASTM C 1260 TEST WITH 1N NaOH SOLUTION AND HA CEMENT

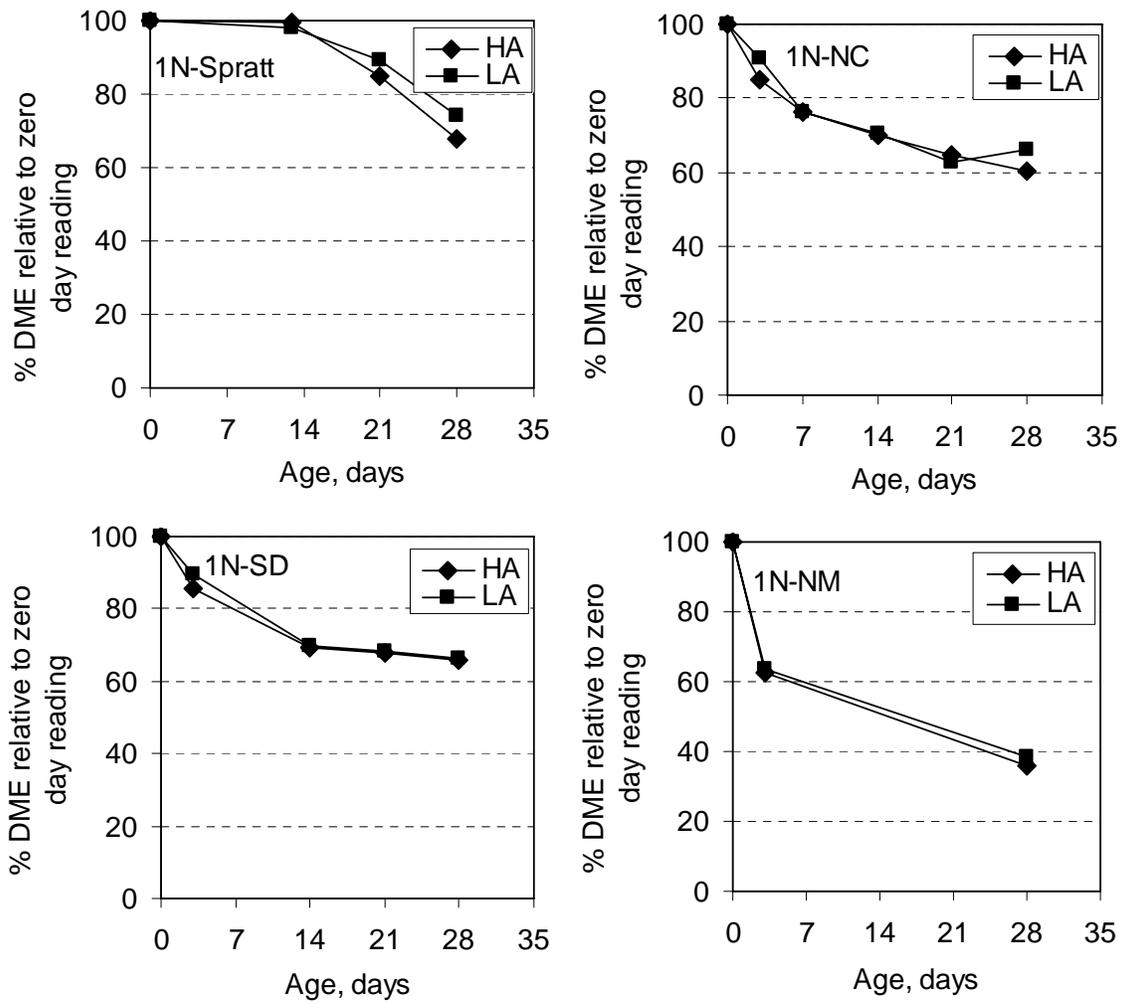
FIGURE 20. CHANGES IN DYNAMIC MODULUS OF MORTAR BARS EXPOSED TO 1 N NaOH SOLUTION IN THE STANDARD ASTM C 1260 TEST

The alkali content of the cement used in the mortar bars did not show an influence on the changes in DME of mortar bars in the standard or modified ASTM C 1260 tests. However, the changes in DME of mortar bars corresponded well with the expansions observed in test specimens.

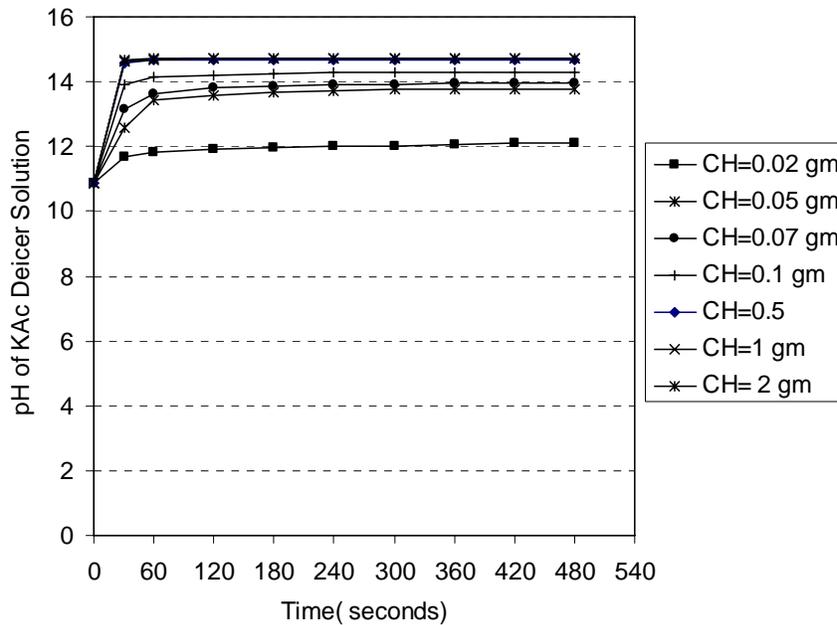
FIGURE 26. INFLUENCE OF ADDITION OF REAGENT GRADE CALCIUM HYDROXIDE (IN GRAMS) ON pH OF THE POTASSIUM ACETATE DEICER SOLUTION (50% Wt. SOLUTION) AT ROOM TEMPERATURE.

Limited investigations were carried out to establish the cause of the increase in the pH of the potassium acetate deicer solutions that had been exposed to the mortar bars, by studying interactions between reagent grade calcium hydroxide and potassium acetate deicer solutions. In these studies, small quantities of calcium hydroxide (ranging between 0.2 grams and 2.0 grams) were added to 50 ml volumes of potassium acetate deicer solution at room temperature, and the pH of the solution was monitored at close intervals. Figure 26 shows the influence of addition of reagent calcium hydroxide on pH of potassium acetate deicer solution.

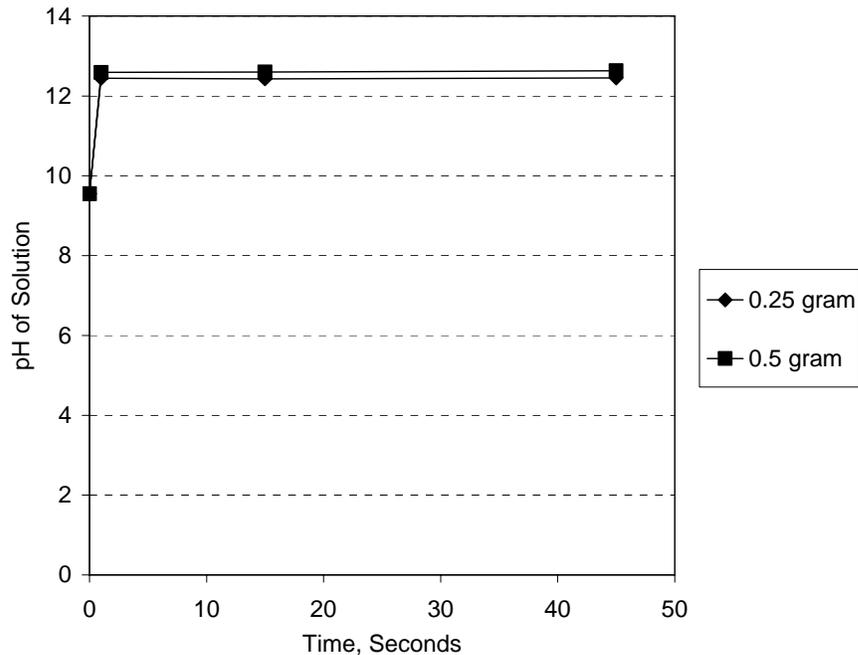
FIGURE 27. INFLUENCE OF ADDITION OF REAGENT GRADE CALCIUM HYDROXIDE (IN GRAMS) ON THE PH OF THE SATURATED SODIUM ACETATE DEICER SOLUTION AT ROOM TEMPERATURE.

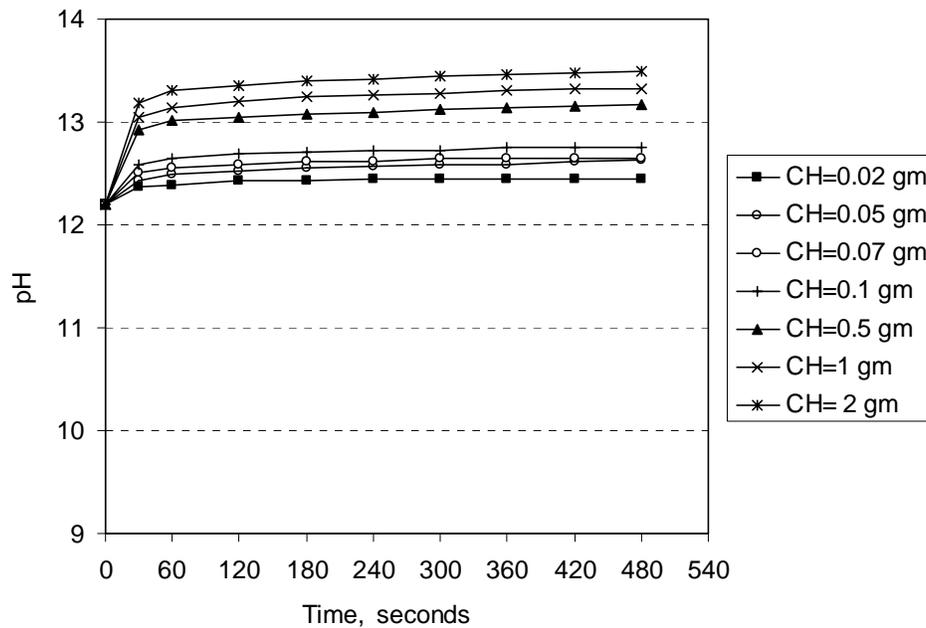
FIGURE 28. INFLUENCE OF ADDITION OF REAGENT GRADE CALCIUM HYDROXIDE (IN GRAMS) ON THE PH OF THE SATURATED SODIUM FORMATE DEICER SOLUTION AT ROOM TEMPERATURE.

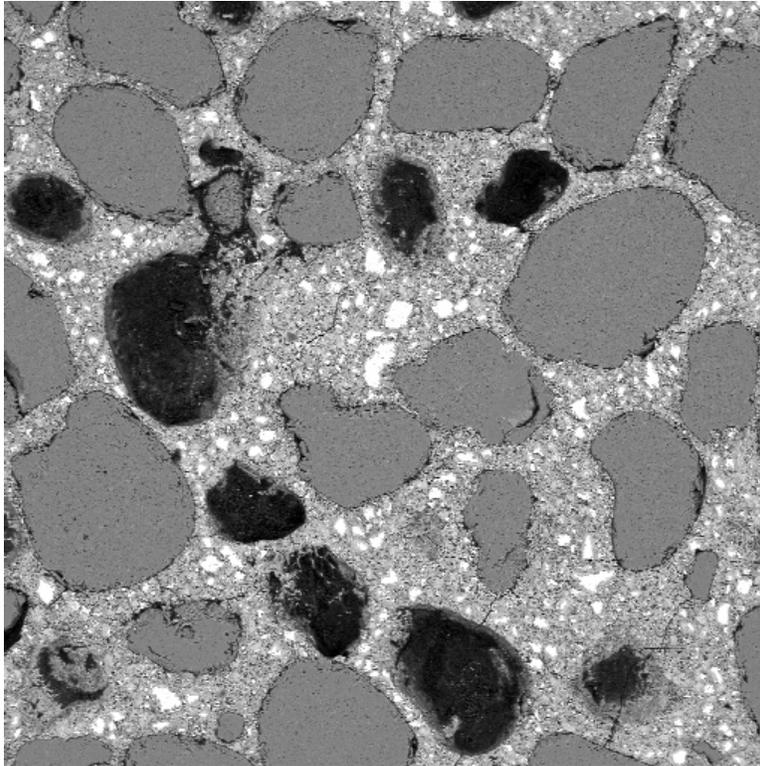
FIGURE 30. TYPICAL MICROSTRUCTURE OF OTTAWA SAND MORTAR EXPOSED TO 1N NaOH SOLUTION

In general, only occasional cracking was observed in the paste of mortar bars containing the reference, non-reactive aggregate (Ottawa sand) but there were no cracks seen in the aggregates themselves. A typical example is presented in Figure 30. The composition of paste for this mortar was not altered and no gel was observed.

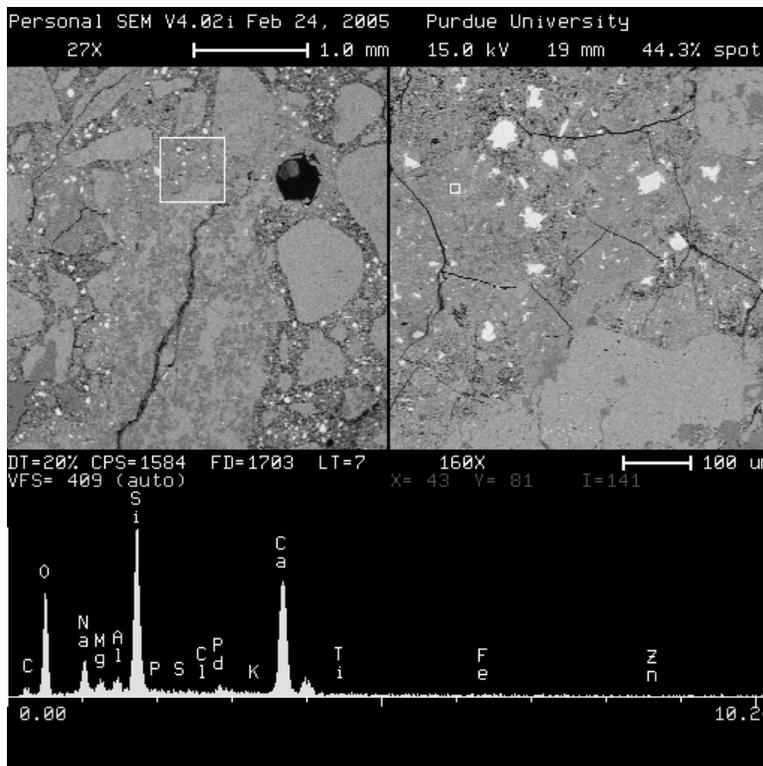
FIGURE 31. MICROSTRUCTURE OF SPRATT LIMESTONE MORTAR EXPOSED TO 1N NaOH SOLUTION

In contrast, a fair amount of cracking was observed both within the aggregates and in the paste components of mortars prepared with the Spratt aggregate. A typical example is shown in Figure 31. For these mortars, dense regions of paste containing deposits of gel (Ca-Si-Na) were also observed (see Figure 31). As seen in the same figure, the paste in the vicinity of these dense regions contained short cracks. In general, the cracks in paste appear to be mostly empty, in contrast the cracks in aggregate are partially or totally in-filled with gel. Occasional deposits of gel were also observed in the air voids (in the form of thin layer deposited around the perimeter of the void) as illustrated in Figure 32.

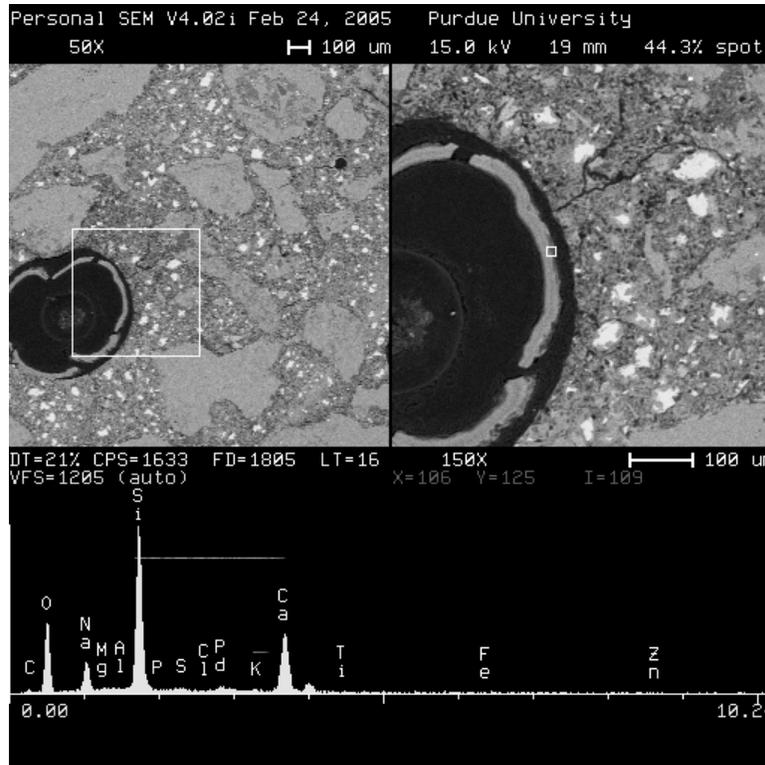
FIGURE 32. ROUND VOID WITH LINING OF Ca-Si-Na GEL IN SPRATT LIMESTONE MORTAR

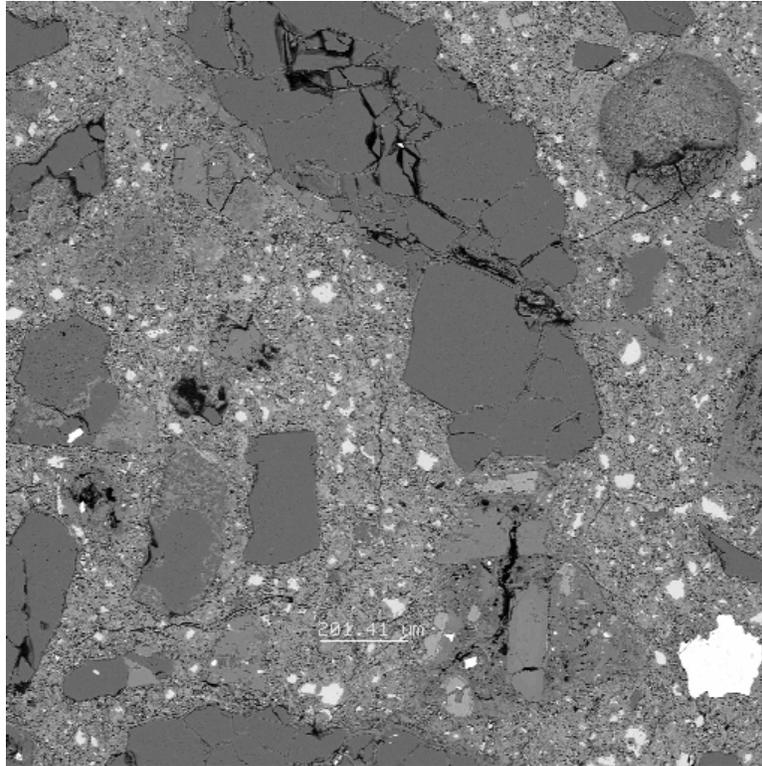
FIGURE 33. MICROSTRUCTURE OF NM RHYOLITE MORTAR EXPOSED TO 1N NaOH SOLUTION

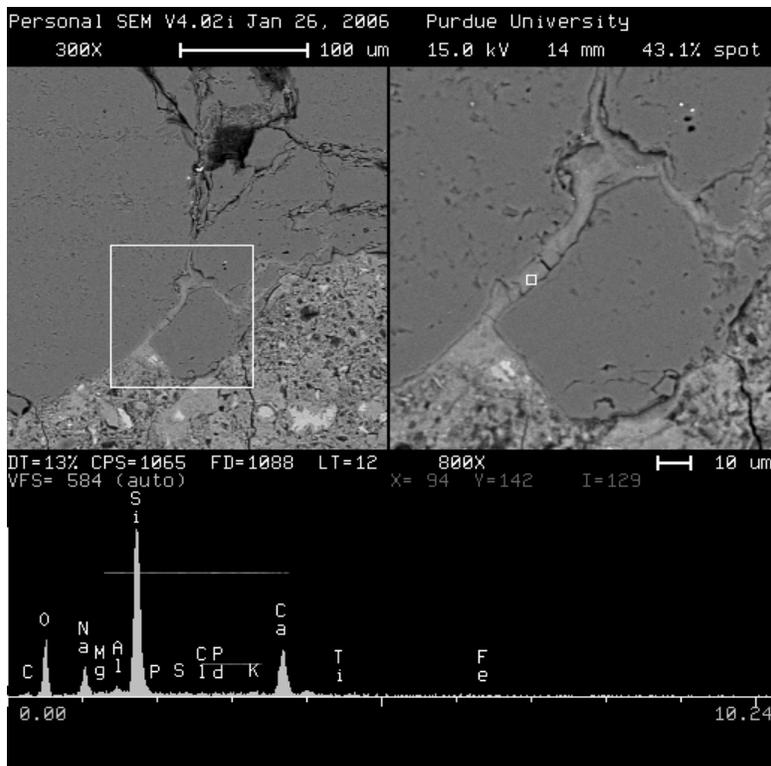
FIGURE 34. Ca-Si-Na GEL IN THE PARTICLE OF SD QUARTZITE EXPOSED TO 1N NaOH SOLUTION

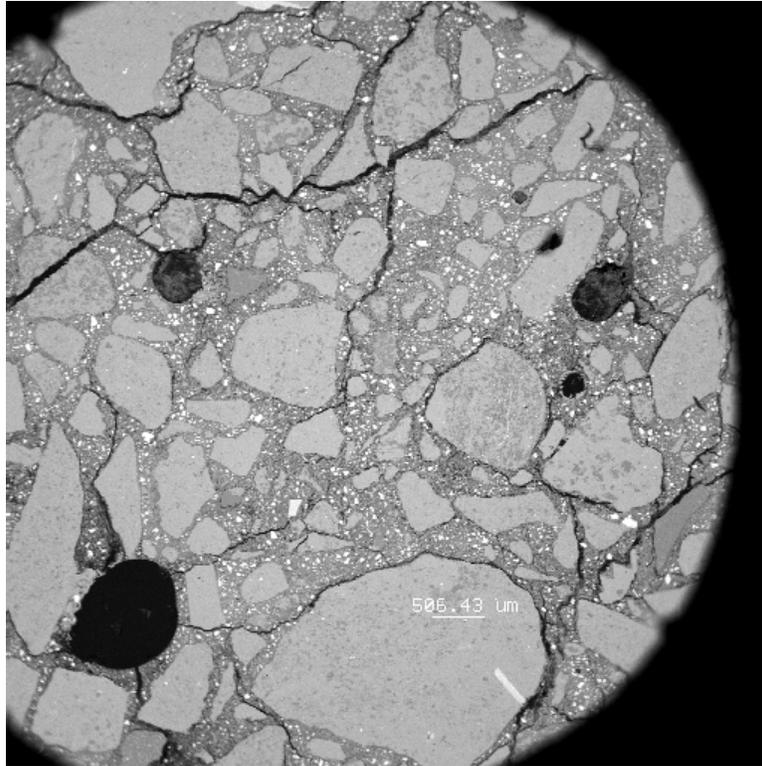
FIGURE 35. EXTENSIVE CRACKING OF THE SPRATT LIMESTONE MORTAR EXPOSED TO KAc SOLUTION

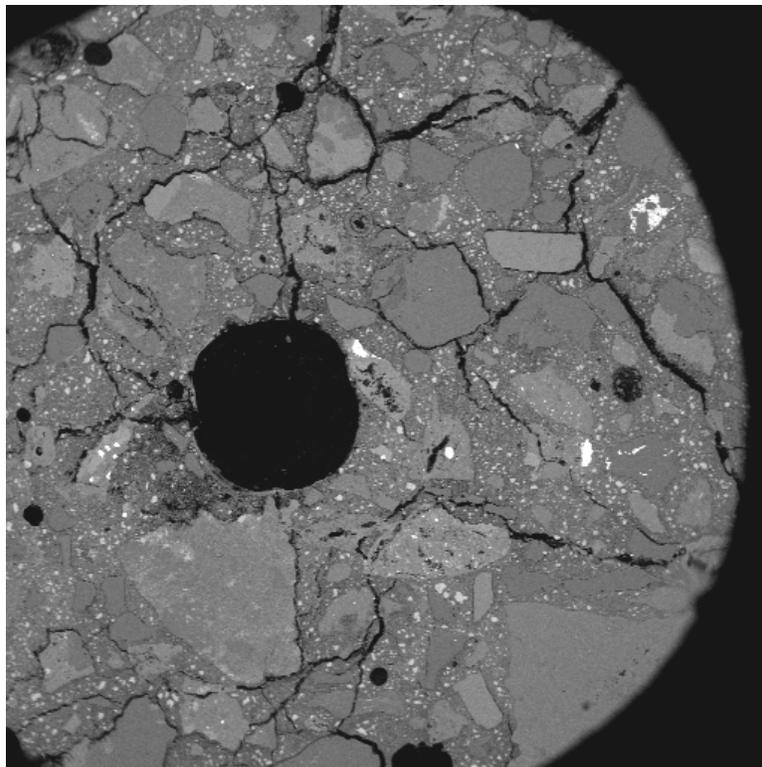
FIGURE 36. CRACKING OF THE NM RHYOLITE MORTAR EXPOSED TO KAc SOLUTION

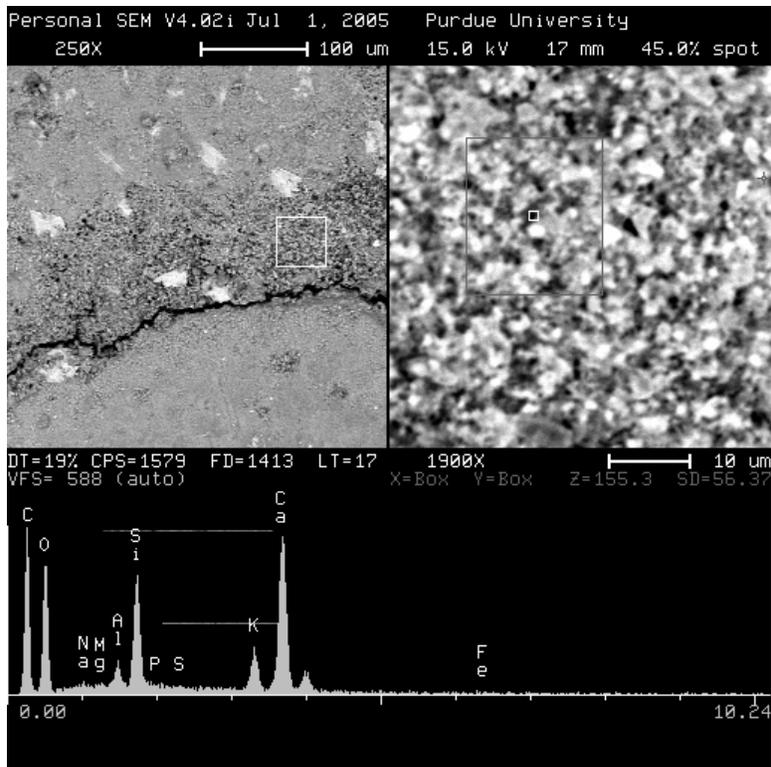
FIGURE 37. Si-K-Ca GEL IN THE INTERFACIAL ZONE OF NM RHYOLITE MORTAR EXPOSED TO KAc SOLUTION

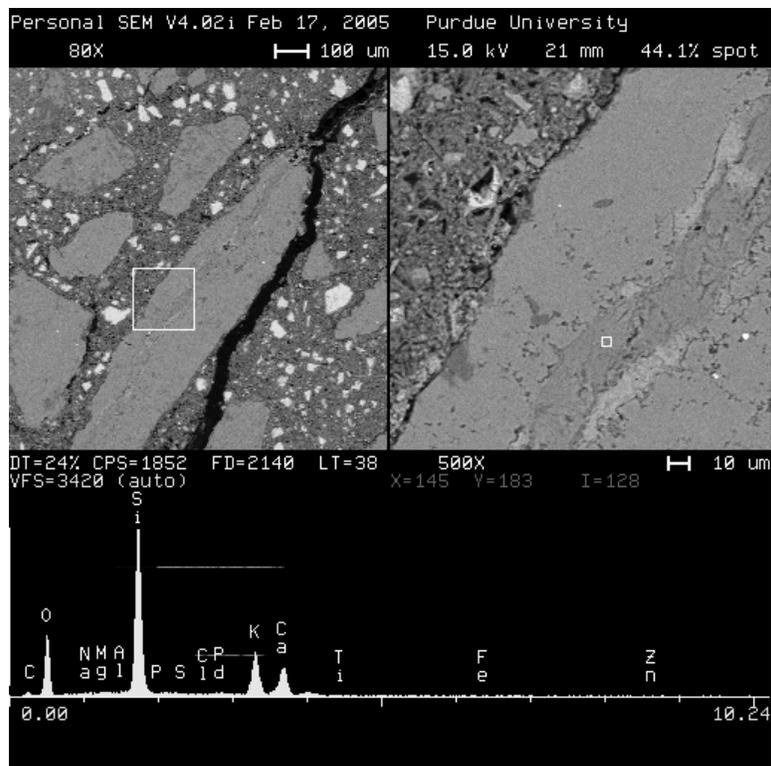
FIGURE 38. Si-K-Ca GEL-FILLED CRACK IN THE PARTICLE OF SPRATT LIMESTONE MORTAR EXPOSED TO KAc SOLUTION

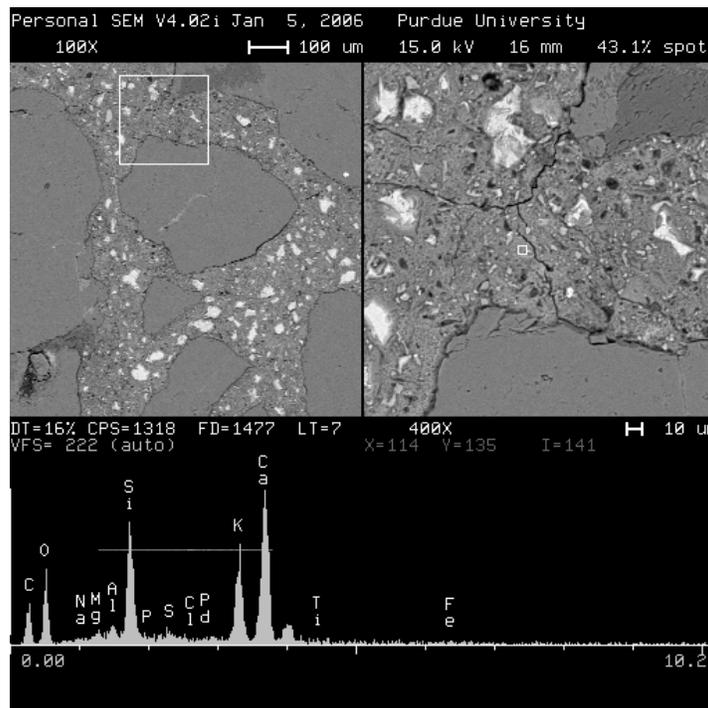
FIGURE 40. GEL-CONTAINING NETWORK OF FINE CRACKS IN THE PASTE FRACTION OF MORTAR SPECIMEN WITH SD QUARTZITE EXPOSED TO KAc SOAK SOLUTION.

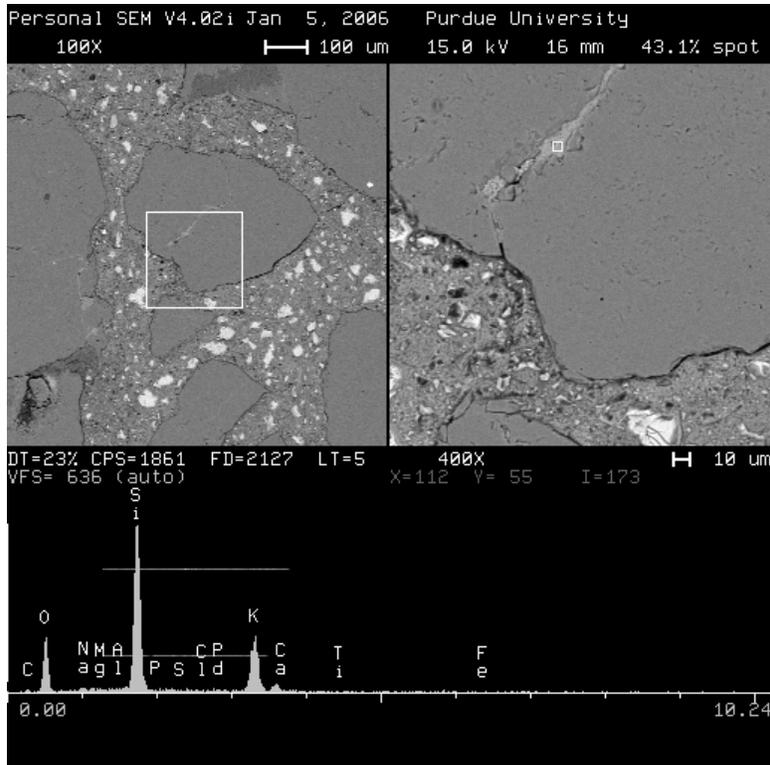
FIGURE 41. Si-K RICH GEL IN THE CRACKS OF MORTAR SPECIMENS CONTAINING SD QUARTZITE EXPOSED TO KAc DEICER

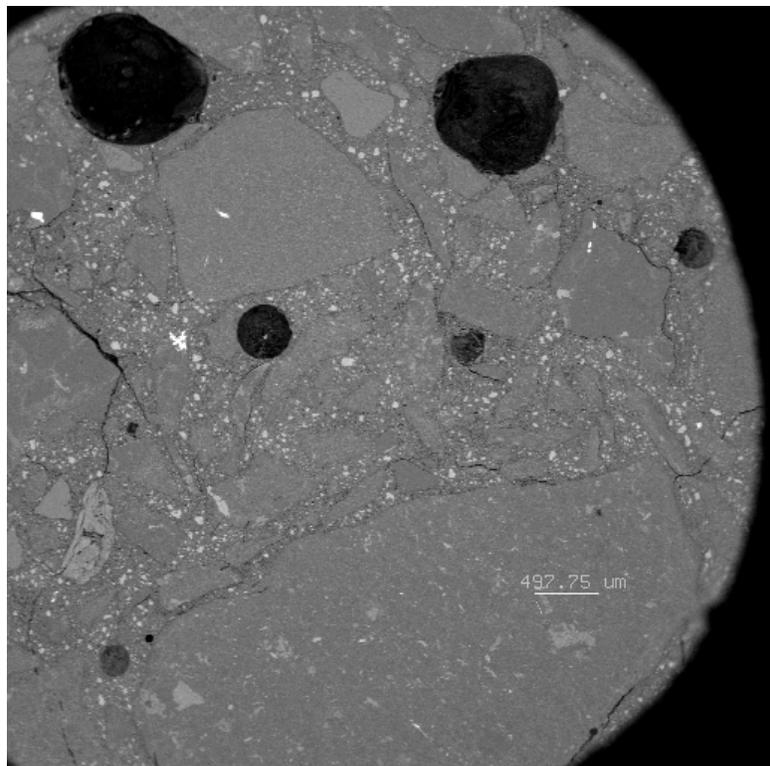
FIGURE 42. NETWORK OF CRACKS IN THE NC ARGILLITE MORTAR SPECIMEN EXPOSED TO POTASSIUM ACETATE DEICER

The cracking observed in the NC argillite mortar was not as extensive as cracking in either the Spratt limestone or the NM rhyolite mortars. An illustration is provided in Figure 42. The bigger cracks were predominantly present either in the aggregate itself or at the paste-aggregate interface. The cracks present in the aggregate were often filled with gel. The larger cracks in the paste itself were mostly empty. They often appeared to be an extension of the cracks that originated in the aggregate (Figure 43). Smaller empty paste cracks were often seen as accompanying the larger crack and were typically oriented perpendicular to them (see Figure 43).

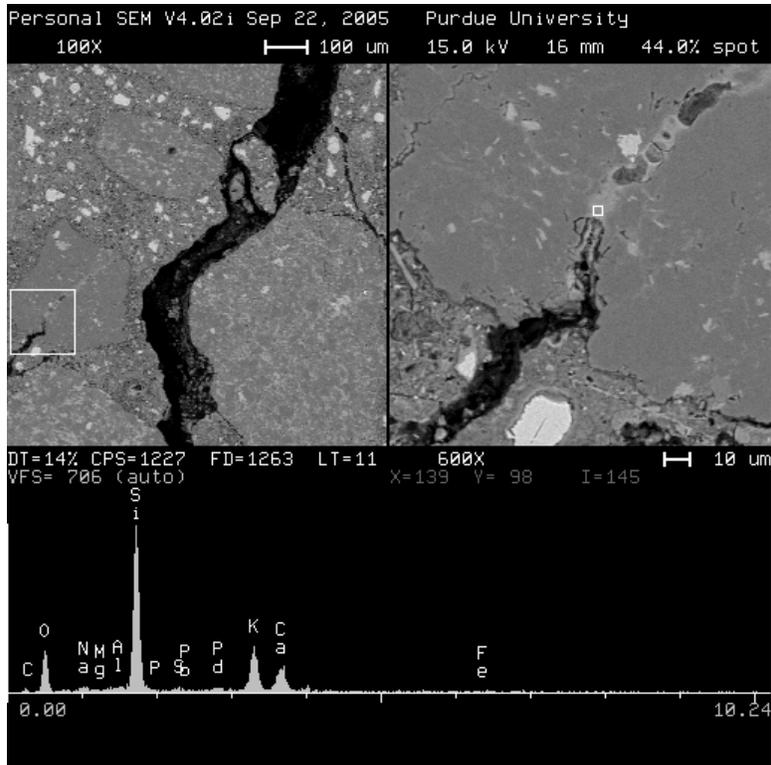
FIGURE 43. LARGE CRACKS IN PASTE (WITH SMALLER CRACKS ORIENTED PERPENDICULAR TO THE LARGER CRACK) IN THE NC ARGILLITE MORTAR SPECIMEN EXPOSED TO KAc DEICER

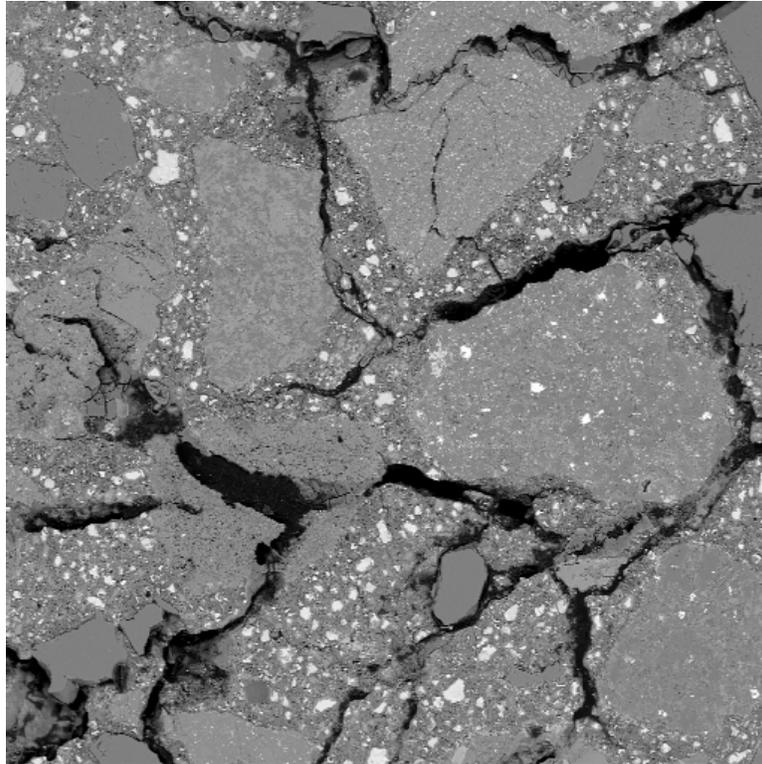
FIGURE 44. GENERAL APPEARANCE OF THE NM RHYOLITE MORTAR SPECIMEN EXPOSED TO THE SODIUM ACETATE DEICER. EXTENSIVE CRACKS IN THE PASTE AND IN THE AGGREGATE.

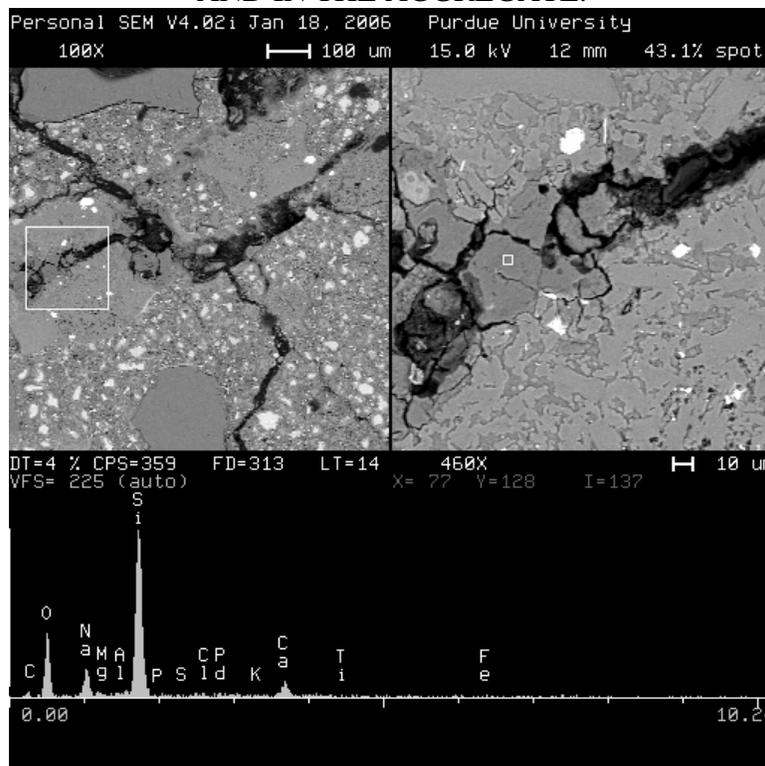
FIGURE 45. Na-Si-Ca GEL IN THE CRACK OF NM RHYOLITE EXPOSED TO SODIUM ACETATE DEICER

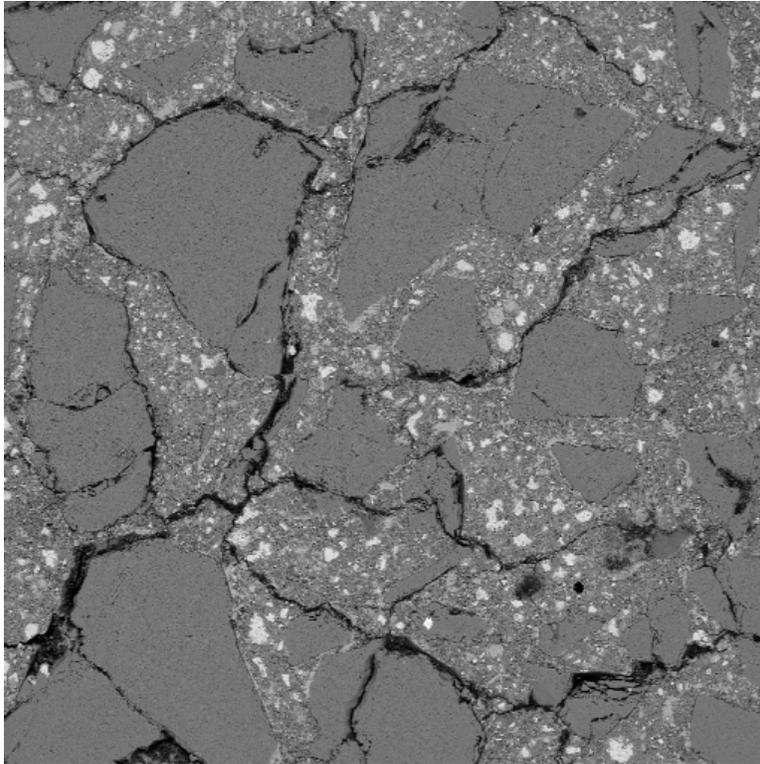
FIGURE 46. EXTENSIVE CRACKING OF THE SD QUARTZITE MORTAR EXPOSED TO THE SODIUM ACETATE DEICER

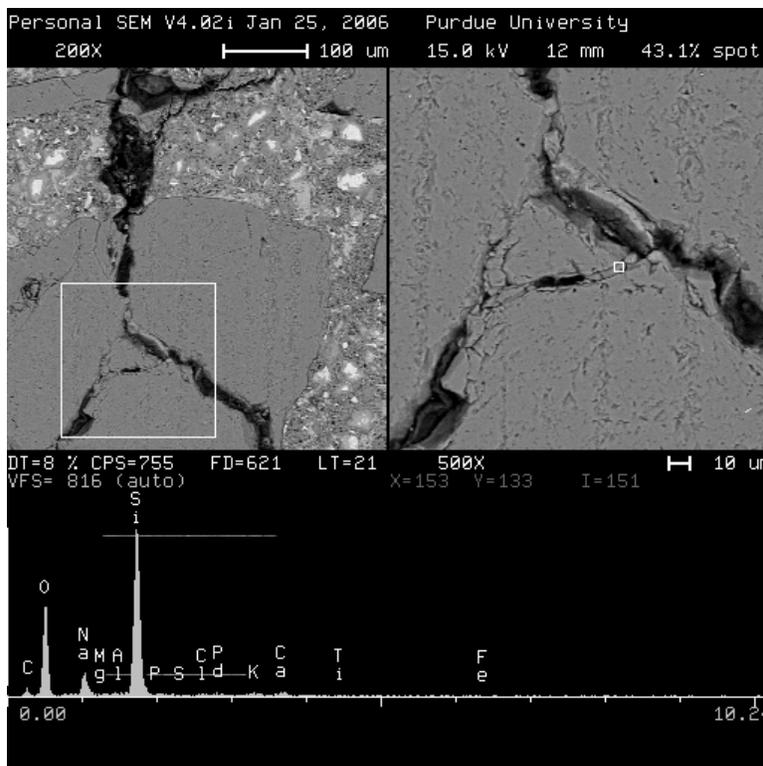
FIGURE 47. CRACK FILLED WITH Na-Si GEL IN THE GRAIN OF SD QUARTZITE EXPOSED TO THE SODIUM ACETATE DEICER

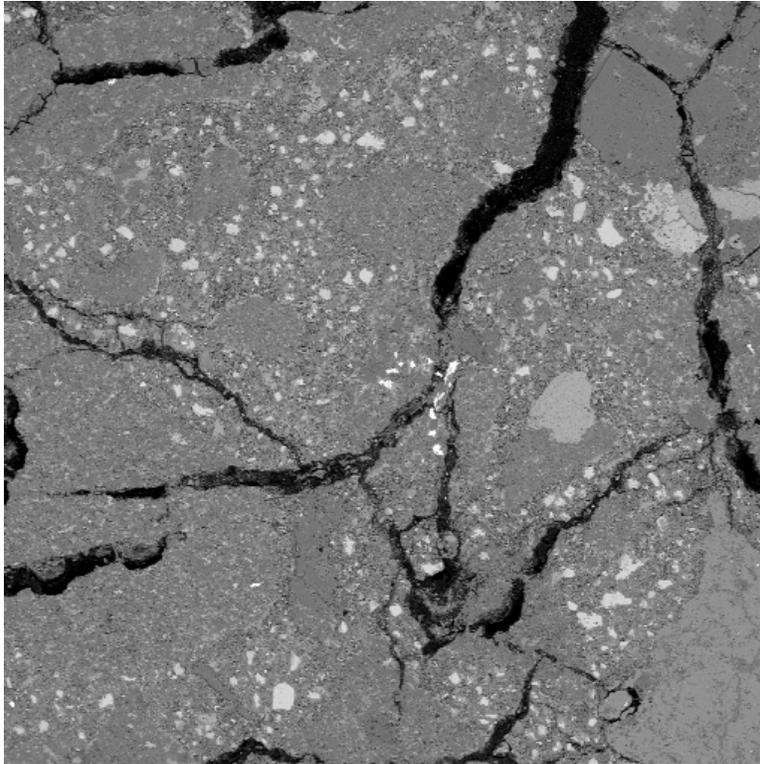
FIGURE 48. CRACKED NC ARGILLITE MORTAR EXPOSED TO SODIUM ACETATE DEICER

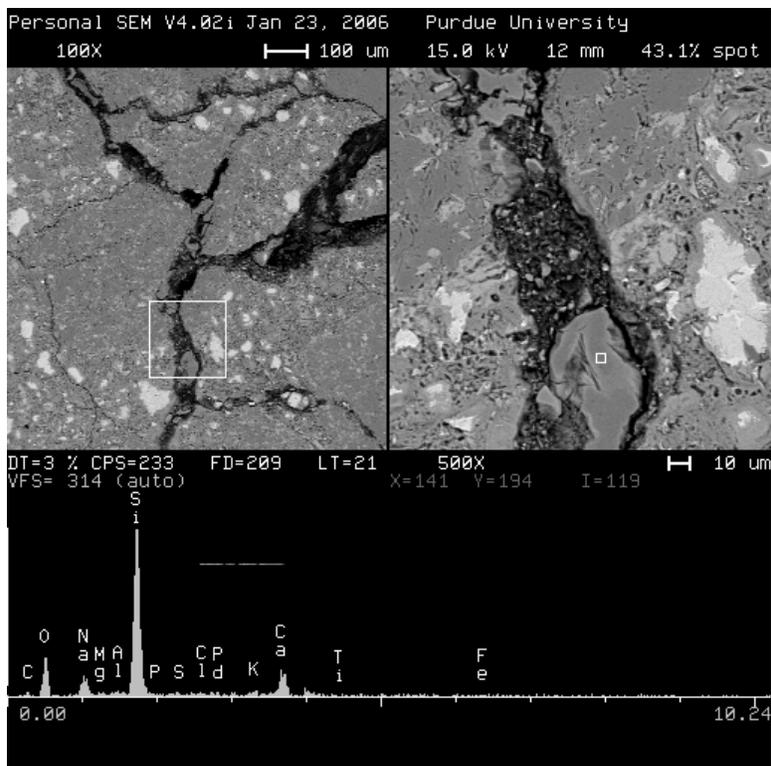
FIGURE 49. Na-Si GEL INSIDE THE CRACK OF NC ARGILLITE SPECIMEN EXPOSED TO SODIUM ACETATE DEICER

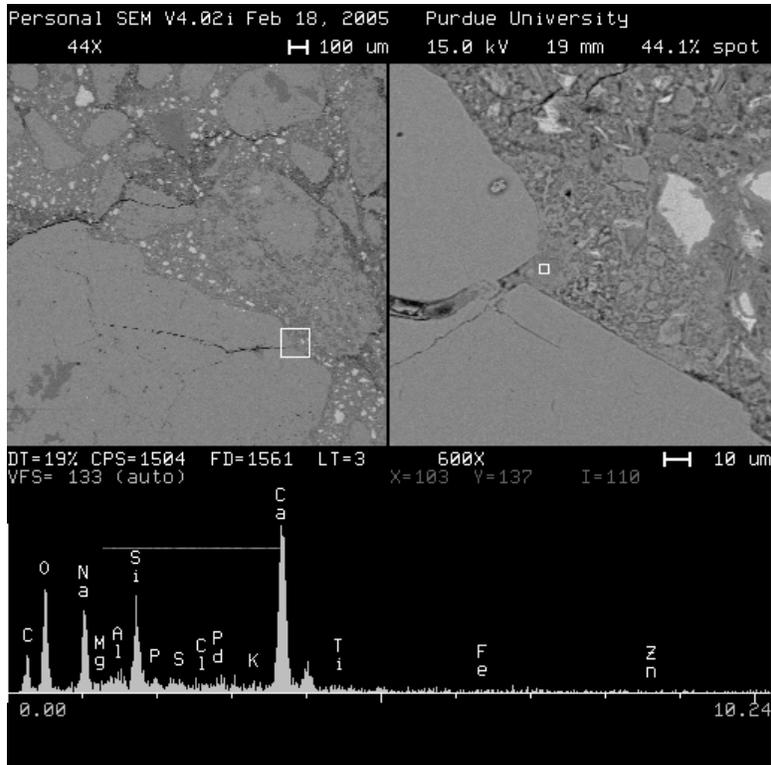
FIGURE 50. RIVER OF GEL IN THE SPRATT LIMESTONE AGGREGATE EXPOSED TO SODIUM ACETATE DEICER

In contrast to mortars made with these aggregates, much less cracking was observed in mortars made with Spratt limestone. A few cracks in the aggregate contained gel that was “outflowing” into the paste (see Figure 50). Several locations within the paste contained monosulfate (see Figure 51).

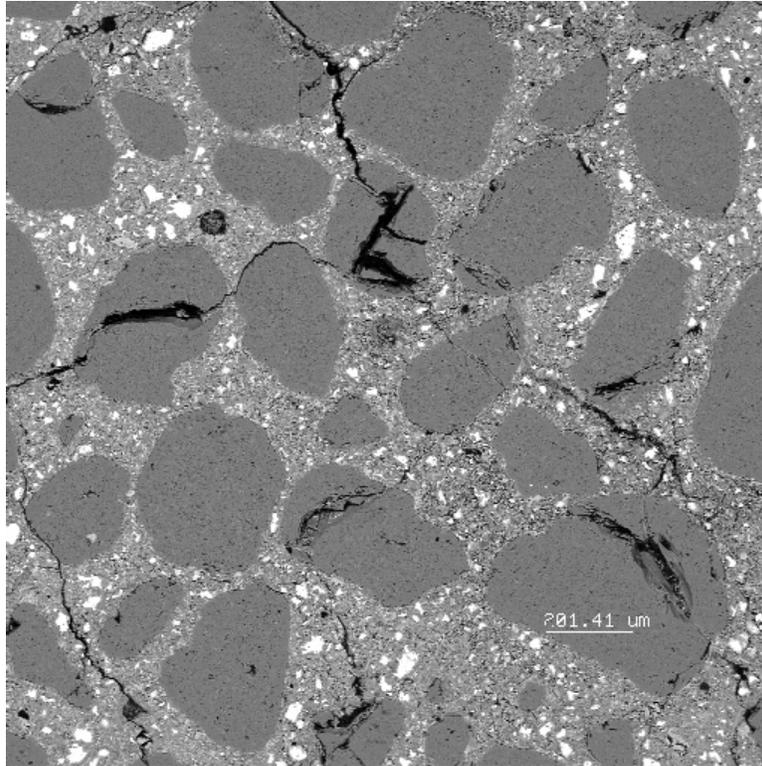
FIGURE 52. AGGREGATE AND PASTE CRACKS IN THE OTTAWA SAND MORTAR SOAKED IN SODIUM FORMATE SOLUTION

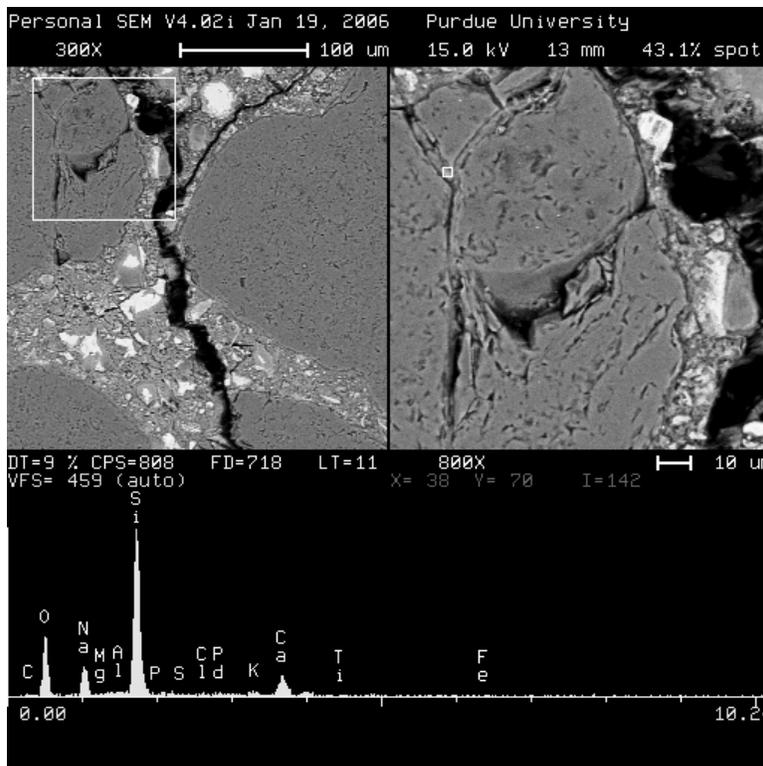
FIGURE 53. Ca-Si-Na GEL IN THE SEVERELY DISTRESSED GRAIN OF OTTAWA SAND (MORTAR SOAKED IN SODIUM FORMATE SOLUTION).

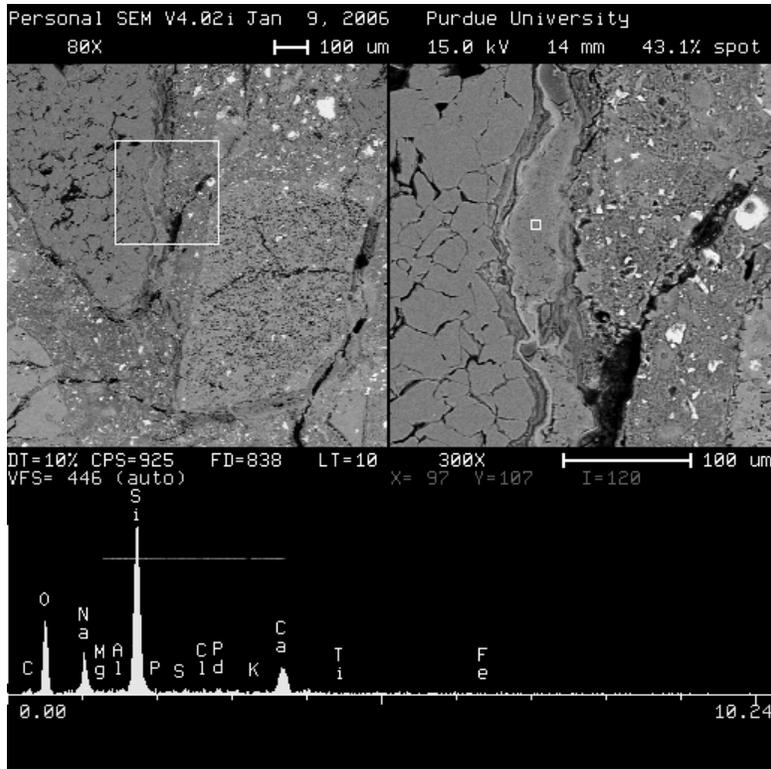
FIGURE 54. MASSIVE CRACKS IN THE PASTE OF NM RHYOLITE MORTARS SOAKED IN SODIUM FORMATE SOLUTION. LAYER OF GEL IN THE AIR VOID

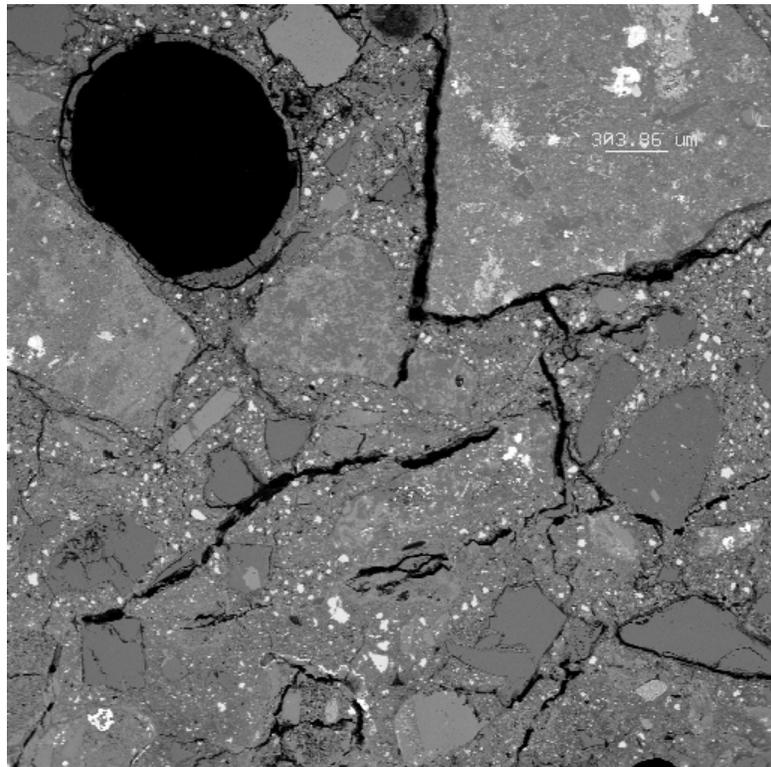
FIGURE 55. LAYER OF GEL AT THE INTERFACE BETWEEN PASTE AND SEVERELY DISTRESSED GRAIN OF NM RHYOLITE IN MORTAR SOAKED IN SODIUM FORMATE SOLUTION.

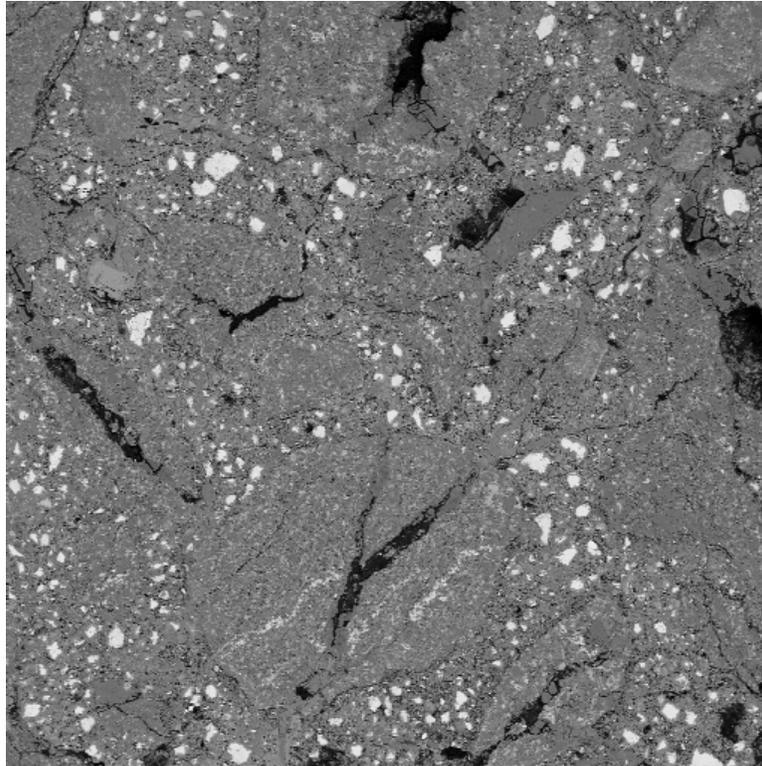
FIGURE 56. EXTENSIVE DAMAGE (CRACKING AND EROSION) IN THE GRAINS OF THE NC ARGILLITE FROM MORTAR SOAKED IN SODIUM FORMATE SOLUTION.

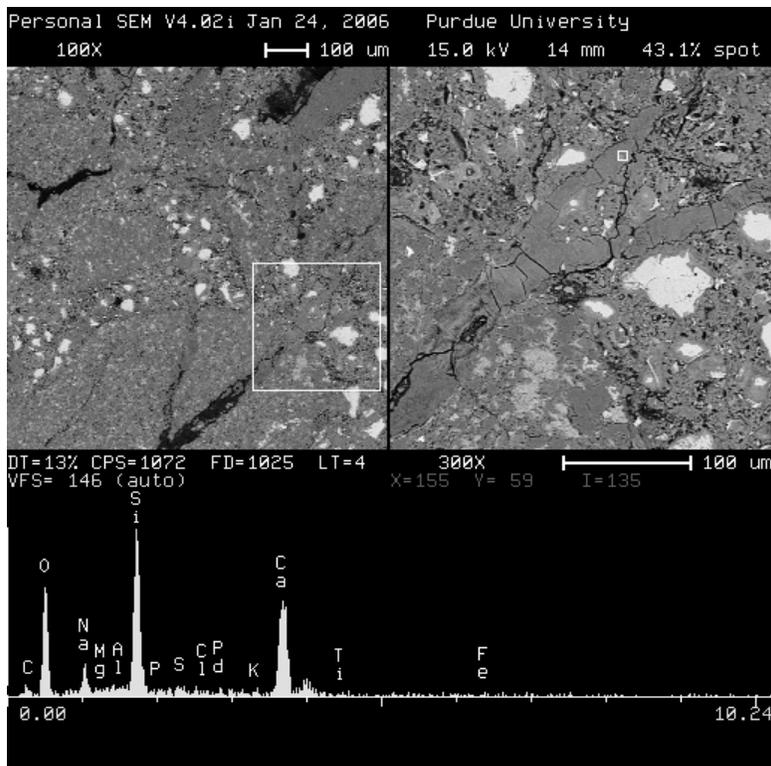
FIGURE 57. GEL OUT-FLOWING INTO THE PASTE FROM THE GRAIN OF THE NC ARGILLITE IN MORTAR SOAKED IN SODIUM FORMATE SOLUTION.
