An **IPRF** Research Report
Innovative Pavement Research Foundation
Airport Concrete Pavement Technology Program

Report IPRF-01-G-002-03-9

**Potential for Acceleration of ASR
in the Presence of Pavement
Deicing Chemicals**

March 2007

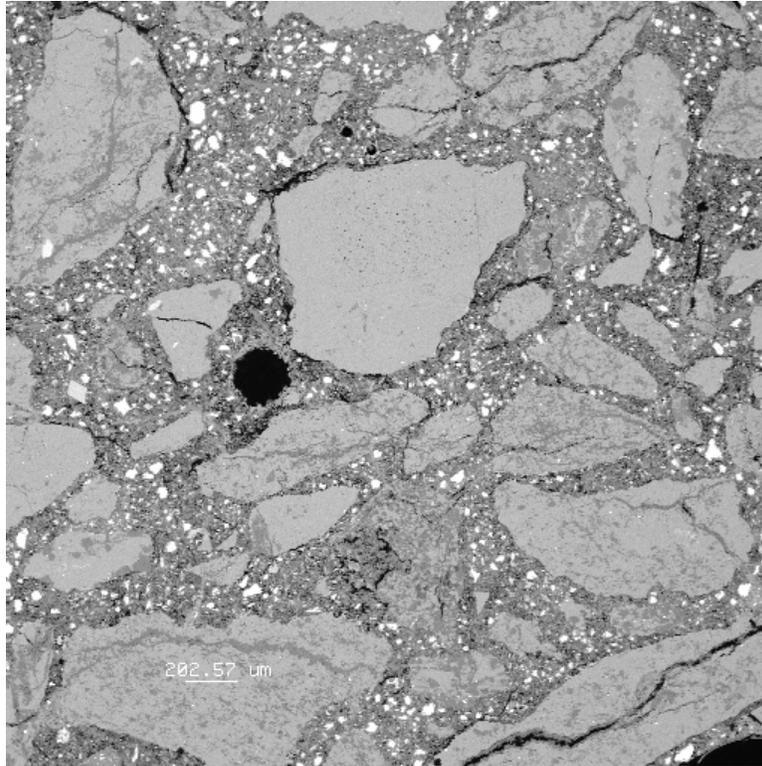
FIGURE 58. NUMEROUS CRACKS IN THE GRAINS OF THE SPRATT LIMESTONE IN MORTAR SOAKED IN SODIUM FORMATE SOLUTION

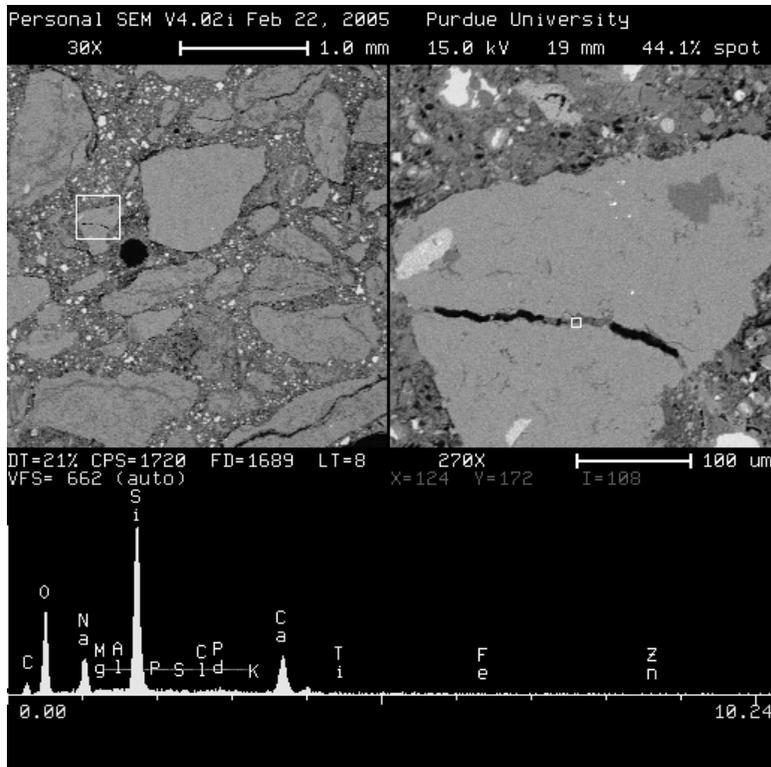
FIGURE 59. Ca-Si-Na GEL IN THE GRAIN OF SPRATT LIMESTONE FROM MORTAR SPECIMEN SOAKED IN SODIUM FORMATE SOLUTION

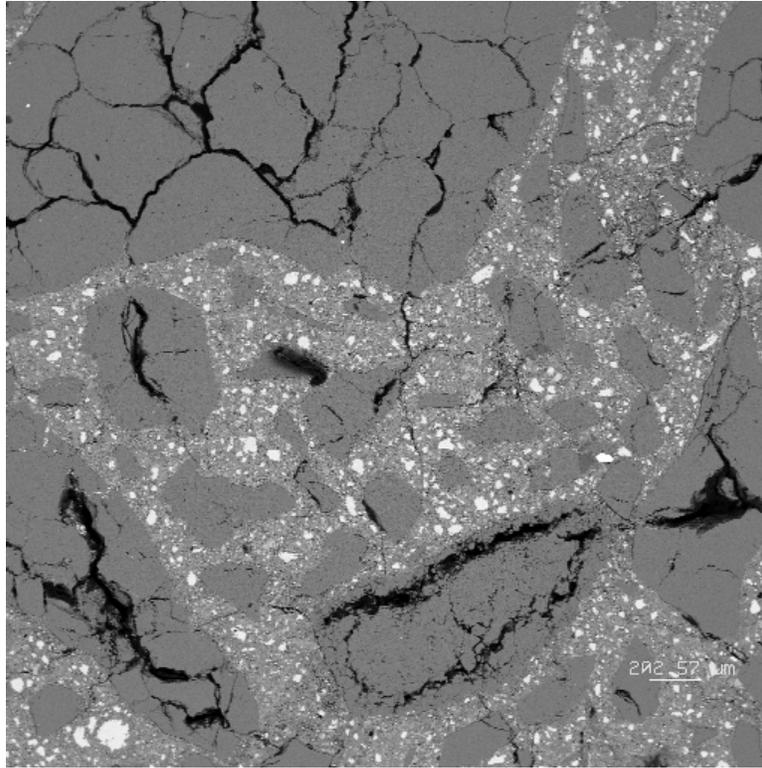
FIGURE 60. CRACKED AND ERODED GRAINS OF SD QUARTZITE AND PASTE CRACKS IN THE MORTAR SPECIMEN SOAKED IN SODIUM FORMATE SOLUTION

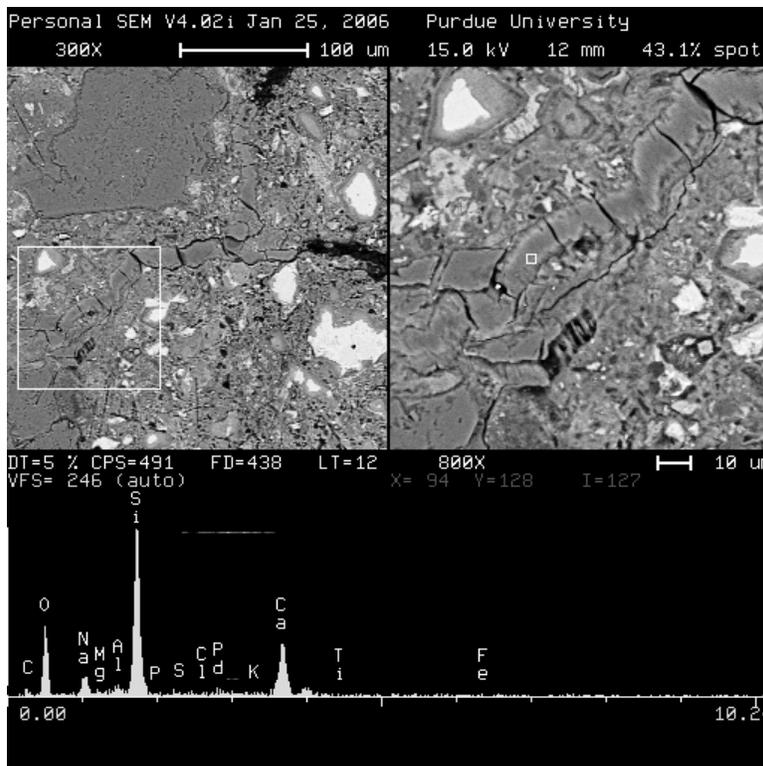
FIGURE 61. RIVER OF Ca-Si-Na GEL IN THE SD QUARTZITE MORTAR SOAKED IN SODIUM FORMATE SOLUTION

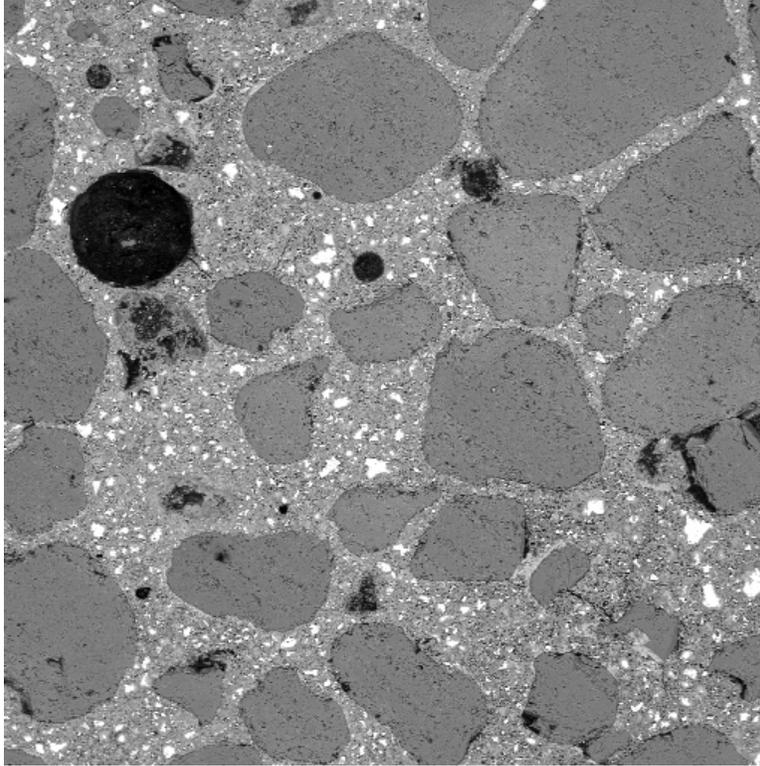
FIGURE 62. GENERAL VIEW OF THE OTTAWA SAND MORTAR EXPOSED TO THE POTASSIUM FORMATE DEICER (SOME GRAIN EROSION AND LIMITED CRACKING OF PASTE).

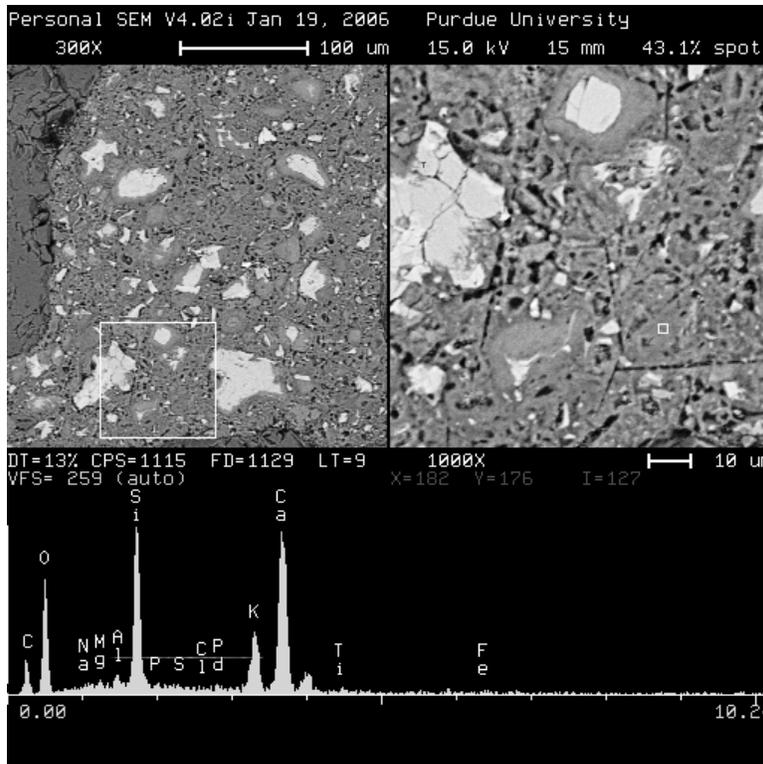
FIGURE 63. DEPOSIT OF Ca-Si-K GEL IN THE PASTE COMPONENT OF THE OTTAWA SAND MORTAR SPECIMEN SOAKED IN POTASSIUM FORMATE SOLUTION

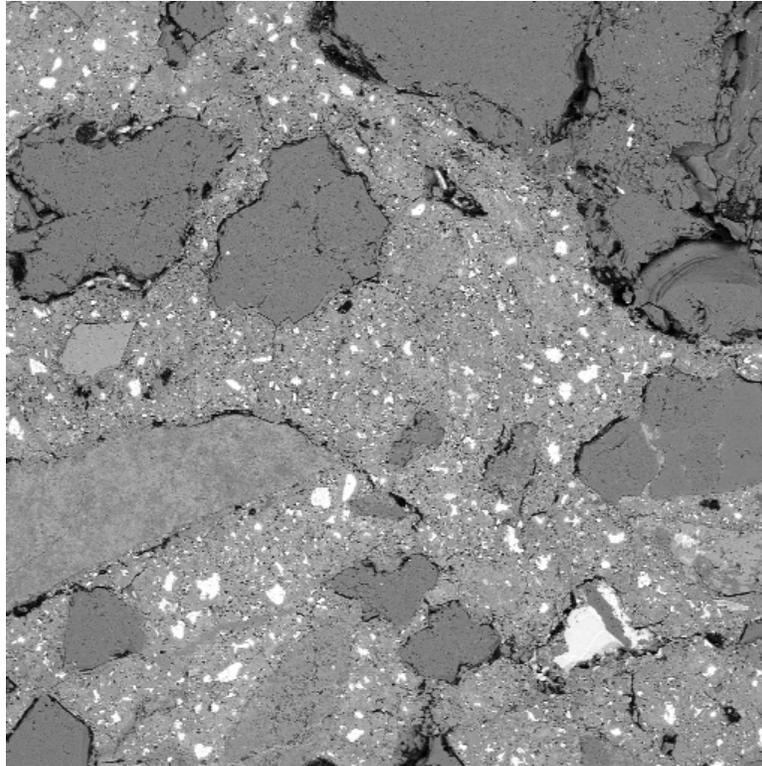
FIGURE 64. GENERAL VIEW OF THE NM RHYOLITE MORTAR EXPOSED TO THE POTASSIUM FORMATE DEICER (SOME GRAIN EROSION AND LIMITED CRACKING OF PASTE).

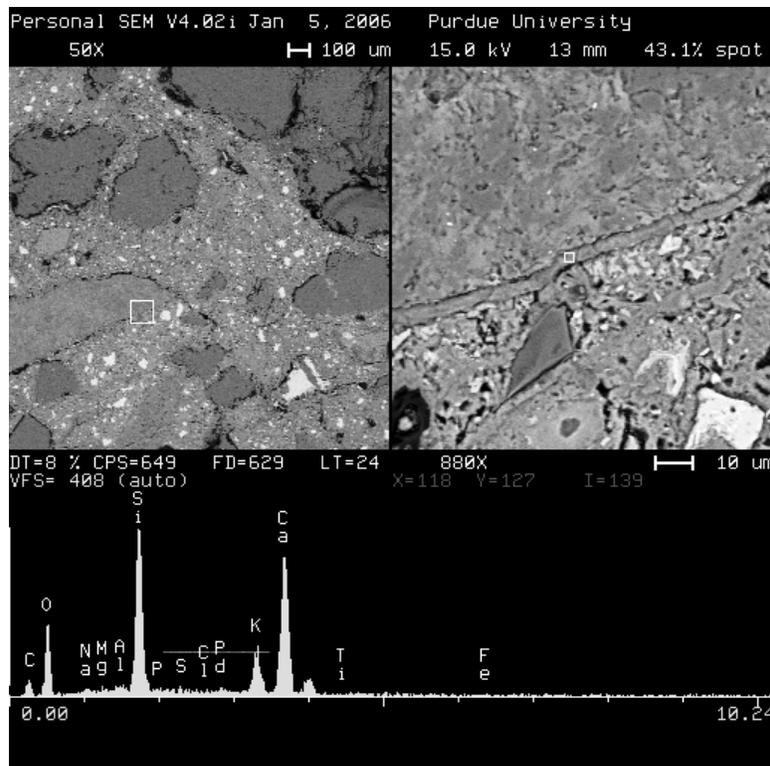
FIGURE 65. DEPOSIT OF Ca-Si-K GEL AT THE NM RHYOLITE GRAIN/PASTE INTERFACE IN THE MORTAR SPECIMEN SOAKED IN KFr SOLUTION

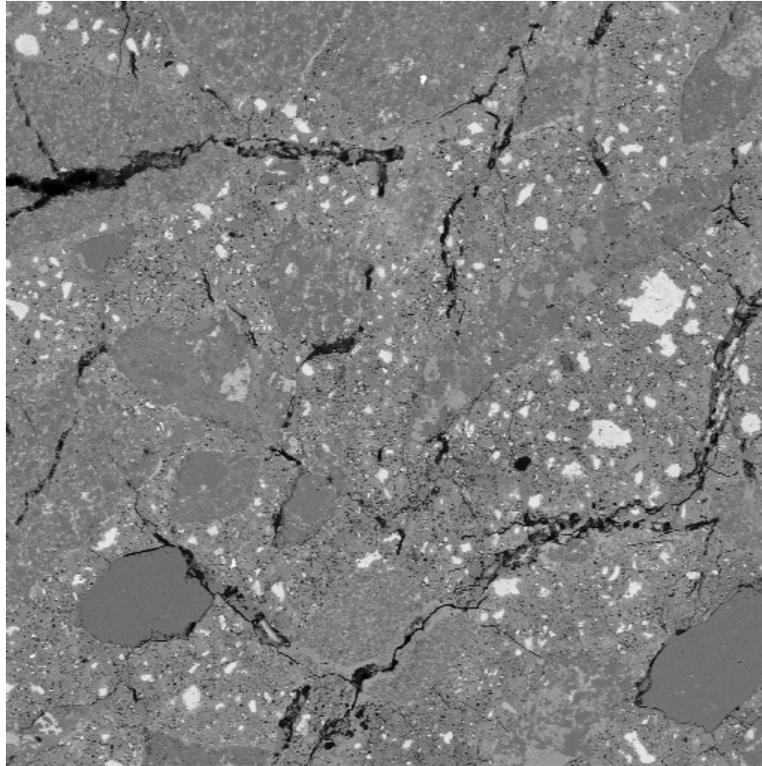
FIGURE 66. GENERAL VIEW OF THE NC ARGILLITE MORTAR EXPOSED TO THE POTASSIUM FORMATE DEICER (EXTENSIVE CRACKING OF PASTE AND AGGREGATE).

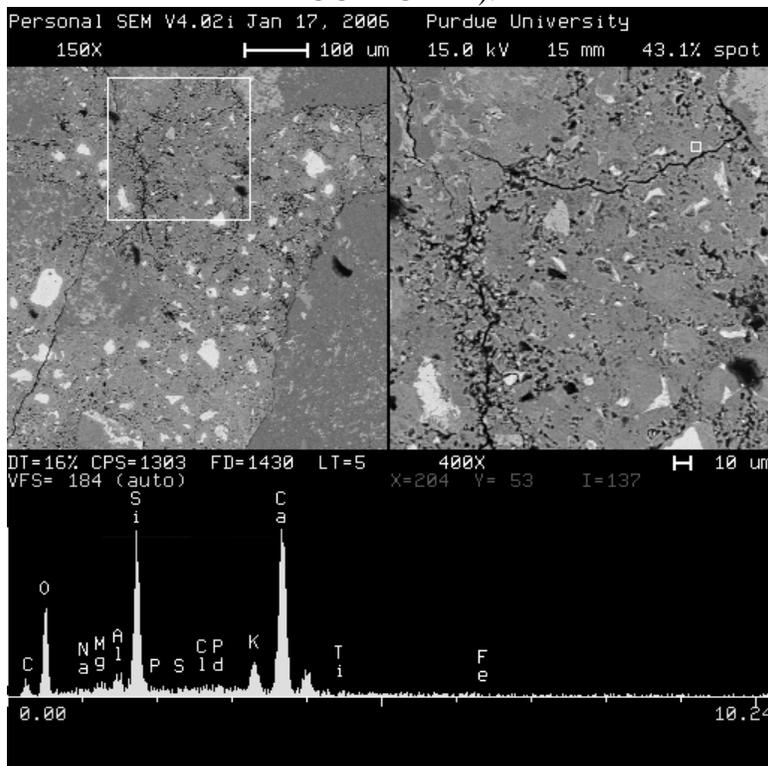
FIGURE 67. DEPOSIT OF Ca-Si-K GEL IN THE PASTE OF NC ARGILLITE MORTAR SPECIMEN SOAKED IN POTASSIUM FORMATE SOLUTION

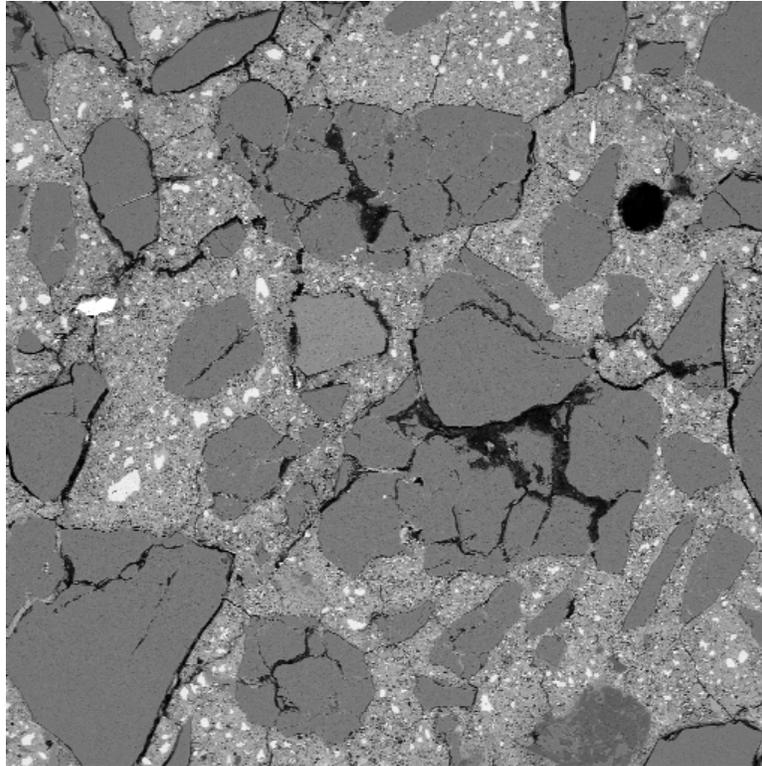
FIGURE 68. GENERAL VIEW OF THE MICROSTRUCTURE OF THE SD QUARTZITE MORTAR EXPOSED TO THE POTASSIUM FORMATE DEICER (EXTENSIVE CRACKING OF AGGREGATE EXTENDING INTO THE PASTE).

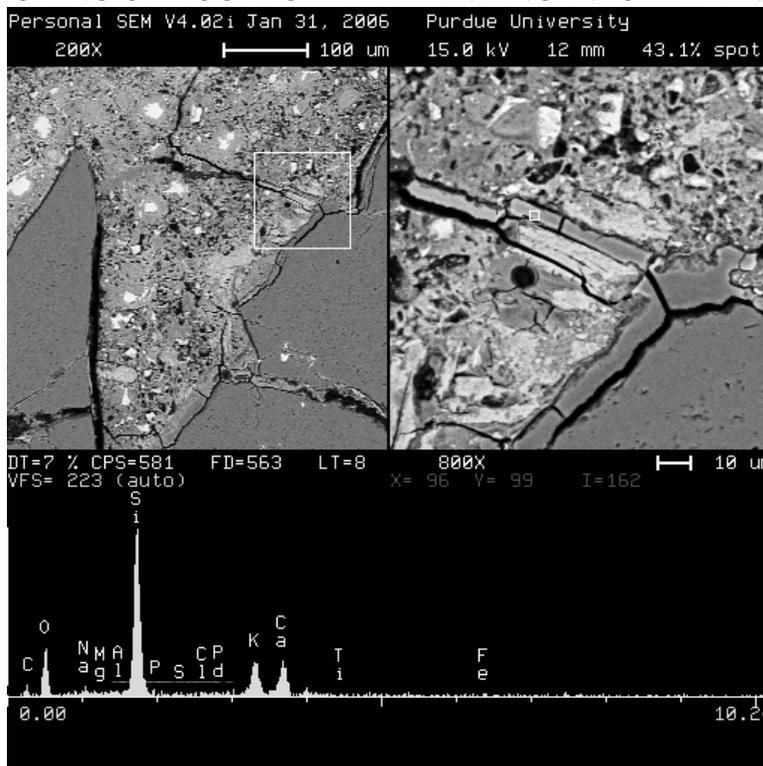
FIGURE 69. CRACK IN THE PASTE OF SD QUARTZITE MORTAR SPECIMEN SOAKED IN POTASSIUM FORMATE SOLUTION FILLED WITH THE Ca-Si-K GEL.

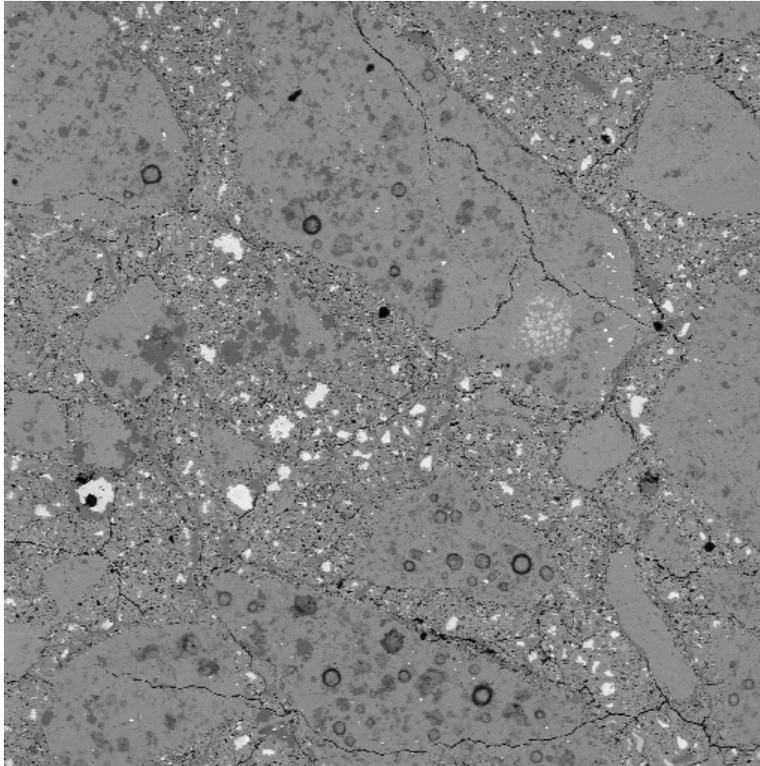
FIGURE 70. GENERAL VIEW OF THE MICROSTRUCTURE OF THE SPRATT LIMESTONE MORTAR EXPOSED TO THE POTASSIUM FORMATE DEICER (FINE AGGREGATE CRACKS EXTEND INTO THE PASTE).

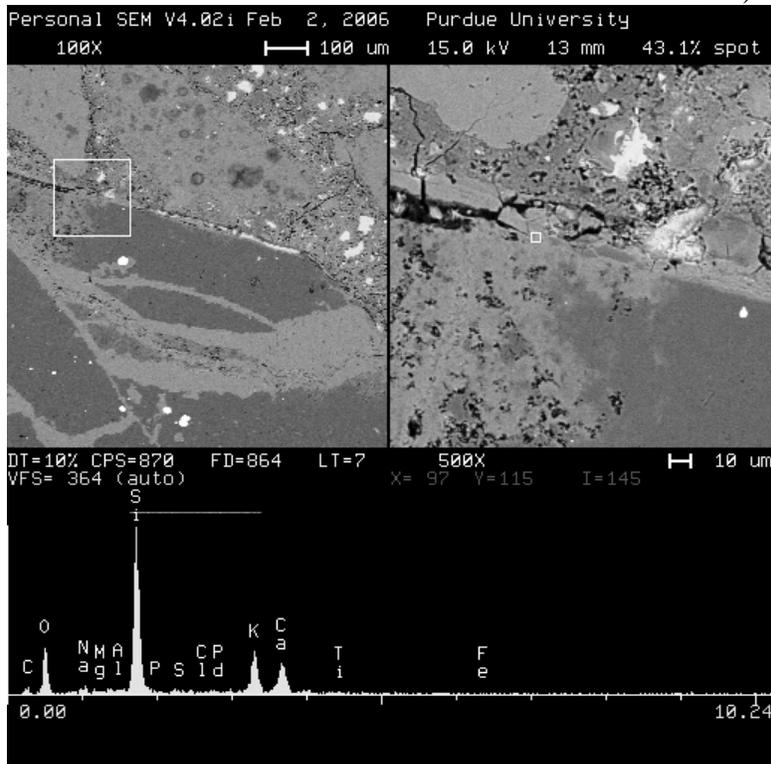
FIGURE 71. Ca-Si-K GEL IN THE CRACK OF SPRATT LIMESTONE GRAIN FROM THE MORTAR SPECIMEN SOAKED IN POTASSIUM FORMATE SOLUTION

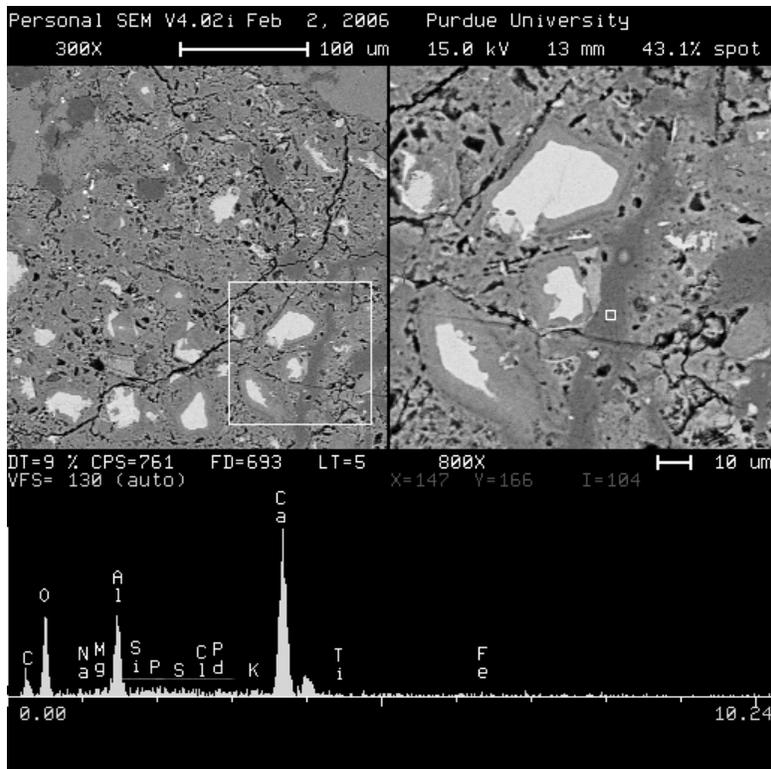
FIGURE 72. Ca-Al RICH DEPOSIT WITHIN THE PASTE OF THE SPRATT LIMESTONE MORTAR SPECIMEN SOAKED IN POTASSIUM FORMATE SOLUTION.

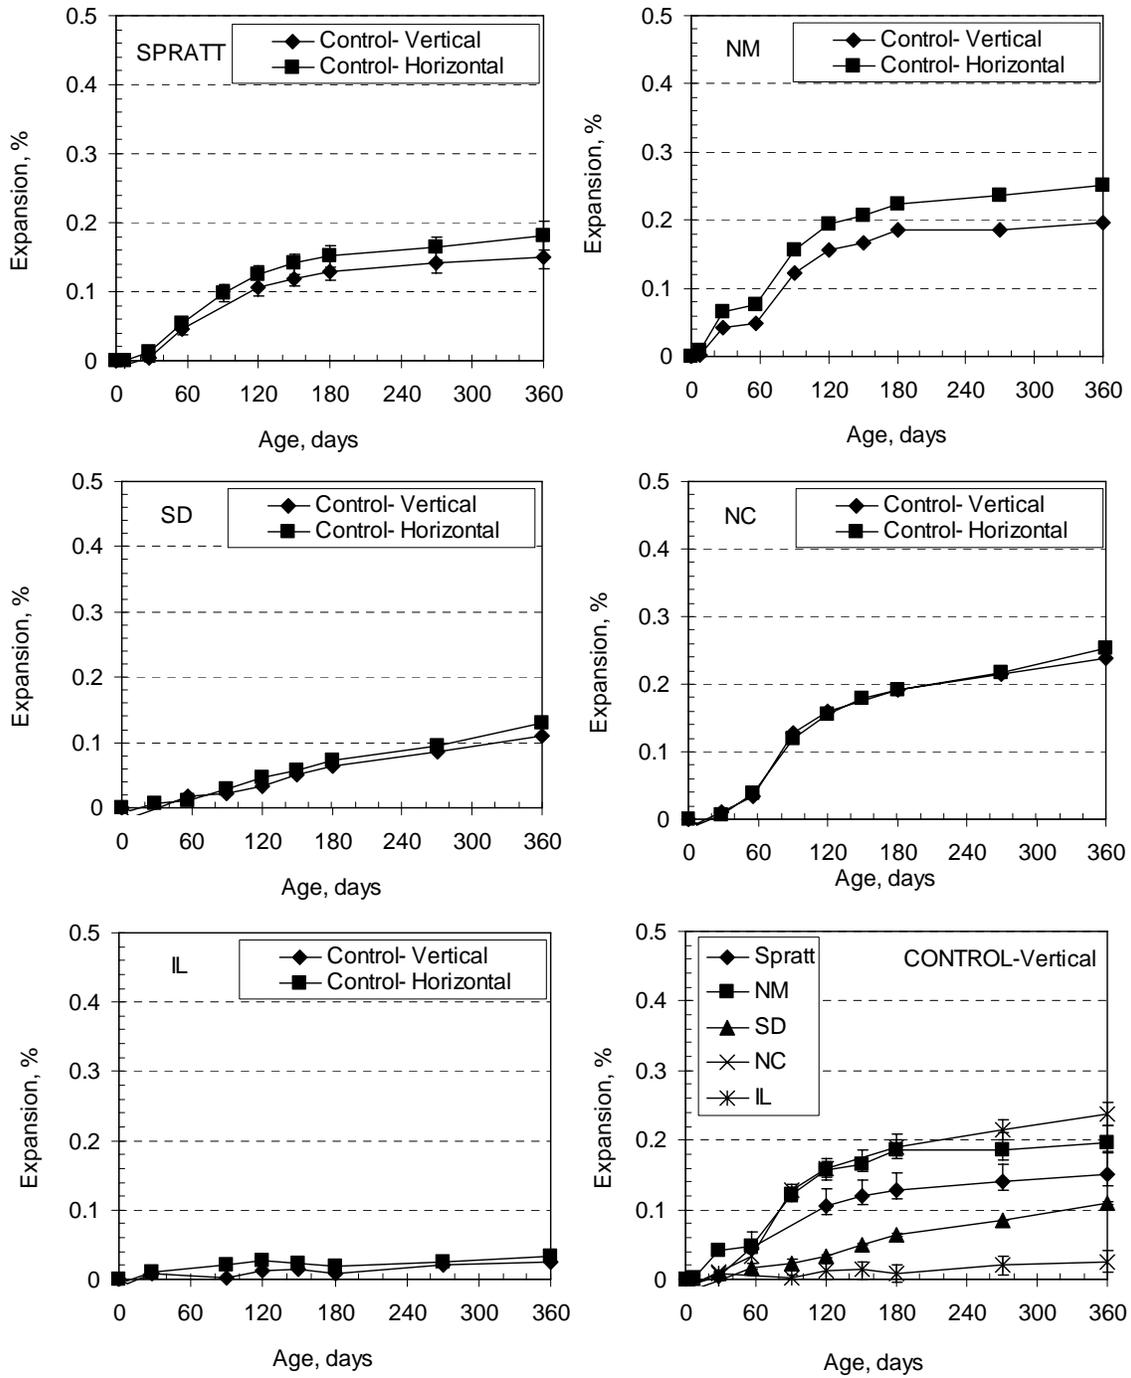
FIGURE 73. EXPANSION OF CONCRETE PRISMS IN STANDARD ASTM C 1293 TESTS WITH HORIZONTAL AND VERTICAL ORIENTATION OF CONCRETE PRISMS IN STORAGE CONTAINERS

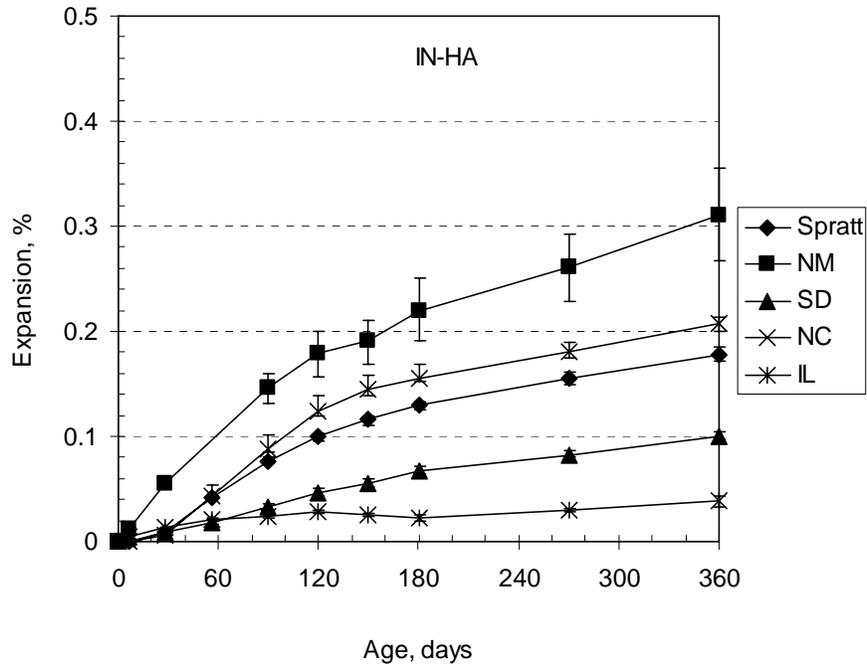
FIGURE 74. EXPANSION OF CONCRETE PRISMS IN MODIFIED ASTM C 1293 TESTS WITH 1N NaOH SOLUTION AND HA CEMENT

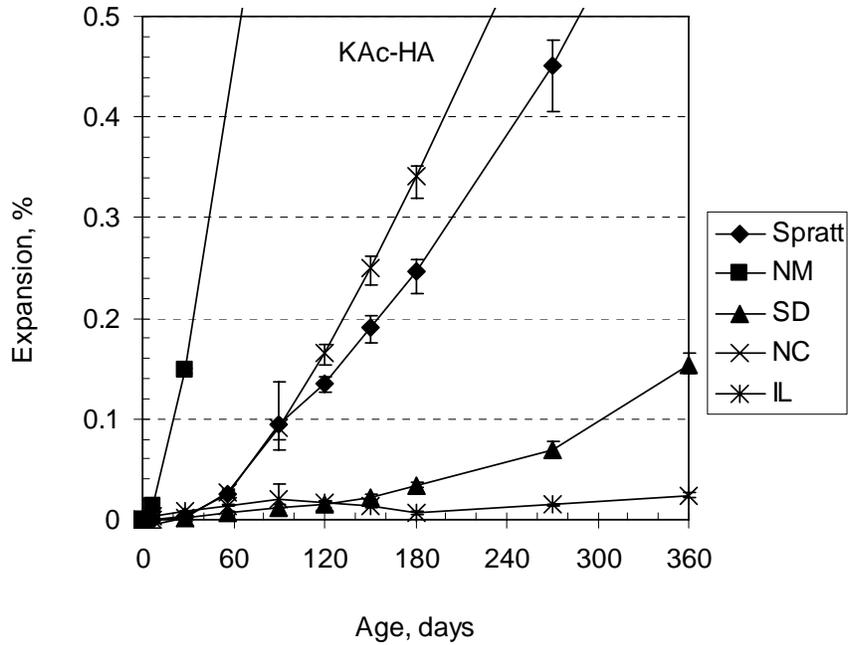
FIGURE 76. EXPANSION OF CONCRETE PRISMS IN MODIFIED ASTM C 1293 TESTS WITH POTASSIUM ACETATE DEICER SOLUTION AND HA CEMENT

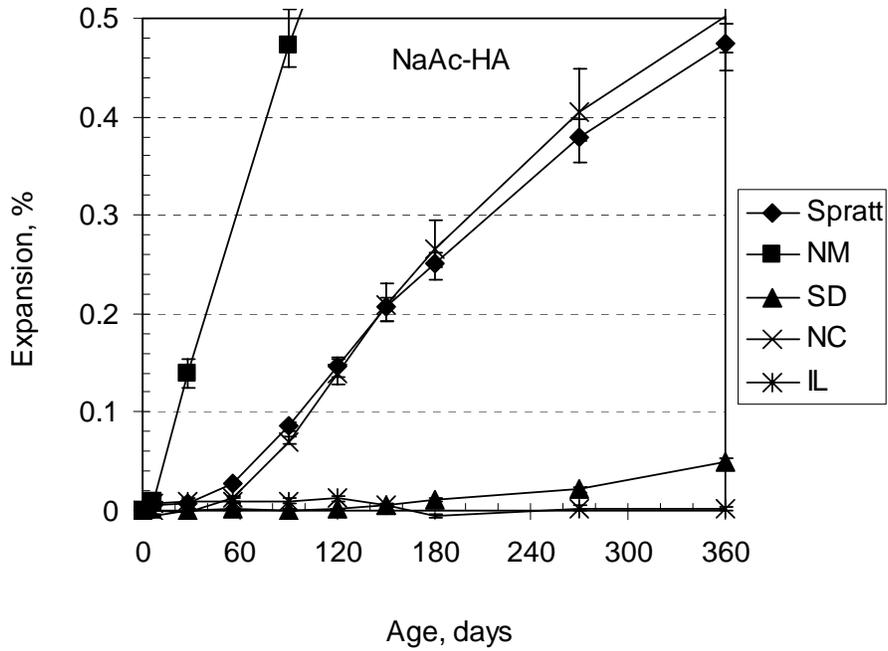
FIGURE 78. EXPANSION OF CONCRETE PRISMS IN MODIFIED ASTM C 1293 TESTS WITH SODIUM ACETATE DEICER SOLUTION AND HA CEMENT

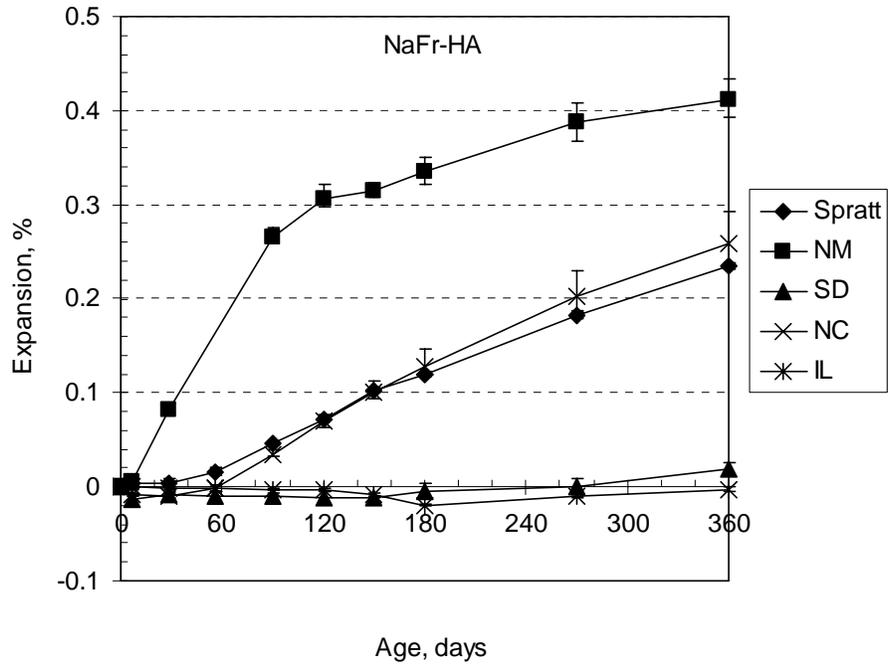
FIGURE 80. EXPANSION OF CONCRETE PRISMS IN MODIFIED ASTM C 1293 TESTS WITH SODIUM FORMATE DEICER SOLUTION AND HA CEMENT

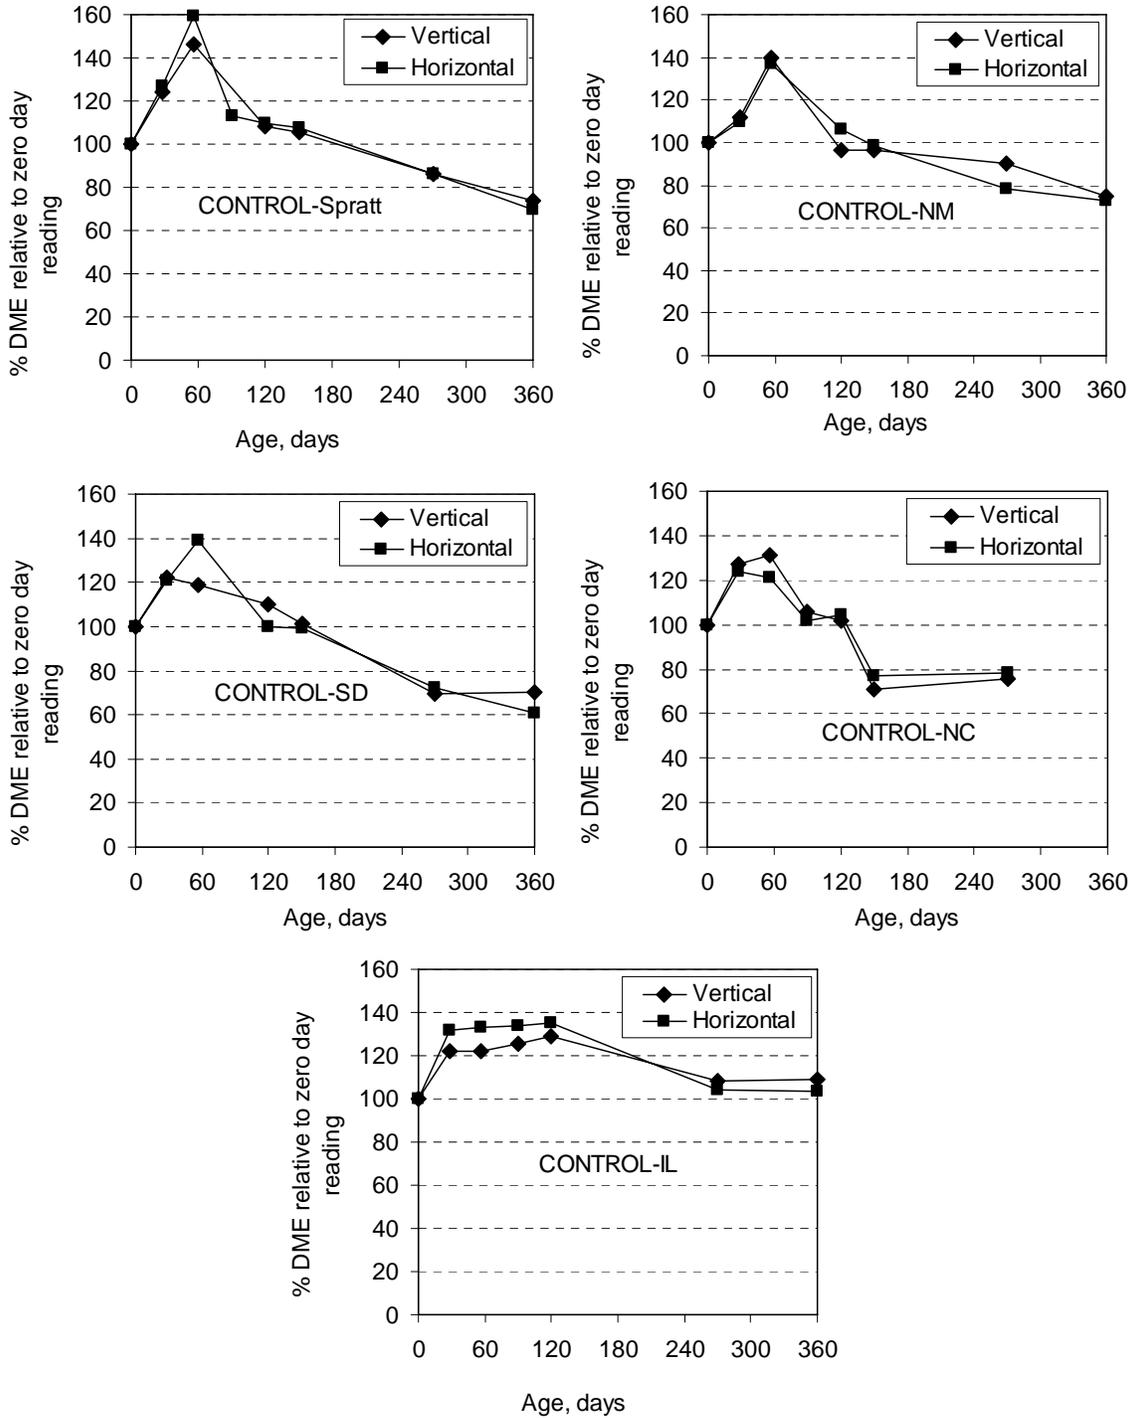
FIGURE 82. CHANGE IN DYNAMIC MODULUS OF CONCRETE PRISMS IN THE STANDARD ASTM C 1293 TEST

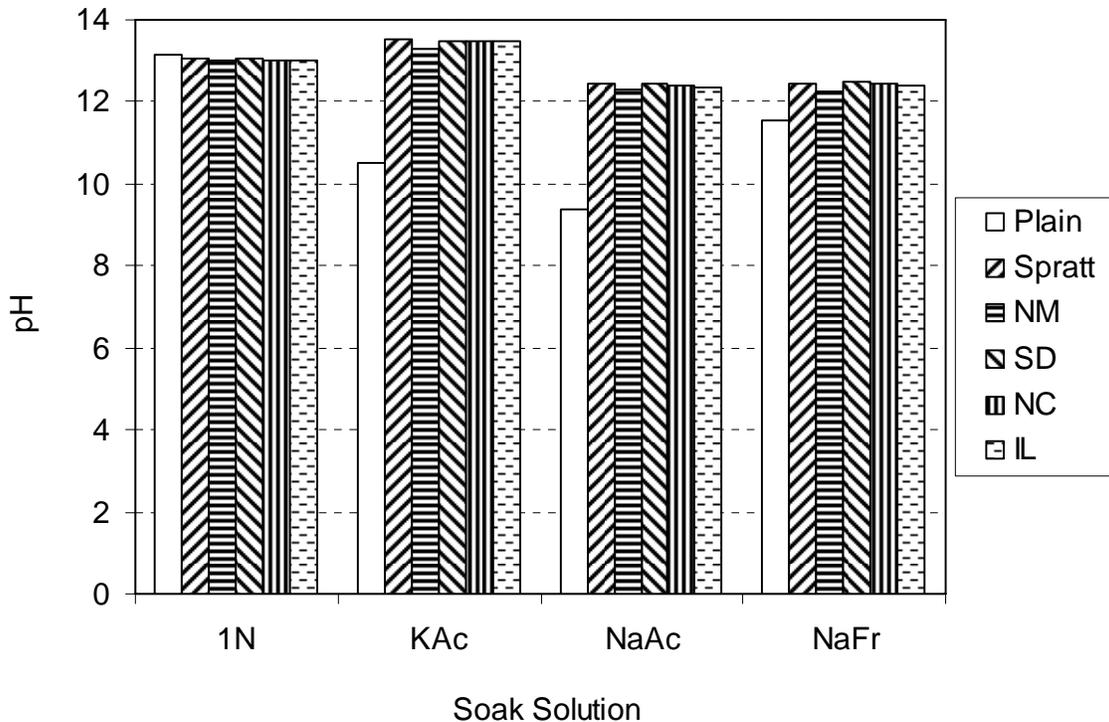
FIGURE 87. pH VALUES MEASURED IN SOAK SOLUTIONS RECOVERED FROM THE MODIFIED ASTM C 1293 TESTS WITH LA CEMENT, AND OF CORRESPONDING SOLUTIONS NOT EXPOSED TO CONCRETE.

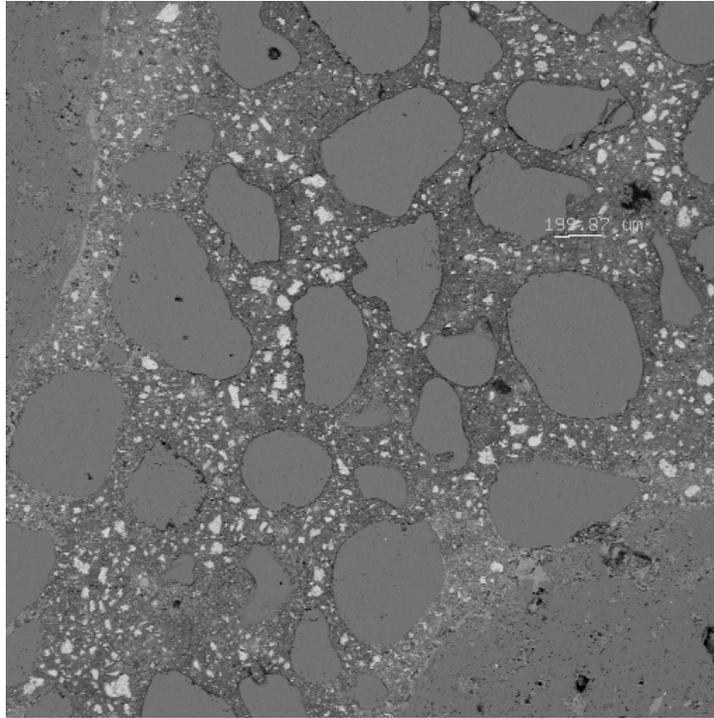
FIGURE 88. TYPICAL MICROSTRUCTURE OF ILLINOIS DOLOMITE CONCRETE AFTER 6 MONTHS OF EXPOSURE TO 1N NaOH SOLUTION

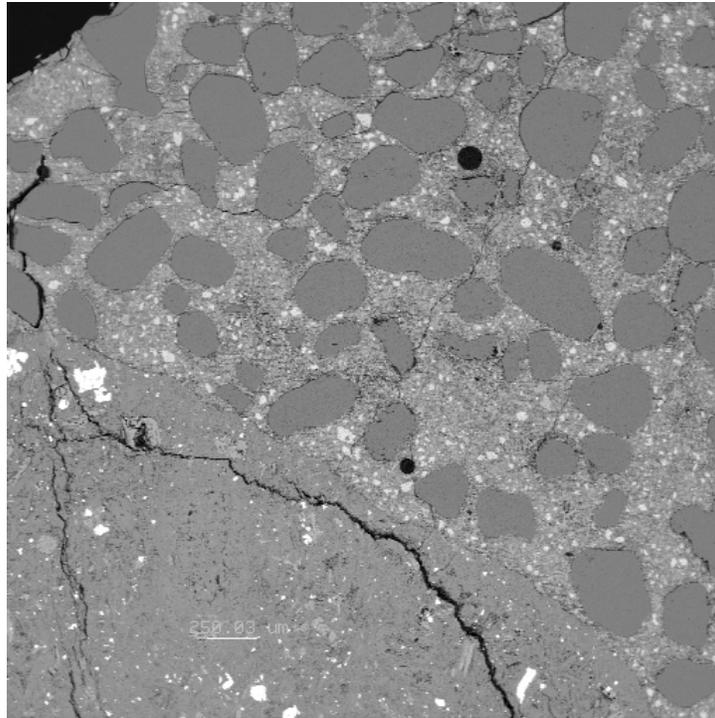
FIGURE 89. CRACKS WITHIN NM AGGREGATE GRAIN, WITHIN THE PASTE AND AT THE INTERFACES.

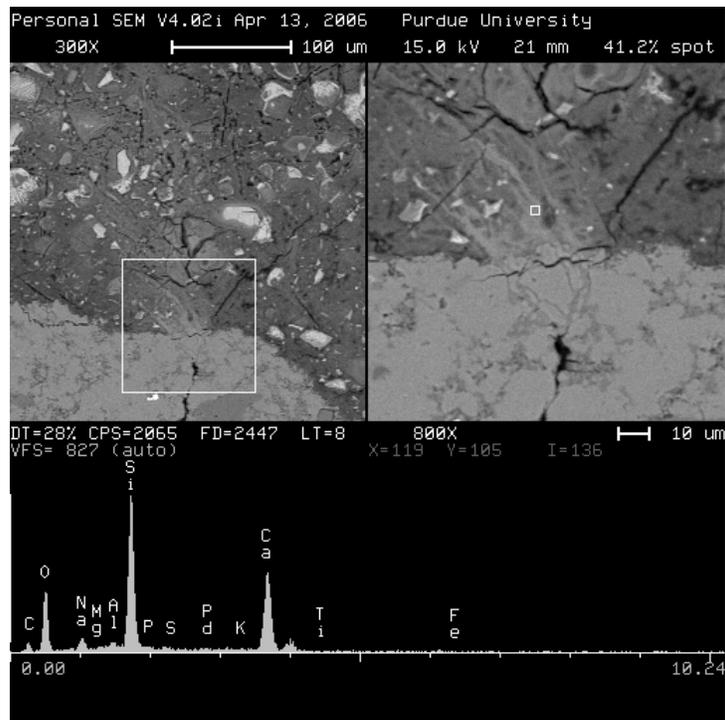
FIGURE 90. Si-Ca-Na GEL FLOWING OUT OF THE AGGREGATE (SPRATT SILICEOUS LIMESTONE)

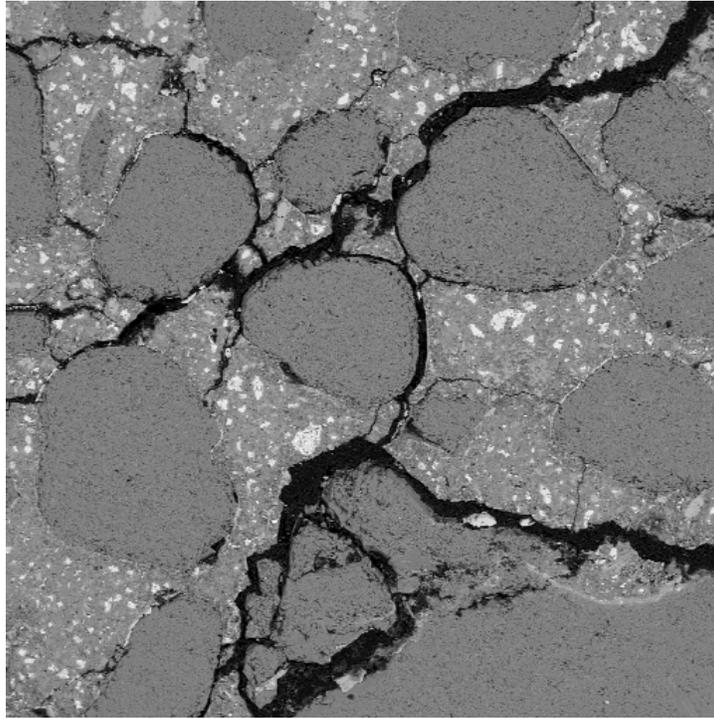
FIGURE 92. SEVERE CRACKING WITHIN THE PASTE AND SOME CRACKING WITHIN AGGREGATES IN NEW MEXICO RHYOLITE CONCRETE

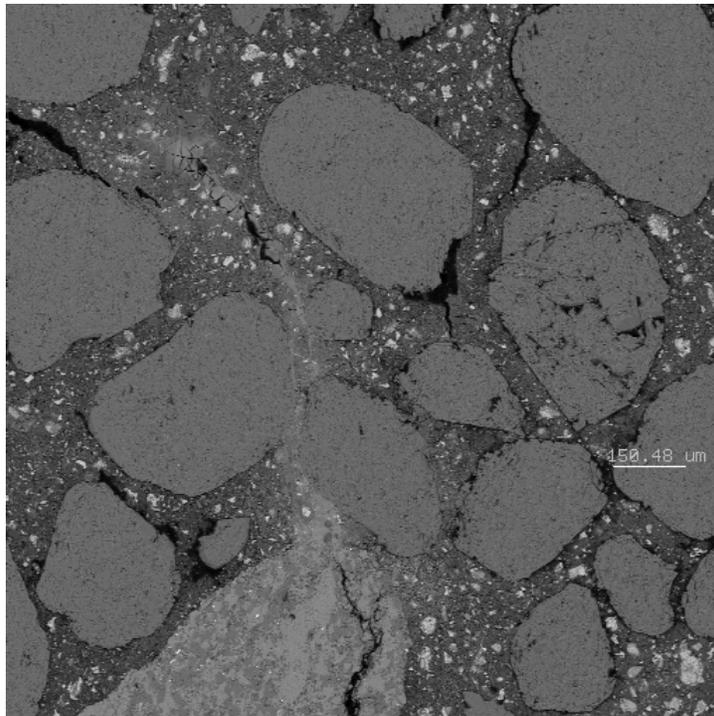
FIGURE 93. RIVER OF GEL IN SPRATT SILICEOUS CONCRETE SAMPLE

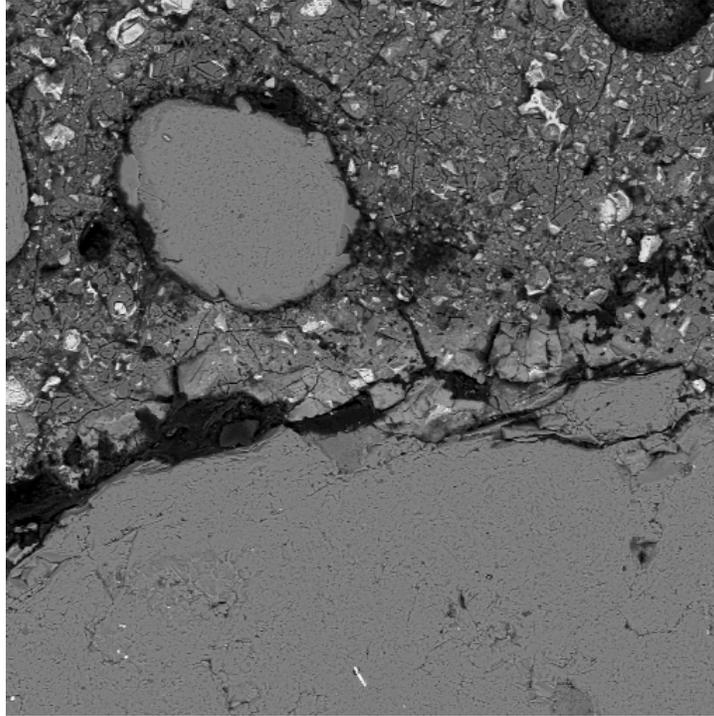
FIGURE 96. CRACKS ALONG THE INTERFACE AND ALSO WITHIN THE PASTE (NM RHYOLITE CONCRETE)

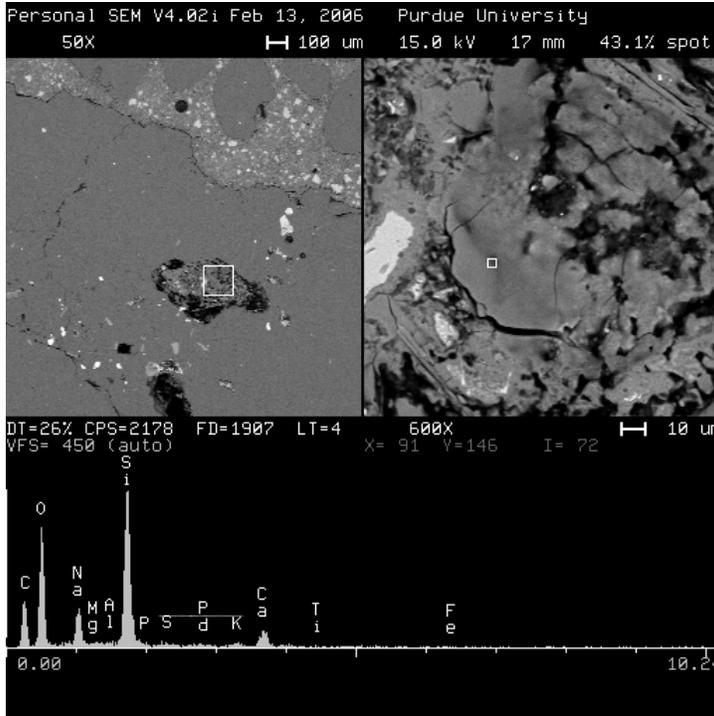
FIGURE 97. CRACKS WITHIN THE AGGREGATE. ALKALI - SILICA GEL VISIBLE INSIDE THE "POCKET" WITHIN THE AGGREGATE (NM RHYOLITE CONCRETE)

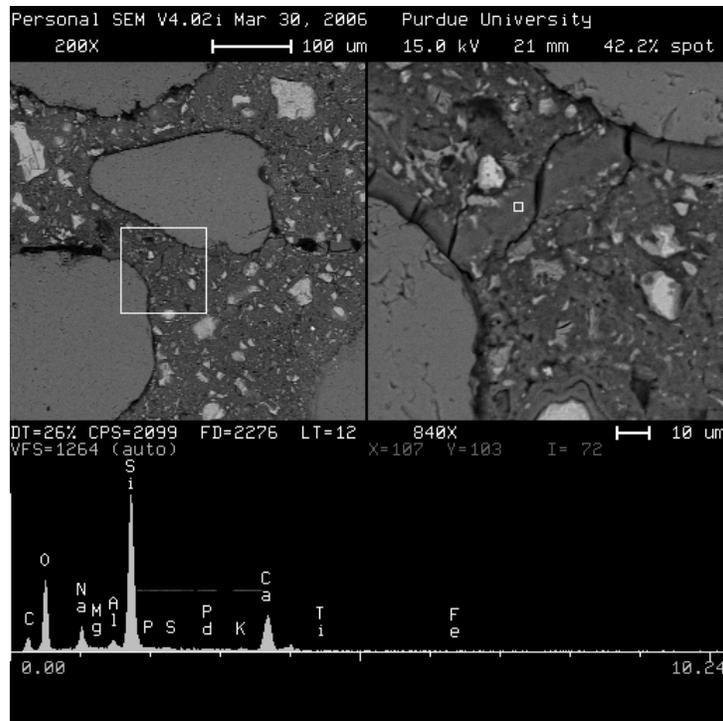
FIGURE 98. CRACK WITHIN THE PASTE AND AT THE INTERFACE FILLED WITH GEL (NC ARGILLITE CONCRETE)

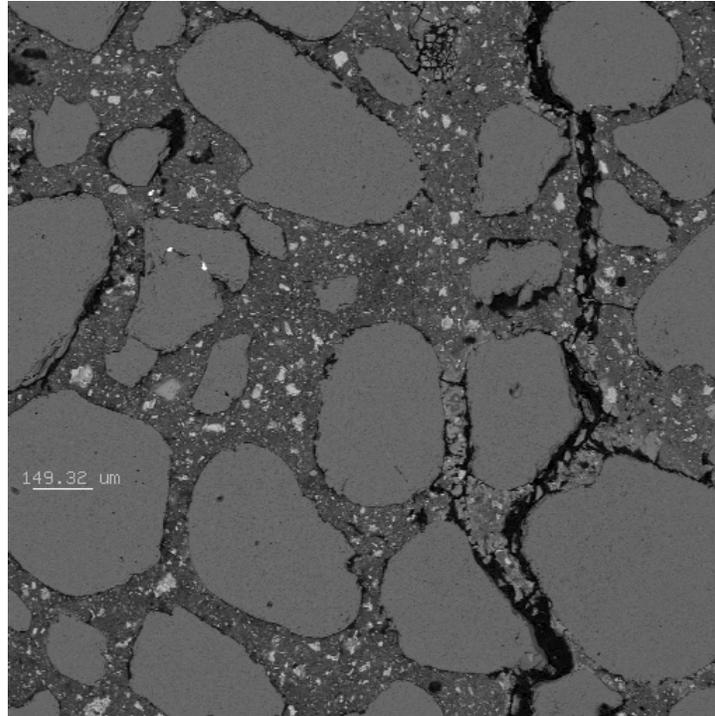
FIGURE 99. CRACKING WITHIN THE PASTE AND AT THE INTERFACE (NORTH CAROLINA ARGILLITE CONCRETE)

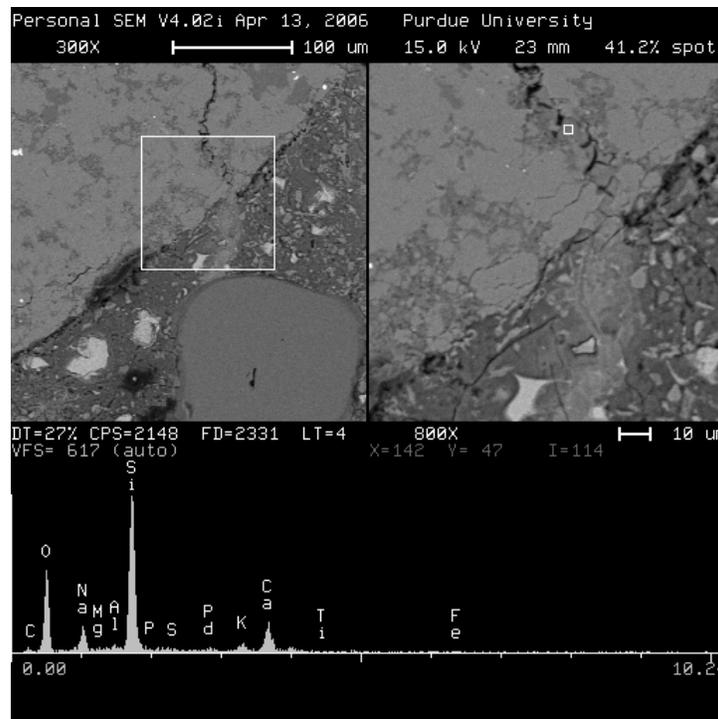
FIGURE 100. CRACK WITHIN THE AGGREGATE. GEL INSIDE THE CRACK (SPRATT SILICEOUS LIMESTONE CONCRETE)

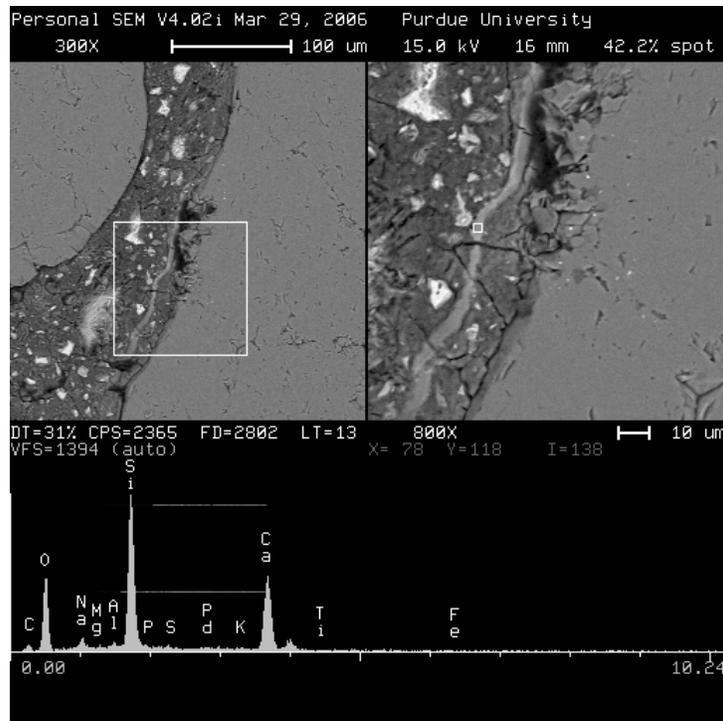
FIGURE 101. RIVER OF GEL ALONG FINE AGGREGATE GRAIN (SOUTH DAKOTA QUARTZITE)

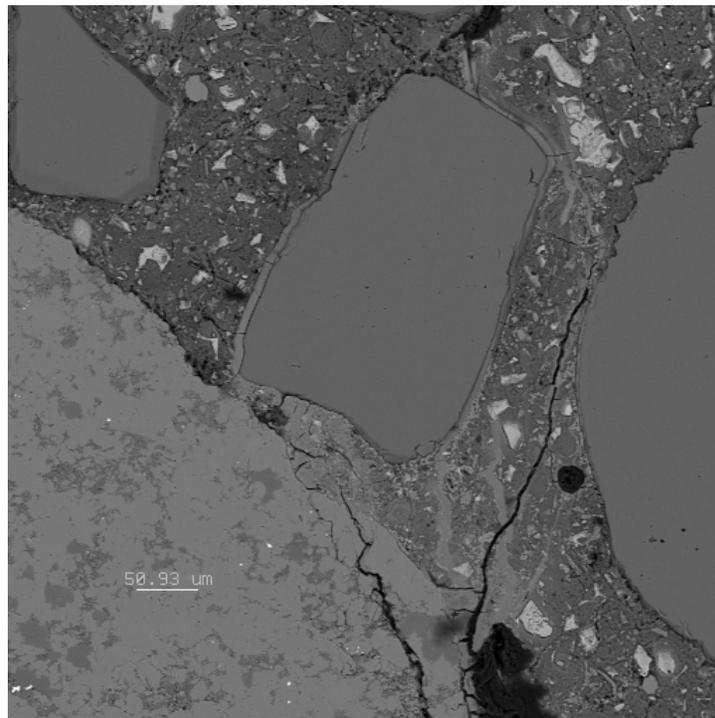
FIGURE 104. GEL RIM AROUND NON-REACTIVE FINE AGGREGATE (IN SPRATT LIMESTONE CONCRETE PRISM)

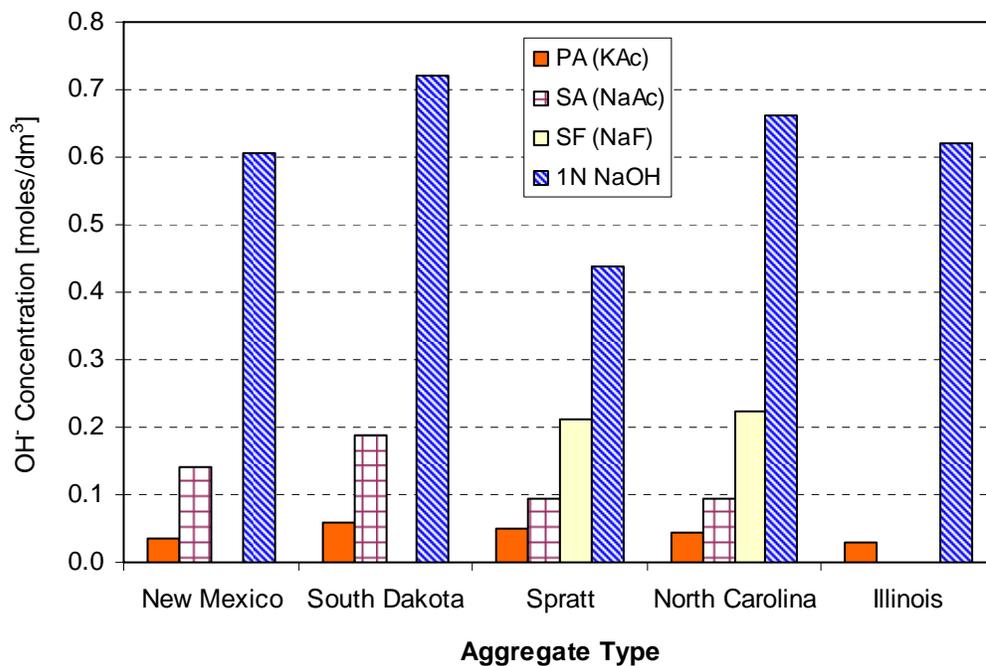
FIGURE 105. OH⁻ ION CONCENTRATIONS IN PORE SOLUTIONS OF CONCRETES EXPOSED TO DIFFERENT DEICERS SOLUTIONS AT THE END OF THREE MONTHS
