An **IPRF** Research Report
Innovative Pavement Research Foundation
Airport Concrete Pavement Technology Program

Report IPRF-01-G-002-03-10

Field Studies in Mitigating ASR in Existing Pavement, Topical Application of Lithium

David W. Whitmore, P.Eng.

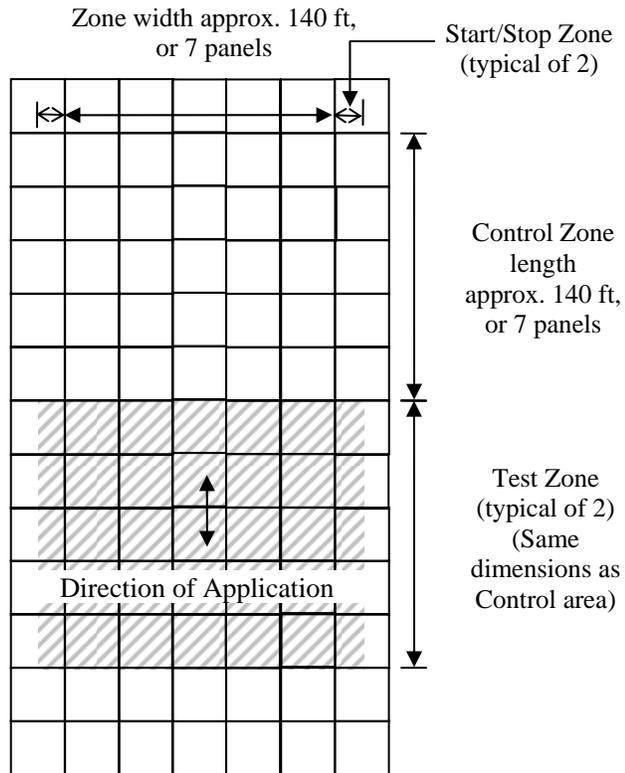
Figure 4: Schematic of Test and Control Zones at S3W at Phoenix Sky Harbor International Airport

The test area at PHX consisted of three (3) zones. As laid out from north to south: Control Zone (Zone 1), Single Application Zone (Zone 2) and Multiple Application Zone (Zone 3). Because of the type of exposure in the area that was chosen for the application, to maintain consistent properties of the concrete, the zones were delineated width-wise along the length of the terminal building. The level of deterioration was found to be higher closer to the terminal building where planes park for loading and unloading passengers. Therefore, to prevent any specific zone from concentrating on an area with possibly different levels of deterioration, each zone, including the control section, incorporated areas near the terminal building and outwardly towards the middle of the ramp area.

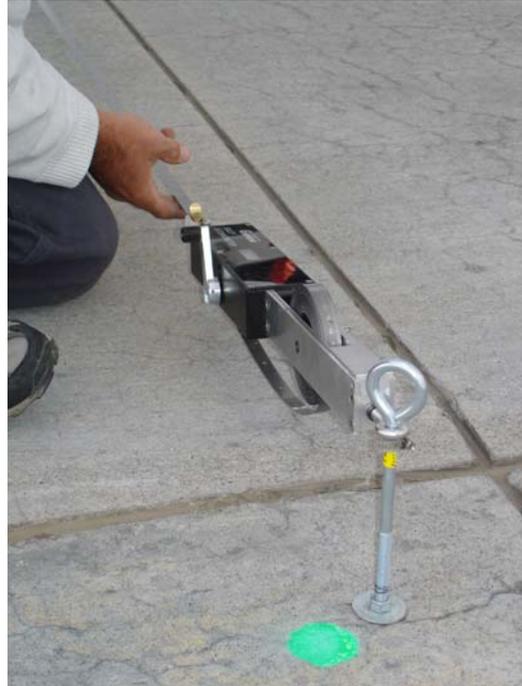
Figure 8: Extensometer Measurement at Cheyenne Regional Airport

Manual temperature readings coupled with the surface measurements in the treated and control sections were used eliminate bias in the data due to thermal expansion and contraction of the pavement. Thermocouple wires were included in the installation of the relative humidity wells.

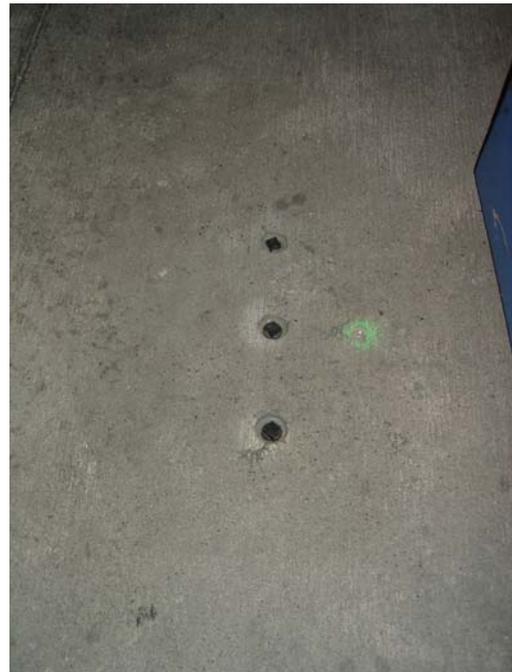
Figure 9: Humidity Wells Installed (12" Top, 6" Center, 2" Bottom) at Phoenix Sky Harbor International Airport

Three concrete relative humidity wells were installed into the concrete pavement near the edge in the center of the overall test area. The tubes are recessed below the pavement surface to avoid interference with maintenance operations and are capped and sealed to provide access during manual inspections. Relative humidity measurements were recorded at the time condition surveys were performed.

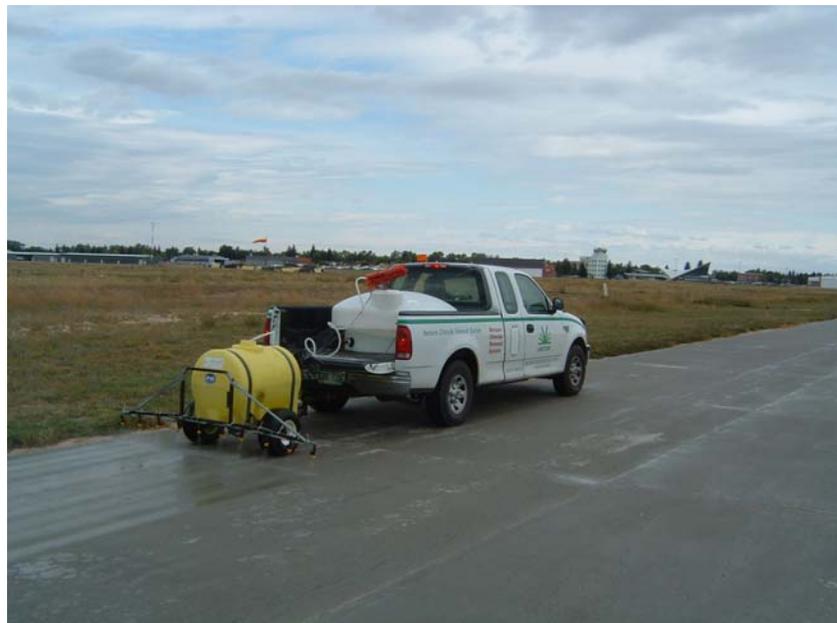
Figure 14: Application at Cheyenne Regional Airport

Initial application occurred in August of 2005. Upon suggestion from lithium distributor, the areas for application were pre-wetted prior to application. After the application of the lithium solution the area was then post-wetted. With the application occurring during the day, warm summer conditions allowed the solution to dry rapidly and crystallize on the surface of the concrete. The post-wetting allowed the lithium salts to be absorbed into the concrete, and prevented high levels of crystallization on the surface.

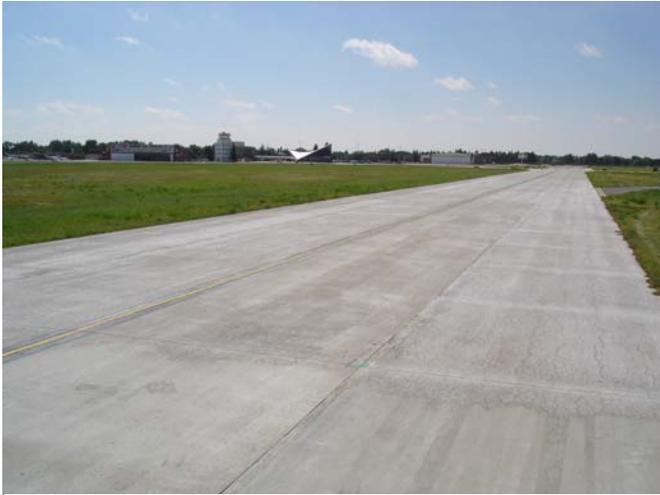
Figure 15: Zone 2 After Application at CYS

It was observed that the lithium solution application initially caused the concrete surface to be slippery in areas where the solution was not fully absorbed. This was especially true where the surface of the concrete was painted with lines or other markings. Post-wetting of the treatment area allowed the lithium solution to be fully absorbed into the concrete and removed any immediate surface crystallization. Some crystallization confined to cracks in the concrete was observed the next day.

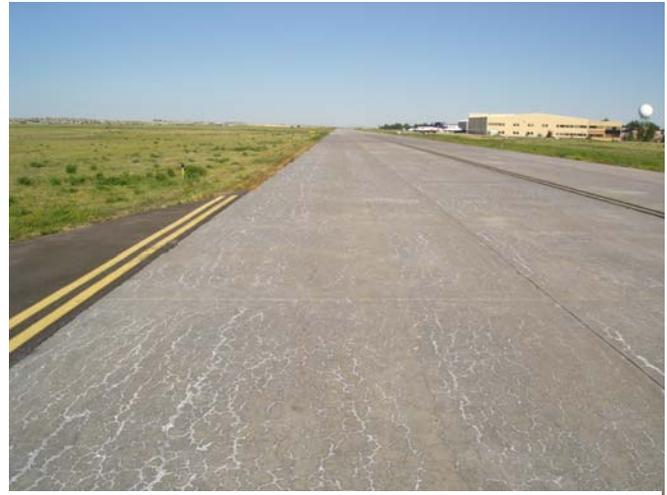
Figure 16: Zone 2 Following Day at CYS

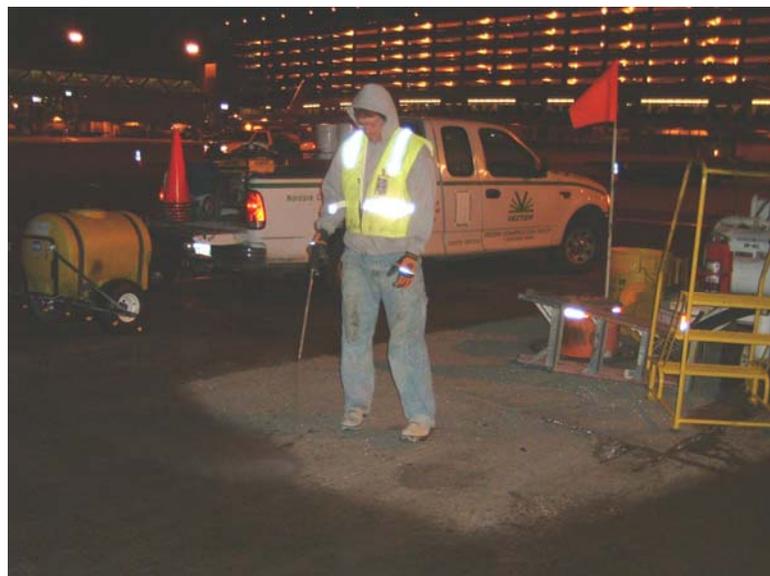
Figure 17: Hand Application Around Facilities at Phoenix Sky Harbor International Airport

Second (March 2006) and third (September 2006) applications occurred in much the same manner. Locations around fixed equipment and facilities on the ramp area required some portions of the lithium solution to be hand applied.

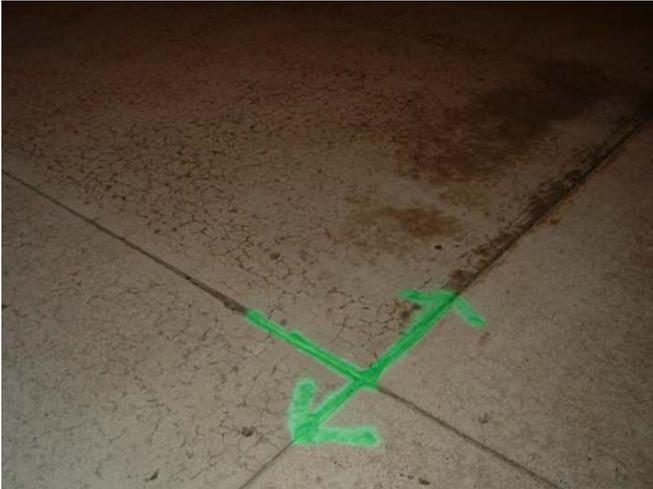
Figure 18: Between Zone 1 (Control) and 2 After Initial Application at PHX

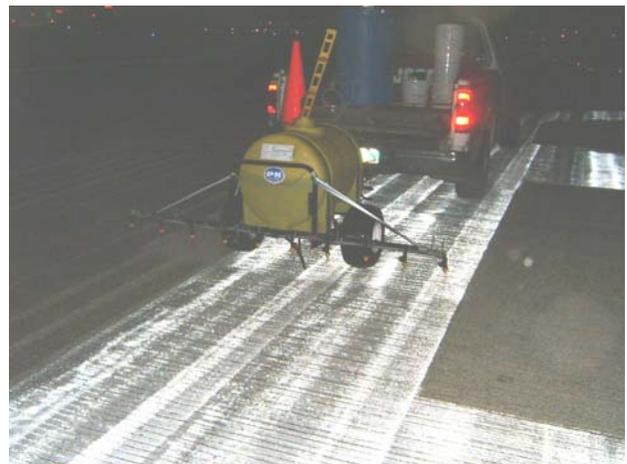
Figure 20: Application On Runway and Runway Markings at Hartsfield-Jackson Atlanta International Airport

Initial application occurred in January of 2006. The application was performed in two (2) coats of approximately 2.25 gal/1000 ft². This allowed for complete absorption and reduced crystallization of the lithium solution after a thorough post-wetting. Post-wetting allowed the lithium salts to absorb into the concrete, and prevented high levels of crystallization on the surface. Because of the grooved surface of the concrete, issues regarding slipperiness and crystallization were not as evident as the un-grooved concrete at the other locations. Observations of the concrete the next day showed very few to no signs of crystallization.

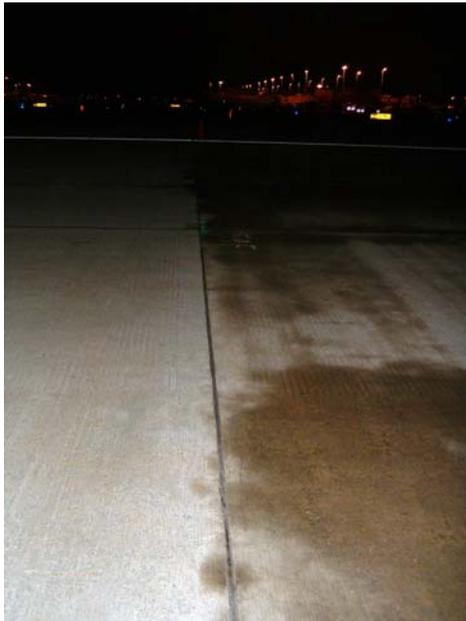
Figure 21: Area 2 Zone 1 Following Day After Half Application

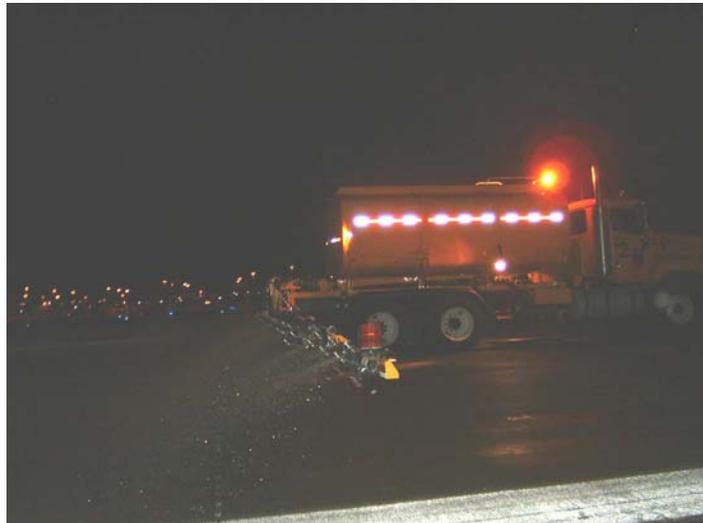
Figure 22: Post-Wetting of Concrete Surface
