Report IPRF-01-G-002-06-5

Role of Dirty Aggregates in the Performance of Concrete Exposed to Airfield Pavement Deicers

July 2011

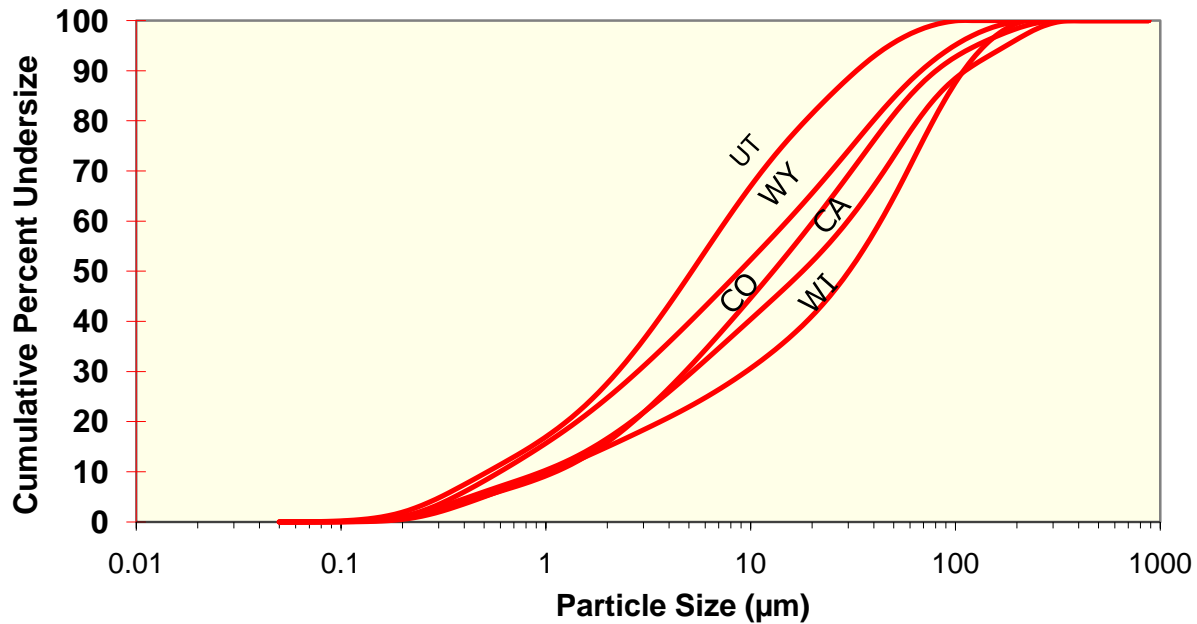
Figure 1. Particle size distributions for the microfines

Particle size distributions for the microfines are shown in figure 1. The microfines ranged in size from 0.1 microns to 100 microns with the microfines from Utah presenting the finest distribution. The percentages passing 45 microns (as one indicator of the different in fineness) for each set of microfines were as follows: CA : 68%, CO : 77%, UT : 95%, WI : 65%, WY: 85%.

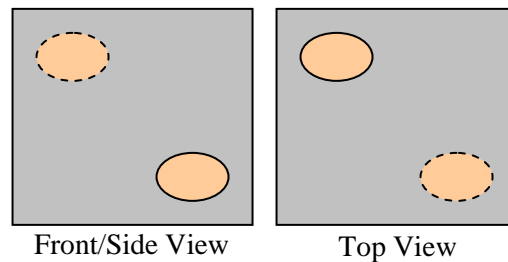
Figure 2. Schematic view of the 2x2x2 in. mortar cubes with embedded aggregates

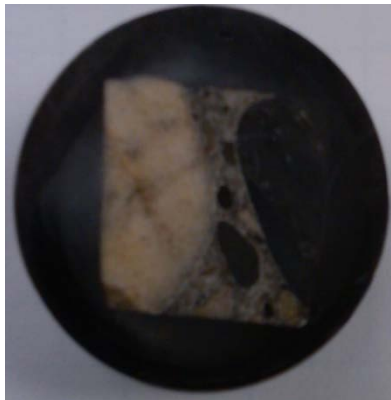
Figure 3. SEM sample prepared for BSE mode and EDS analysis

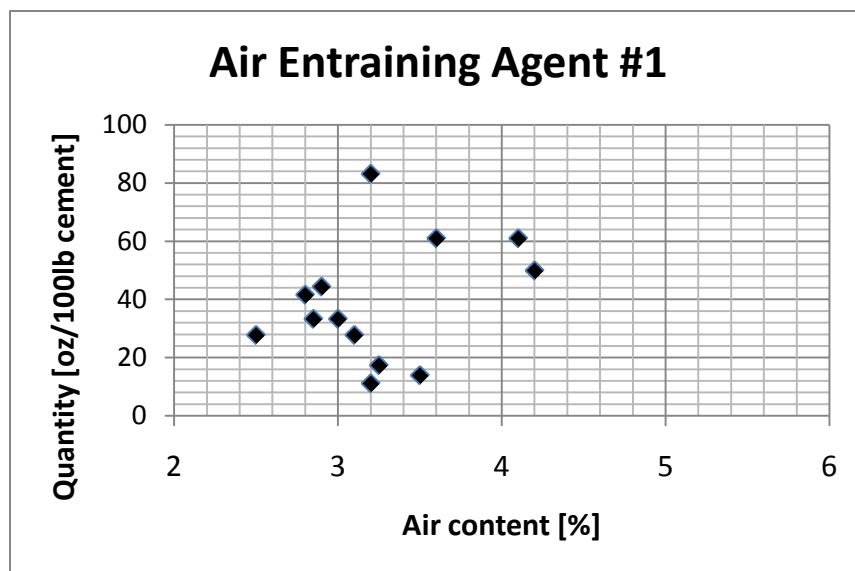
Figure 4. Air content achieved in concrete batches containing WY microfines with different dosages of air entraining agent No. 1. The manufacturer’s recommended typical field dosage falls between 1 and 3 fl. oz. per 100 lbs of cement.

During mixing, the microfines appeared to neutralize the initial selection of air entraining admixture. As indicated in figure 4, with Wyoming microfines, the research team was unable to achieve target air levels independent of the amount of air entraining agent used. The air entraining agent used was a common agent provided by a national distributor. An alternative and less commonly used air entraining agent was ultimately selected for use in mixing. As shown in figure 5, this AEA proved more effective though dosage rates far exceeded normal field levels. Figure 5 shows the air contents achieved with the second AEA in trial batches. Ultimately, AEA #2 produced air contents as shown in figures 6 and 7 with the dosage rates shown. These figures show that microfines-containing mixes require significantly larger dosages of AEA. The target air content was not achieved in all cases because of the unpredictability of the process.

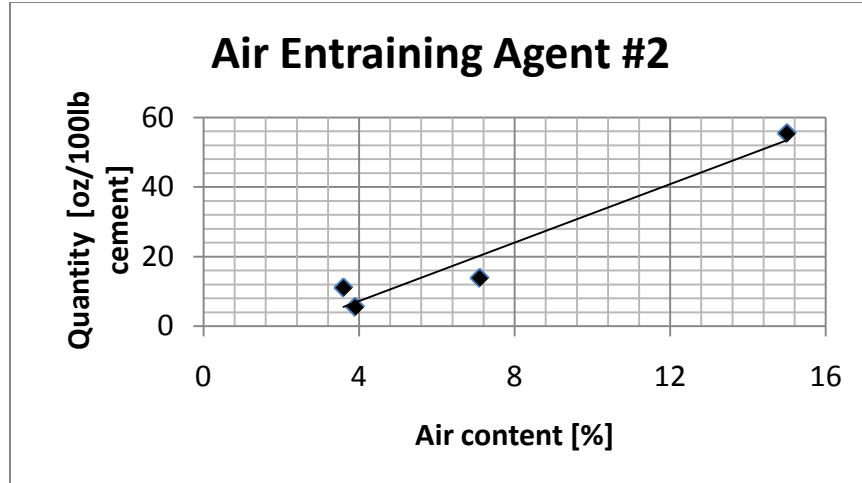
Figure 5. Air content achieved in concrete batches containing WY microfines with different dosages of air entraining agent No. 2. The manufacturer’s recommended typical field dosage falls between 0.15 and 3 fl. oz. per 100 lbs of cement.

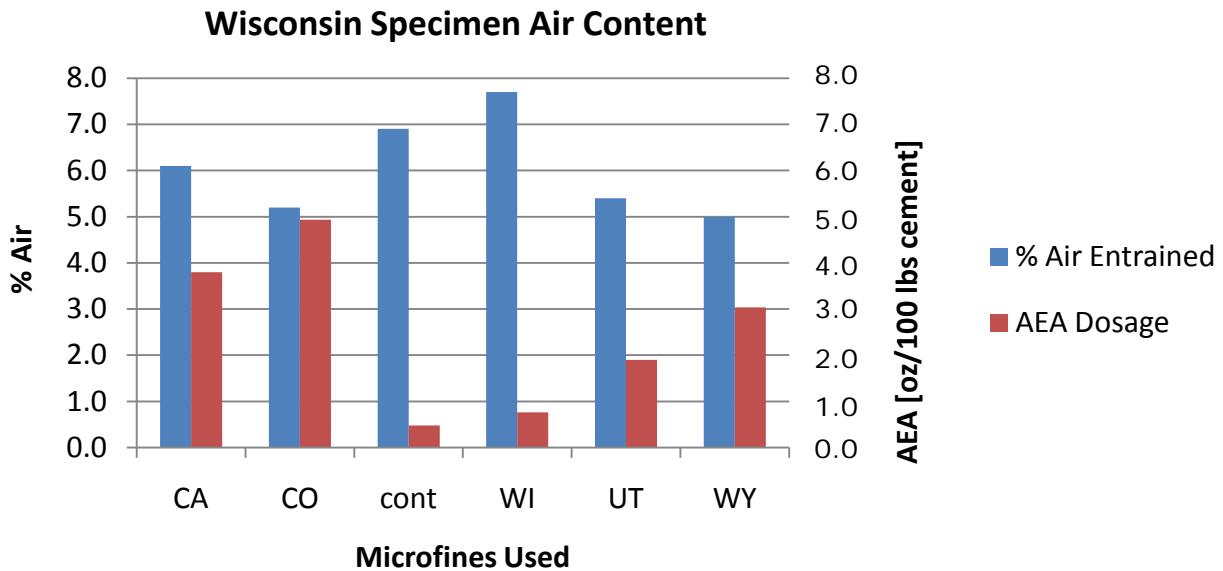
Figure 6. Air content and air entraining agent dosages for concrete batches using Wisconsin aggregate.

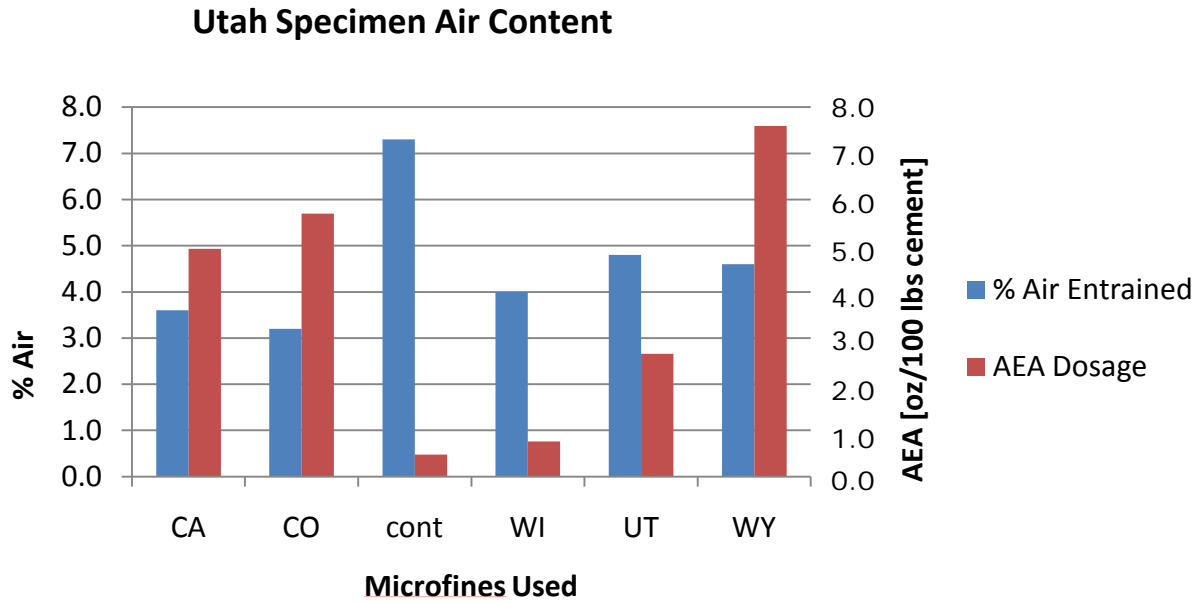
Figure 7. Air content and air entraining agent dosages for concrete batches using Utah aggregate.

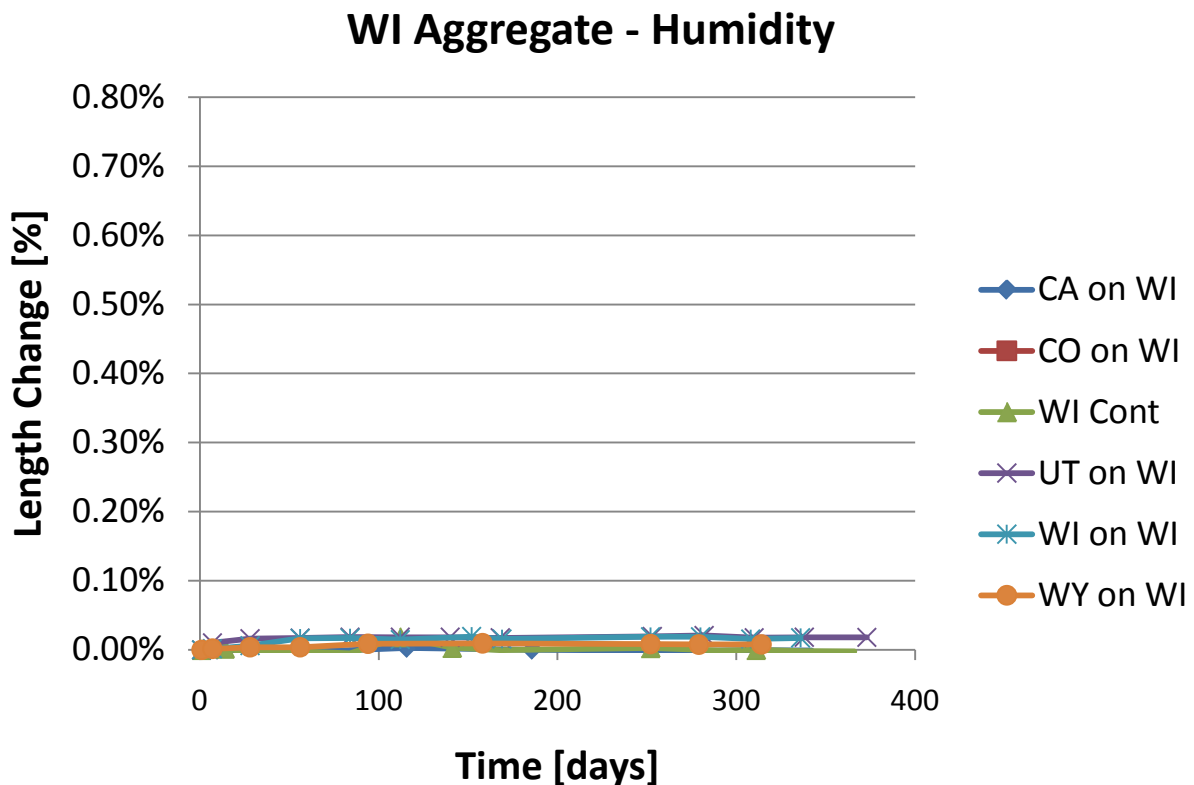
Figure 10. Length change for C1293 Humid specimens based on Wisconsin aggregate

Expansion data for C1293-Humid testing are shown in figures 10 and 11. Expansions from specimens associated with each of the aggregate sources have been negligible. Since these specimens lacked the artificial alkali addition of NaOH, this result is perhaps not surprising. As such, it does not appear that any significance can be attached to the small differences in these values.

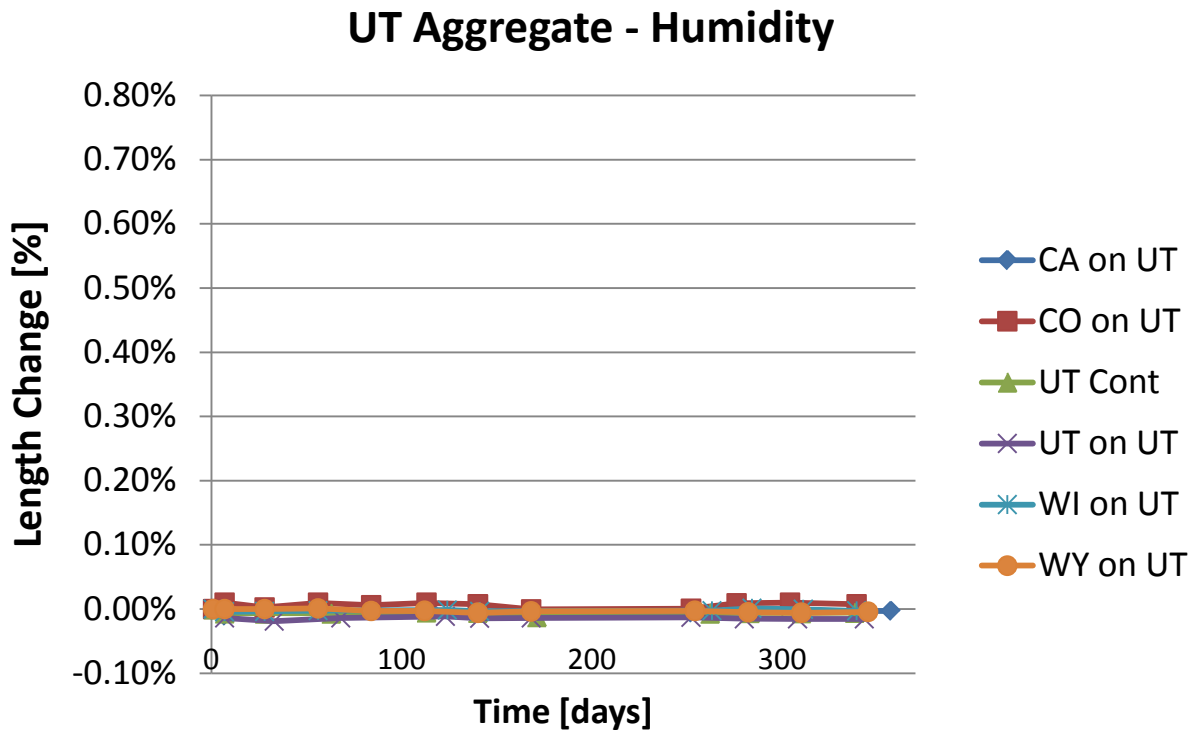
Figure 11. Length change for C1293 Humid specimens based on Utah aggregate

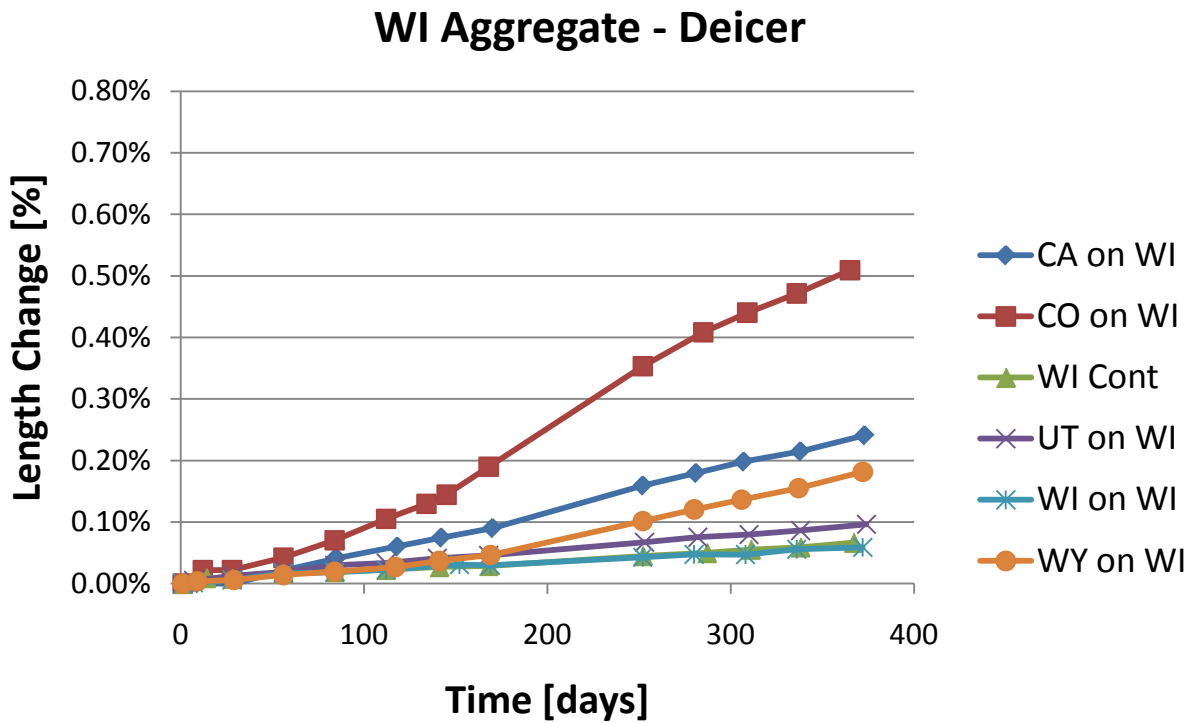
Figure 12. Length change for C1293-Deicer specimens based on Wisconsin aggregate

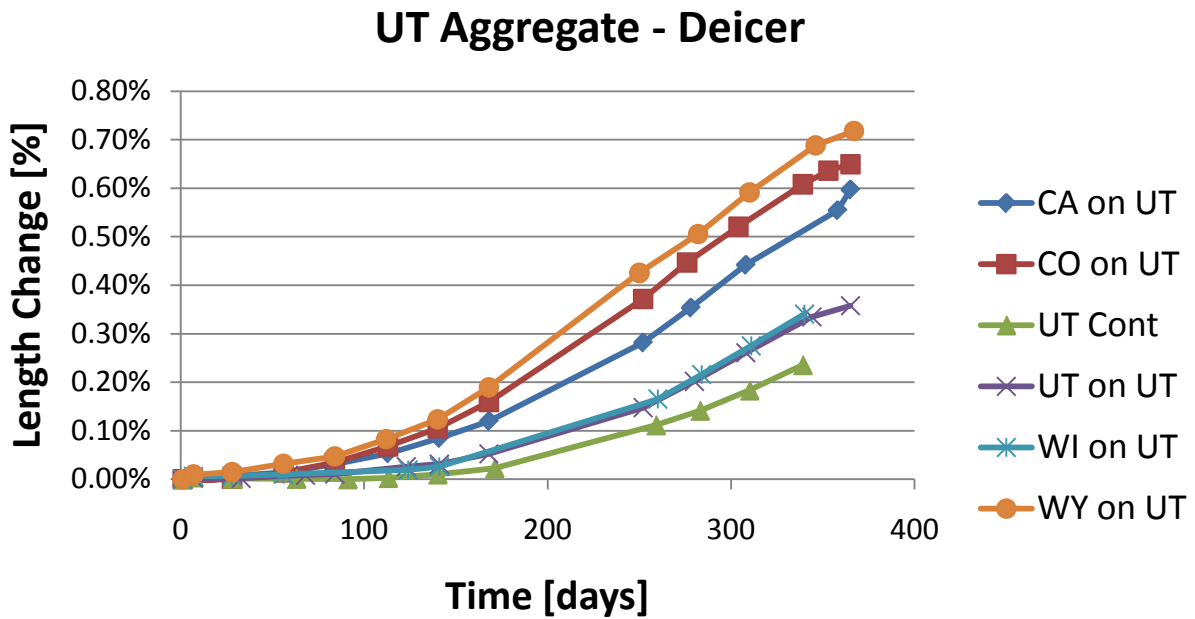
Figure 13. Length change for C1293-Deicer specimens based on Utah aggregate

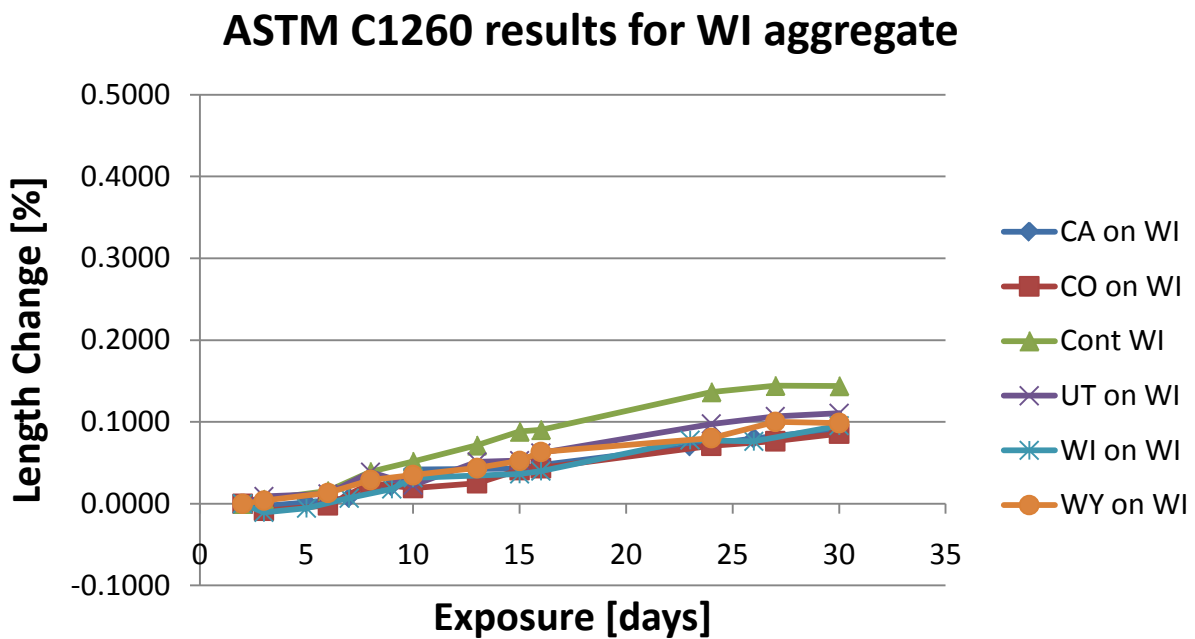
Figure 14. ASTM C1260 expansion for specimens containing Wisconsin fine aggregate different sources of microfines

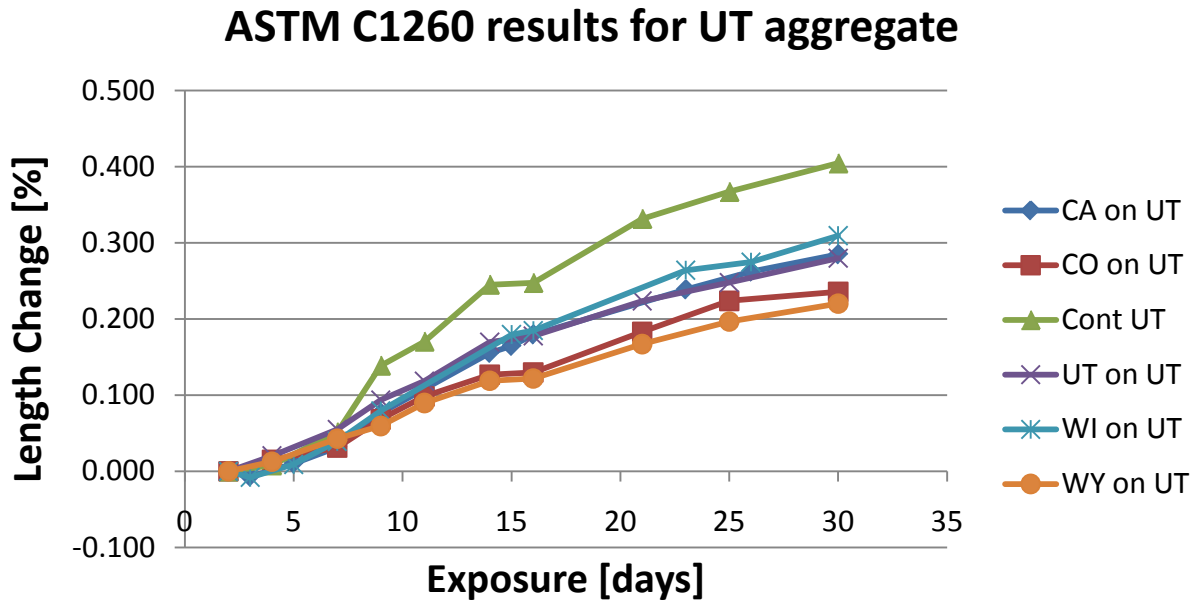
Figure 15. ASTM C1260 expansions for specimens containing Utah fine aggregate and different sources of microfines

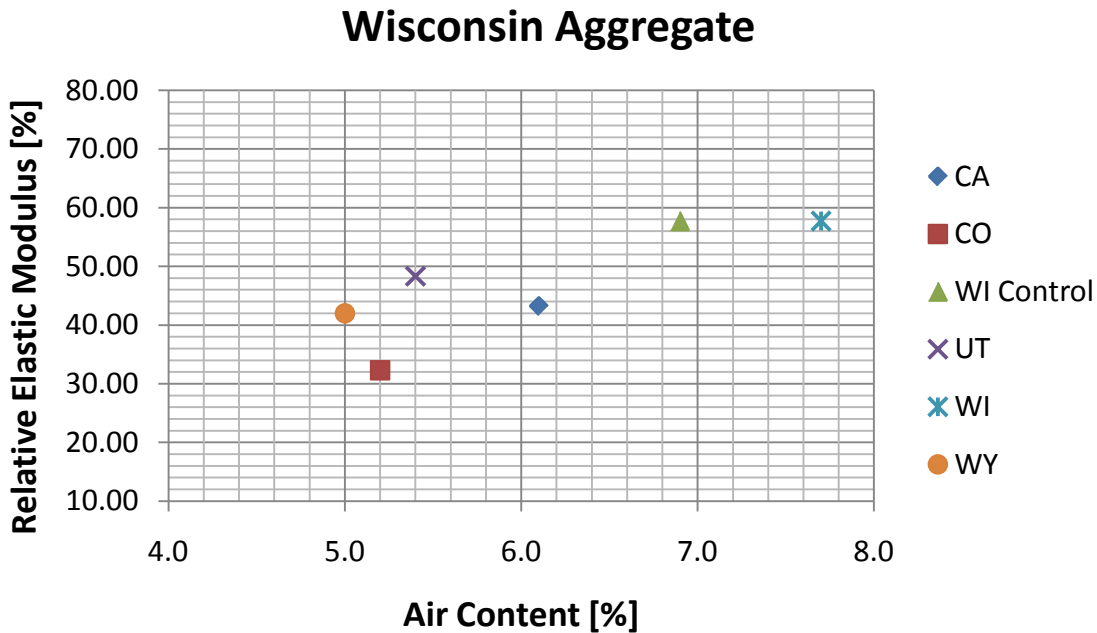
Figure 16. Relative dynamic modulus for specimens containing Wisconsin aggregate and subject to the modified ASTM C666 protocol versus the corresponding air content

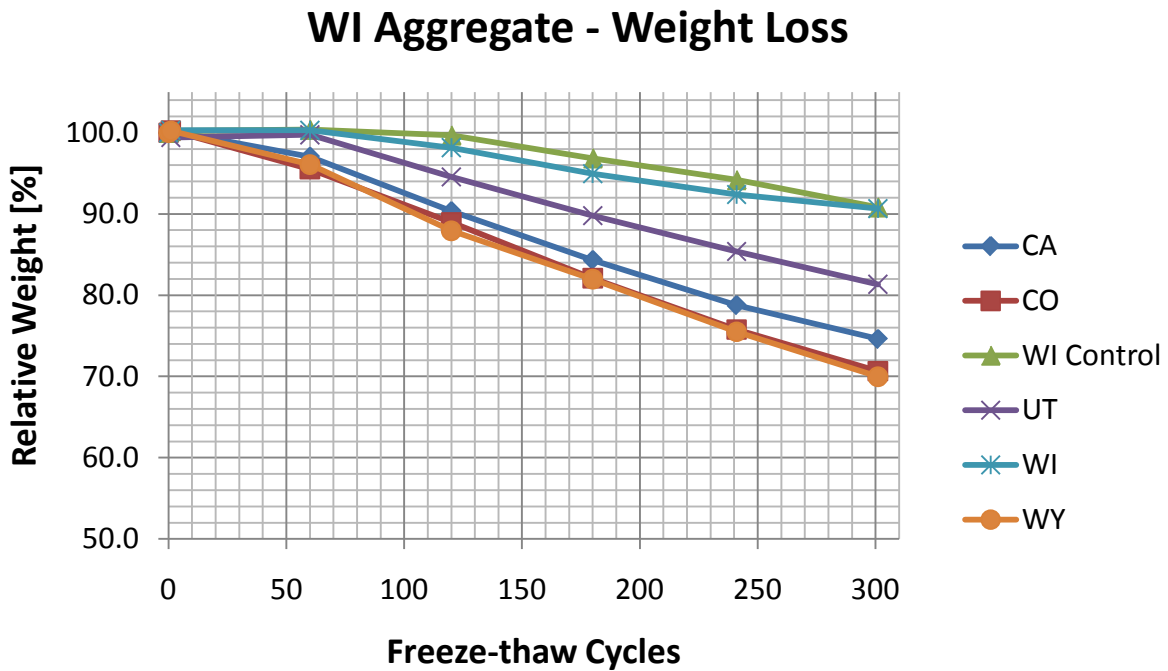
Figure 18. Relative weight loss of Wisconsin aggregate specimens with freeze-thaw cycles

Weight loss data for increasing freeze-thaw exposure is shown in figures 17 and 18. The trends are similar to those with the relative elastic modulus data.

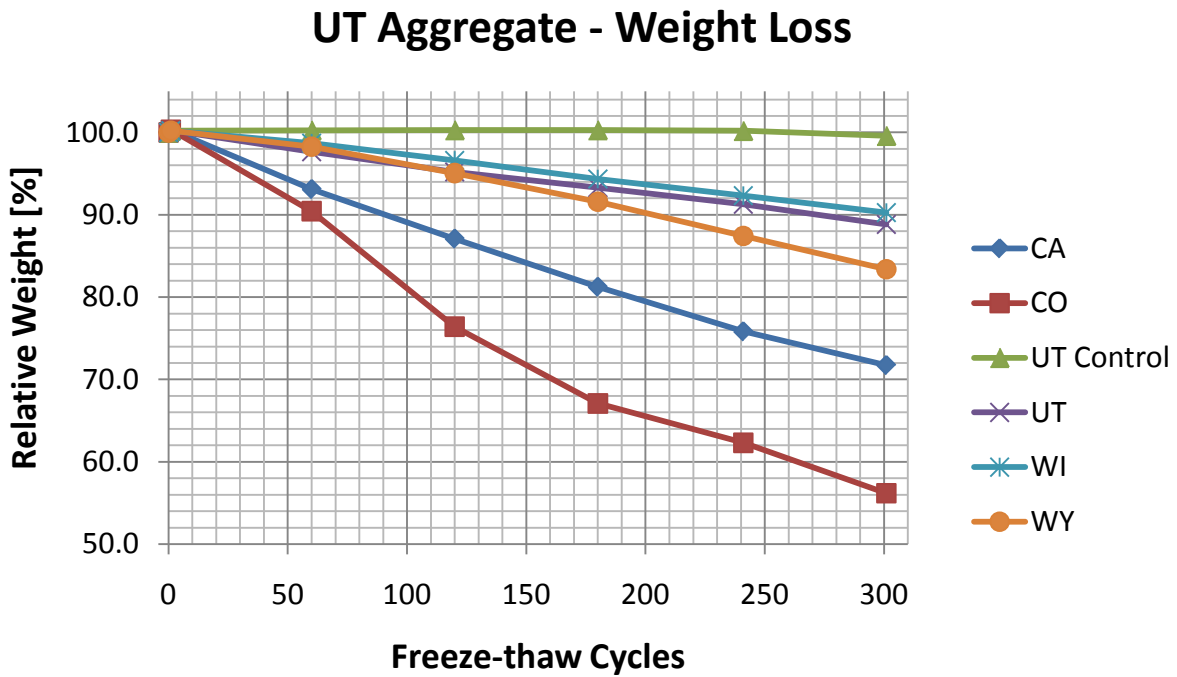
Figure 19. Relative weight loss of Utah aggregate specimens with freeze-thaw cycles

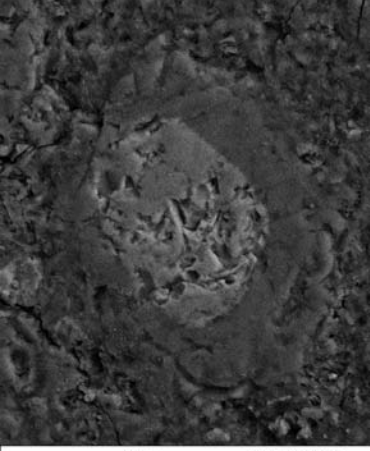
Expected cement and hydrated cement compounds			
Compound	Formula	Image of compound	Ratio of elements
Cement particle (Alite particle) (CO on UT C1293-Humid 9mo)	3CaO SiO_2

<p>Mag = 2.50 K X 10 μm EHT = 15.00 kV WD = 9.0 mm</p>	Reaction Rim: $\text{Ca/Si} = 1.7$ Unhydrated center: $\text{Ca/Si} = 2.7$
Cement Particle (Belite Particle) (CO on UT C1293-Humid 9mo)	2CaO SiO_2

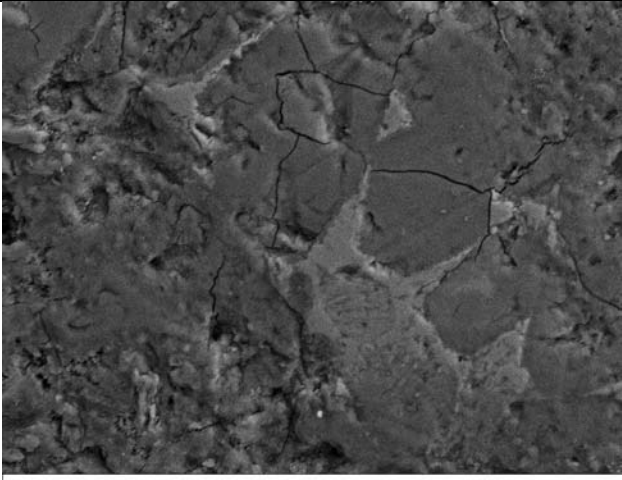
<p>Mag = 2.50 K X 10 μm EHT = 15.00 kV Signal A = RBSD Date :23 Mar 2011 WD = 9.0 mm Photo No. = 6407 Time :11:47:10</p>	Reaction Rim: $\text{Ca/Si} = 1.7$ Unhydrated center: $\text{Ca/Si} = 2$
Calcium Hydroxide Crystal (WI on UT C1293-Humid 6mo)	Ca(OH)_2

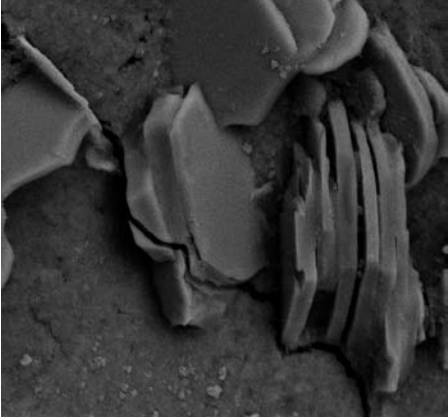
<p>Mag = 4.00 K X 10 μm EHT = 15.00 kV Signal A = RBSD WD = 9.0 mm Photo No. = 137</p>	$\text{Ca/O} = 1$

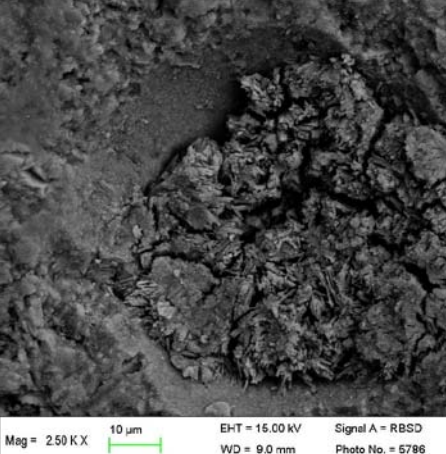
<p>Ettringite Crystal (CO on WI C1293-Humid 3mo)</p>	<p>3CaO Al₂O₃ 3CaSO₄ 32H₂O</p>

<p>Ca/Al = 2.8 Ca/S = 3.4</p>
---	---	--	--

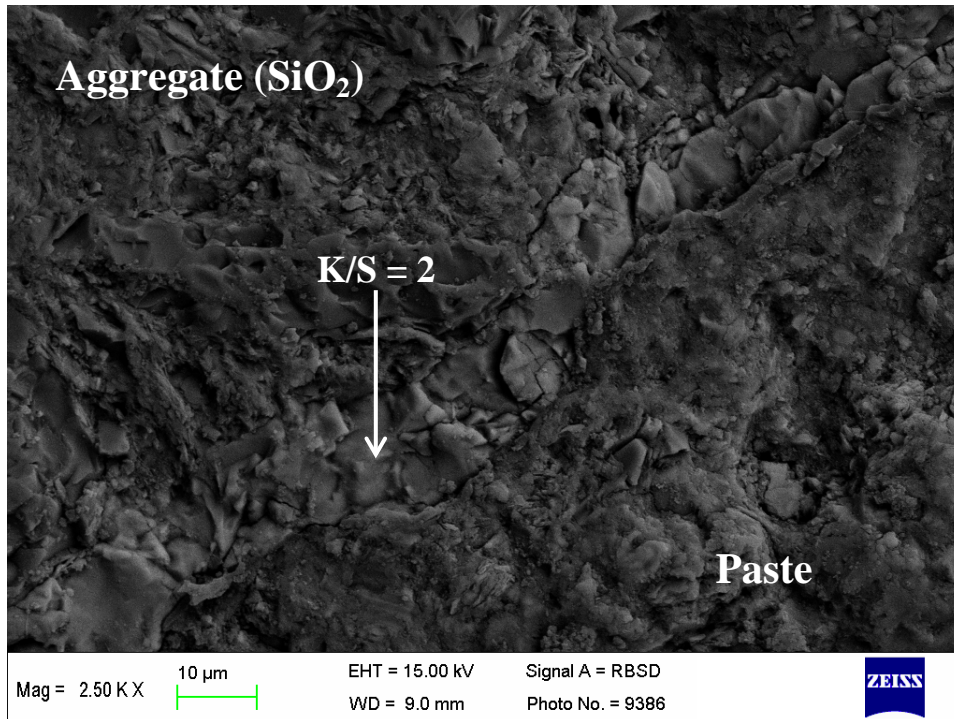
Figure 20. Potassium sulfate complex in CA on UT Deicer specimen after 6mo

Potassium Sulfate Products: Large areas composed of potassium sulfate crystals (molecular formula K_2SO_4 abbreviated KS) were observed in the ITZ of many of the deicer treated specimens (figures 20, 21, and appendix 5 for other C1293-Deicer specimens with KS). Normally in the early ages of forming the ITZ layer, ettringite forms and eventually transforms into monosulfate. CSH is continuously formed along with CH. By immersing the fresh concrete specimens (24 hours of curing) into the deicer, KAc penetration was relatively unimpeded compared to more mature concretes. To understand the formation of the KS observed in the ITZ, the source of sulfate and its transformation were needed. Typically the sulfate originates from gypsum, and potassium originates from the deicer solution (6.4MKAc) since contributions from some siliceous aggregates or clays would be relatively minor. The sulfate in gypsum usually transforms to form ettringite in very early stages of concrete hydration, which eventually transforms to monosulfate. Thus, in order to form these potassium sulfate crystals the sulfate must be pulled out from either ettringite, monosulfate, or both. This transformation is expected to prompt a change in the microstructure of the ITZ and to the adhesion of the cement paste to the aggregate. The formation of KS is not the only chemical reaction that can extract sulfates from ettringite, this also happens in the formation monosulphoaluminate. The formation of the KS also should limit the carbonation of monosulphoaluminate, which leads to the formation of secondary ettringite. In these concretes secondary ettringite was not observed to line the voids and cracks of specimens.

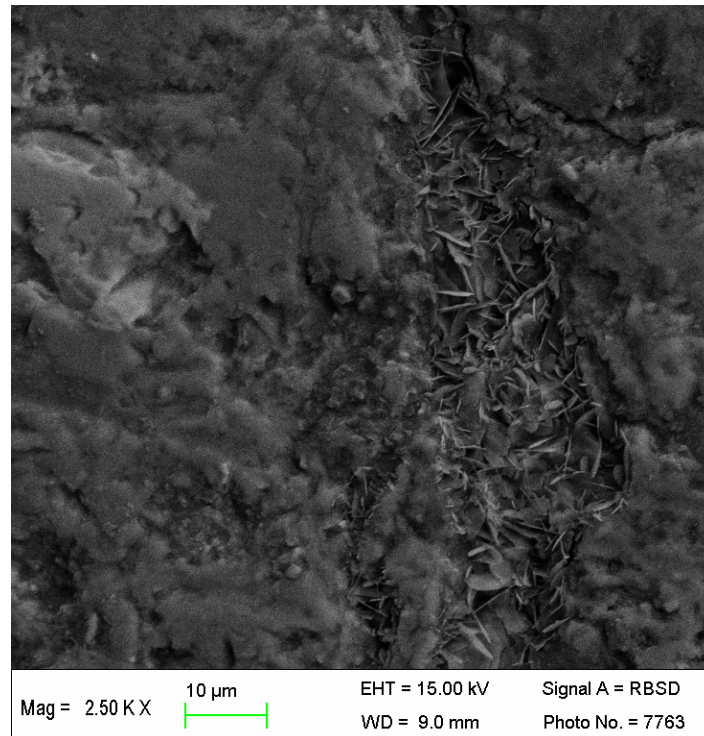
Figure 22. KS complex existing in a void in the bulk

The bulk paste was examined to determine if the potassium entered the system near the problem areas. Abundant potassium was observed in the paste. The potassium was further traced to determine if it was paired with the acetate or if it attached itself to some other compound in the bulk matrix. The potassium was observed to exist with varying amounts of carbon and oxygen indicating it may be associated with the acetate. Combinations of Ca, Si, Al, and K in the bulk were clearly observed with the possibility that free potassium ions exist in the pores of the matrix of CSH or CH or the potassium could be combining in at exchangeable sites of the CSH. It is observed that the platy crystals typical of the KS seen in the ITZ are also seen in some cracks and pores of the bulk as in figure 22.

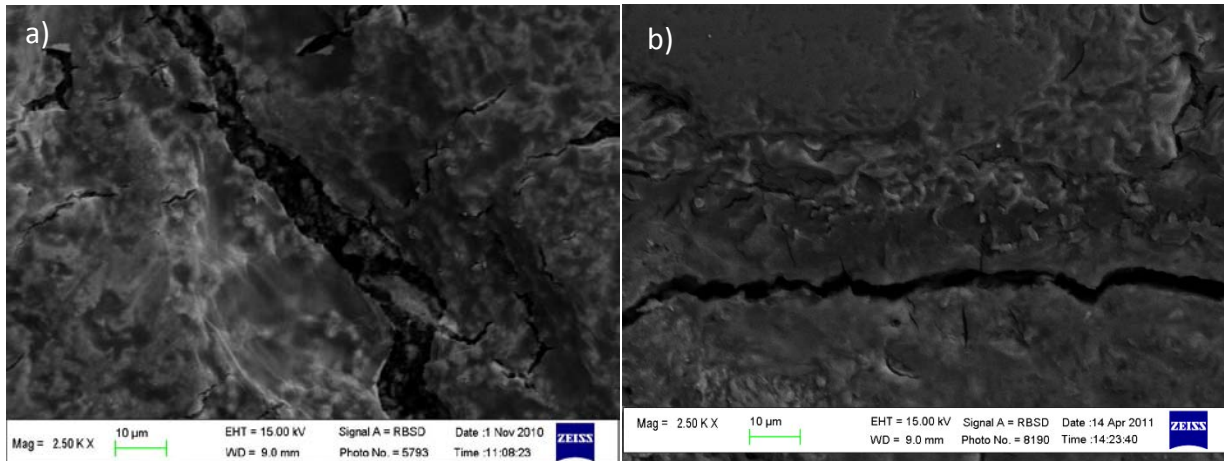
Figure 23. a) A sheety, gel material, composed primarily of calcium and silica, found in the CO on WI Deicer species after 3mo, and b) gel material, composed primarily of calcium and potassium, found in the UT control deicer species after 9mo

Figure 23 shows various gels seen in the potassium acetate specimens. The gel structures are composed of Ca, Si, and K. The data show there was potential for ASR and some species that resemble it. Typical deterioration would be visible as distressed aggregates and gel expanding into the paste. These indicators of distress were not observed in the research specimens. The conditions are favorable for ASR and some ASR was present, but it was not observed as a significant cause of deterioration.

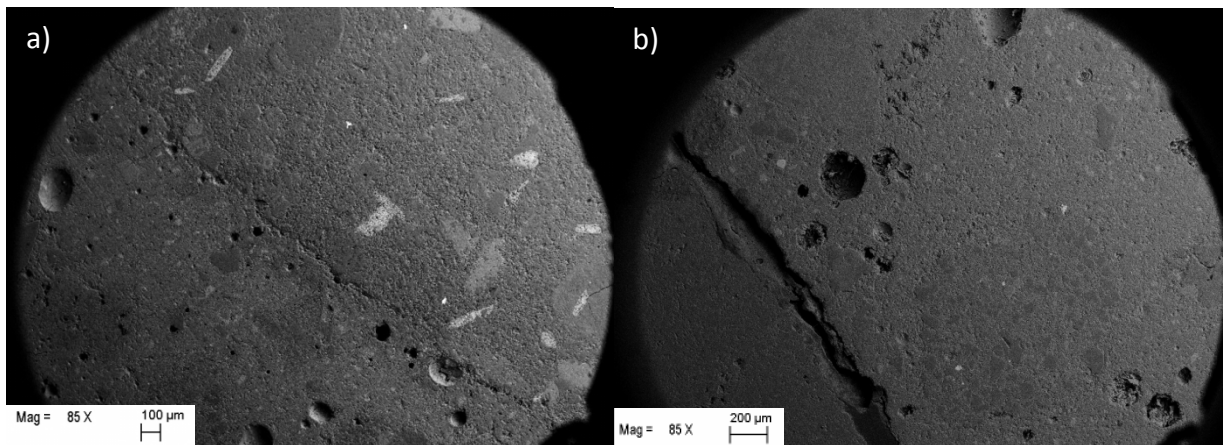
Figure 24. Images showing the deterioration over time; a) WY on UT Humid 3mo b) WY on UT Deicer 9mo

Deterioration of the paste was observed as an increasing porosity in later stages of the KAc testing. Extreme deterioration of the ITZ was also observed and in most cases the bond between the aggregate and the paste was completely destroyed (see figure 24). Therefore, it appeared that normal hydration products were attacked, breaking down sulfate compounds, CSH, and CH. Many of the ions released in this attack form new associations leaving the normally solid phases broken. See appendix 7 to see more evidence of deteriorated aggregates. See appendix 8 to see how the various microfines deteriorated in the modified C1293 tests.

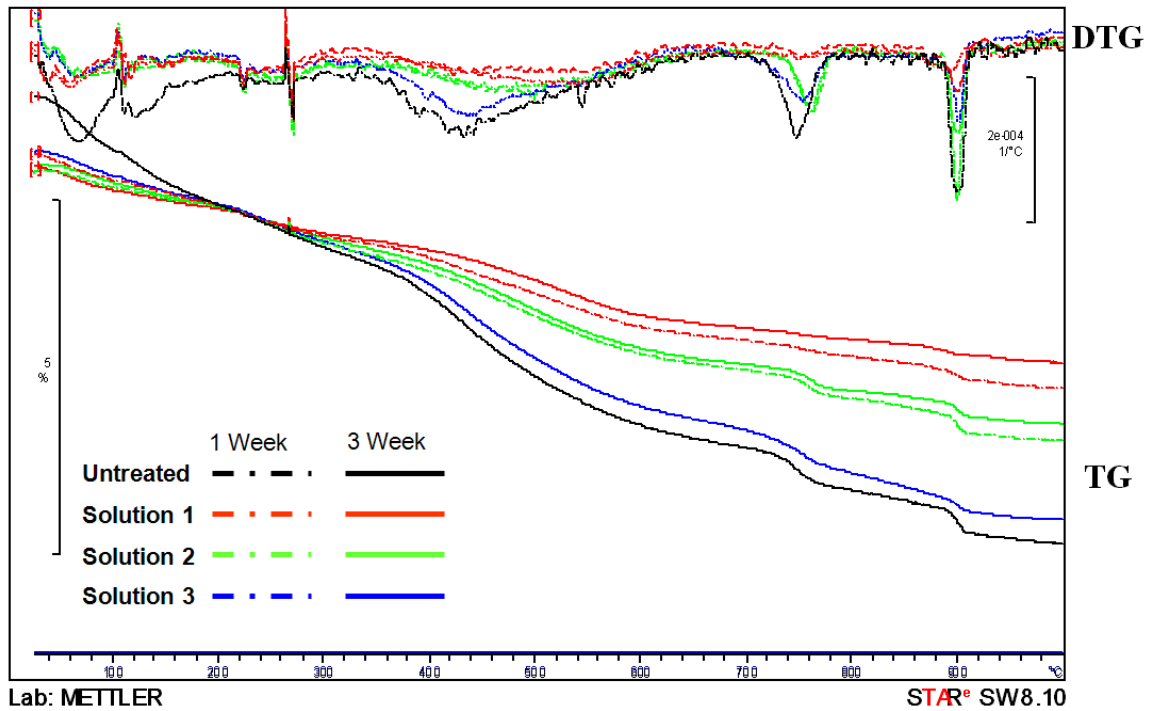
Figure A1.1. TG results from the California microfiners showing solution two with carbonates and hydroxylated silicates being destroyed. Also, since the silicate is shifted possibly new silicates with hydroxide are being affected.

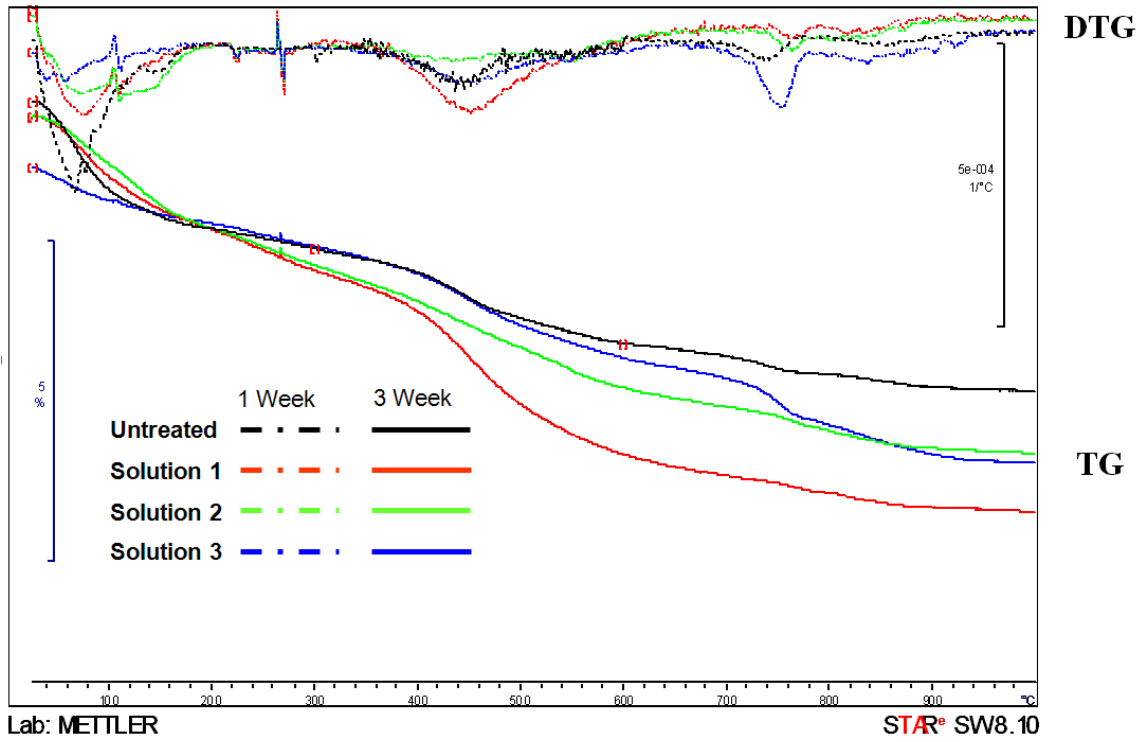
Figure A1.3. TG results for Colorado microfines indicating a decrease of species with hydroxide contents when subjected to solution 2.

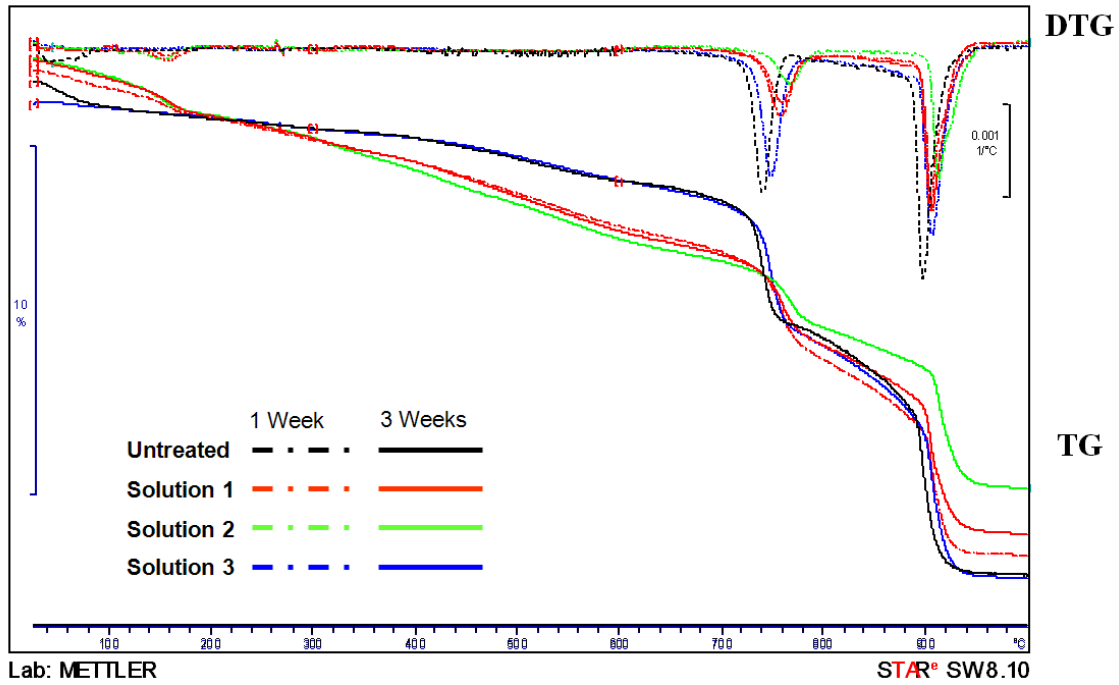
Figure A1.4. TG results for Utah microfines which depict losses in carbonate species. It is observed that the carbonate output is less defined so they react early, possibly changing to something less stable. It is also observed that magnesium is leaching because the output shows it is not as crystalline as the untreated specimen.

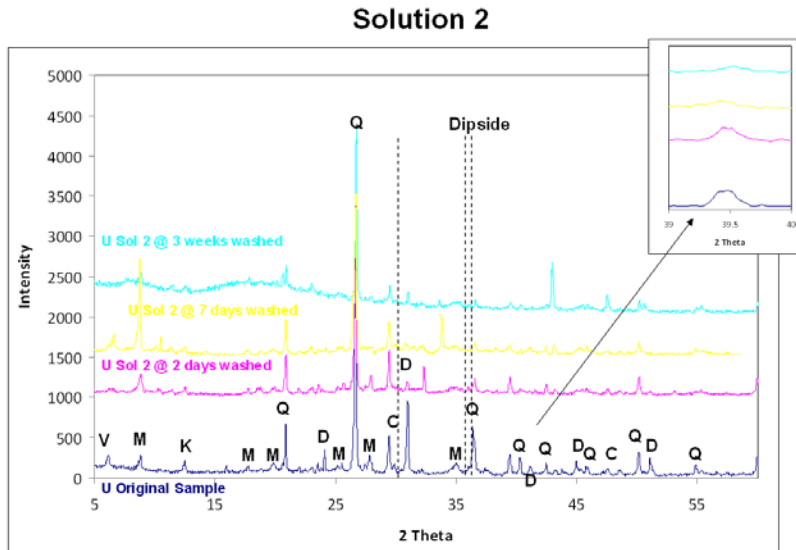
Figure A1.5. XRD results show a decrease in crystalline dolomite at 2 theta angle 32 and a reduction in crystalline silica at 2 theta angle 39.5 (shown in the exploded view).

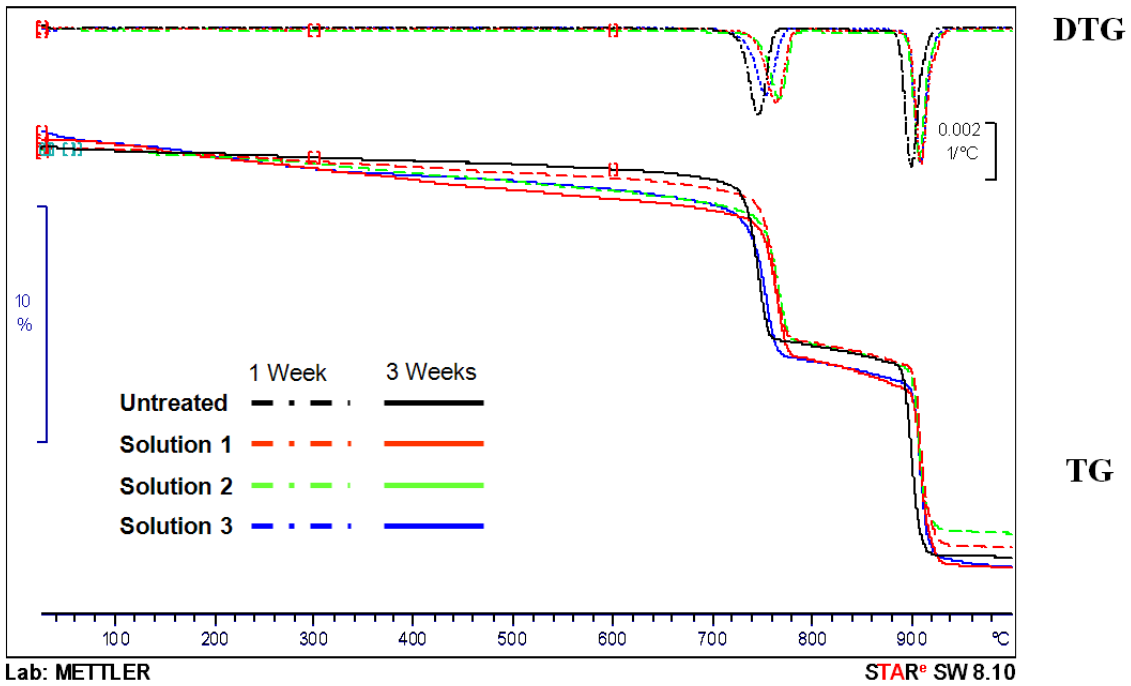
Figure A1.6. TG results show the Wisconsin microfines change the least when subjected to the various solutions and compared to the other microfines. The results indicate the microfines consist of well crystalline dolomite being barely attacked.

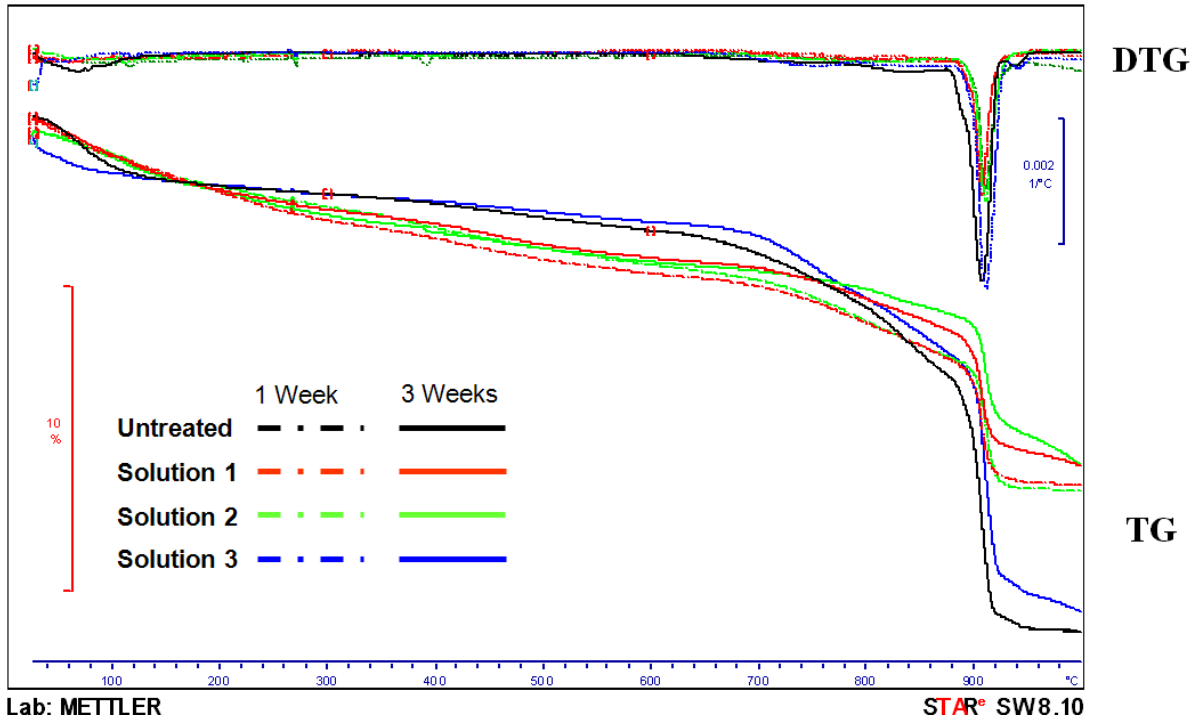
Figure A1.7. TG results indicating the Wyoming microfines consist of poorly crystallized dolomite which is more reactive. The hydroxylated silica species is minimally altered. They are not well defined in the DTG results, but losses are seen in the TG results.

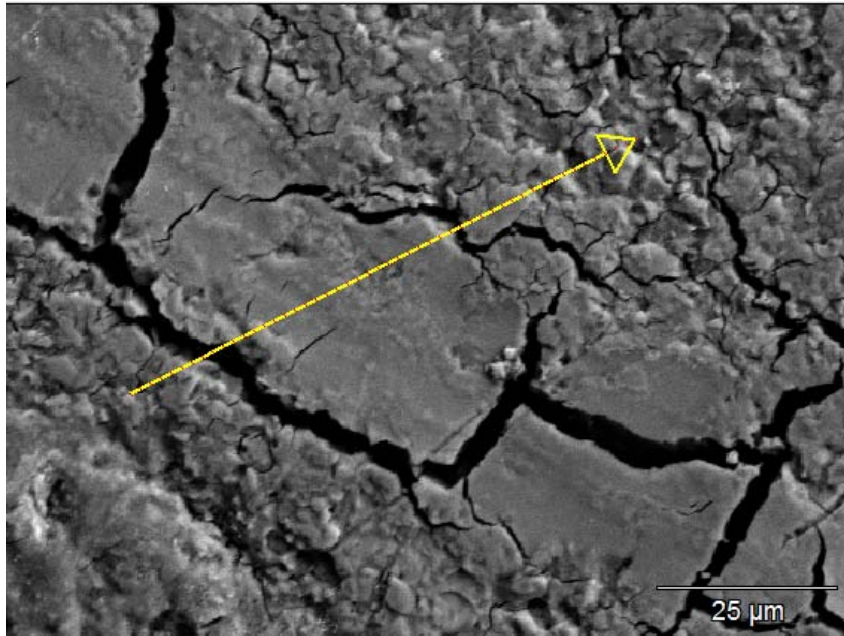
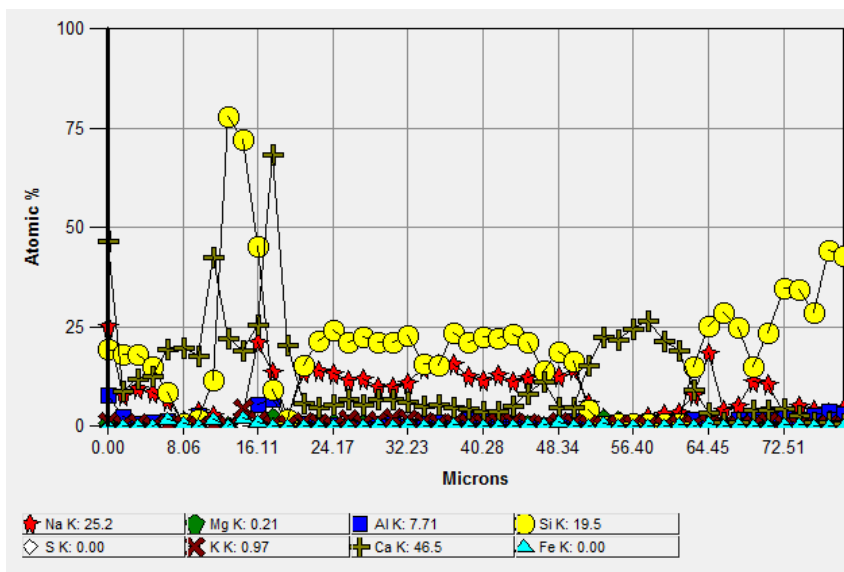
Figure A3.1. Micrograph (above) and EDS scan (below) of ASR gel in ASTM C1260 specimen (UT microfines on UT aggregate).

At the conclusion of the ASTM C1260 tests, specimens were cut from the center of the bar in order to conduct SEM analyses of the specimens. It was found that specimens containing the reactive Utah fine aggregate contained obvious signs of ASR. Unlike the samples from the ASTM C1293-Deicer series, a clear gel composed of Si, Na, and Ca was found despite the source of microfines. Figure A3.1 shows one example of ASR gel in the matrix from the UT microfines on UT aggregate specimens.
