Report IPRF-01-G-002-06-5

Role of Dirty Aggregates in the Performance of Concrete Exposed to Airfield Pavement Deicers

July 2011

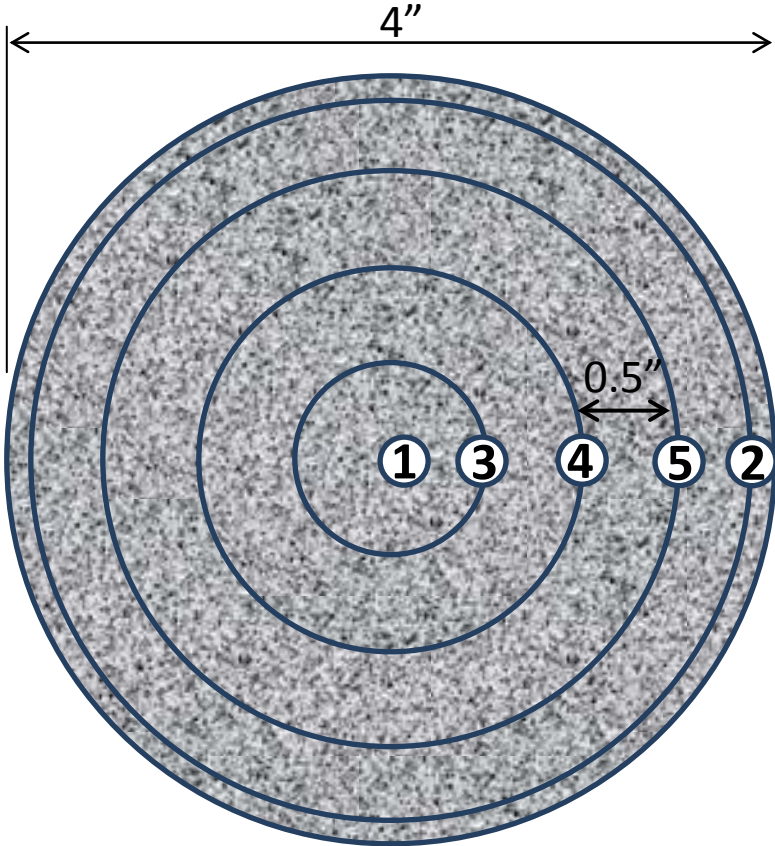
Figure A4.1. Sample sites from cylinders exposed to deicer as in C1293-Deicer tests.

While handling and examining samples for SEM at 3, 6, and 9 months, the specimens became increasingly fragile even at the center of the cylinder. This led to the belief that the potassium acetate associated deterioration was deeper than 15mm as seen in previous work. Since this concrete was immature when subjected to the potassium acetate, a test was conducted to determine how far the potassium acetate penetrated into the specimens at one year. This test used Infrared Spectrometry to determine if acetate compounds have penetrated the concrete. This test was run on concrete samples with the following four microfine-and-aggregate combinations: CA on UT, CO on UT, WI on WI, and WY on WI. These were chosen as the fresh air content varied in each and would give a better representation of ingress despite the air void system. From each specimen, a slice was taken at three inches from the finished cylinder surface. Samples from this slice were taken in three locations using a 5/32 hammer drill bit, at incremental intervals from the surface. First the center was analyzed and then a comparison was taken from the edge to determine if acetates had reached full strength in the core of the piece. If it had not, then pulverized samples could have been analyzed heading towards the edge. See Figure A4.1 for a representation of the samples taken from the cylinders. Around each numbered ring, at least 3 samples were taken from the paste regions of the specimen.

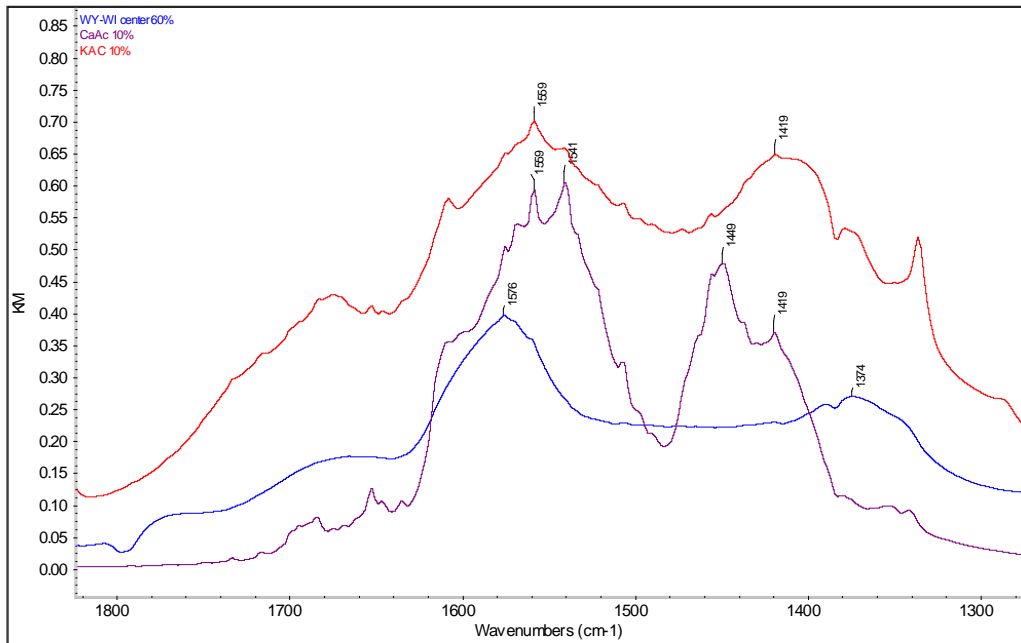
Figure A4.2. DRIFT diagram of calcium acetate, potassium acetate, and center WY on WI C1293-Deicer results. WY on WI C1293-Deicer results show most of the acetate is weakly coordinated to some metal (probably Ca) forming a monodentate complex.

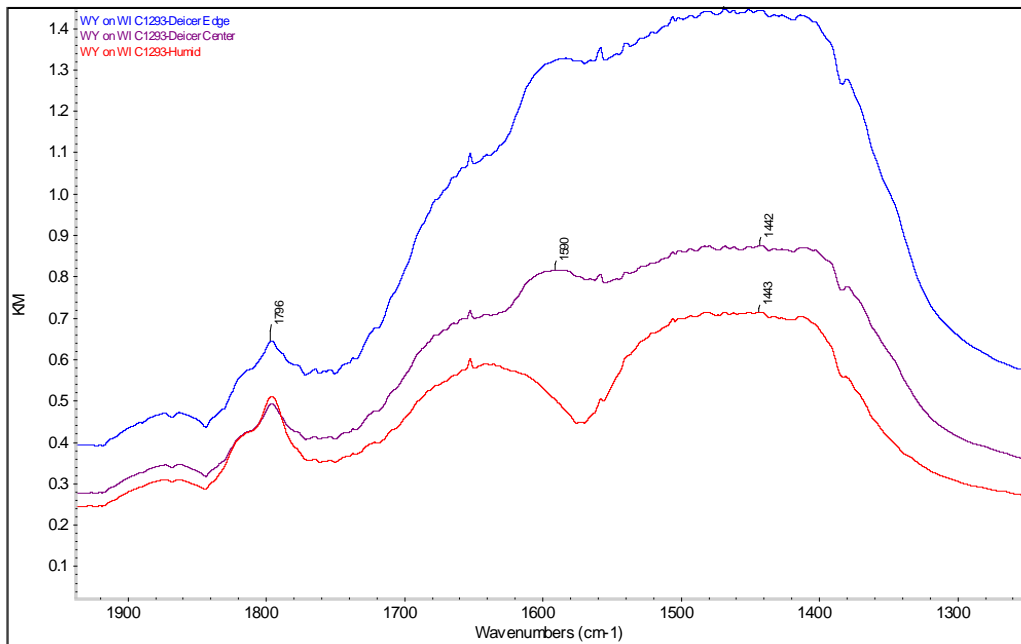
Figure A4.3. DRIFT diagram showing an acetate peak in both the WY on WI C1293-Deicer outer and center samples.

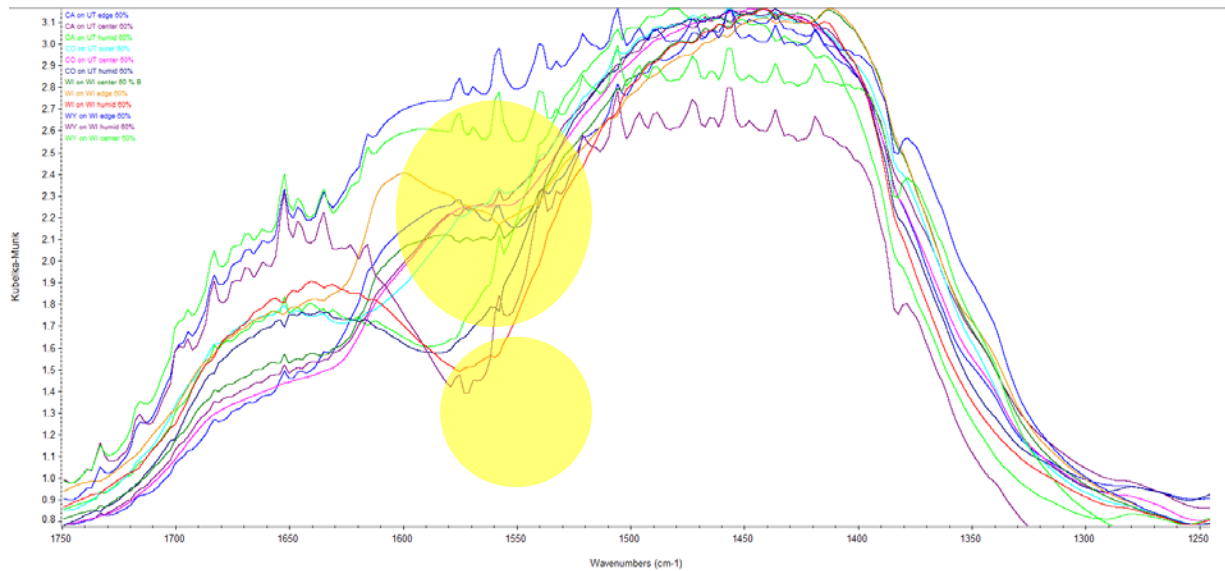
Figure A4.4. DRIFT diagram depicting acetate in all specimens exposed to deicer at both outer and center areas in the concrete and no acetate in Humid specimens.

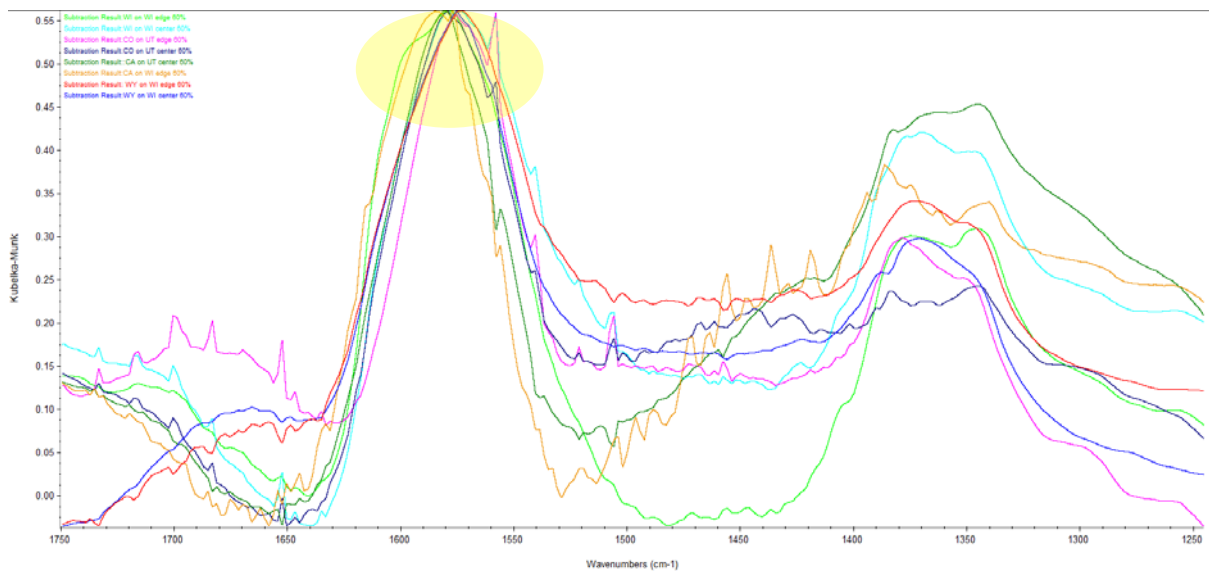
Figure A4.5. DRIFT diagram shows the peaks near 1578cm-1 are not completely overlapped indicating differing complexations of the acetate. This figure also shows the monodentate complex near 1340cm-1 appearing in the various specimens.

We can also say that the acetate is likely complexed with calcium based on the location of the peaks. The different spectra reported in Figure A4.5 shows a frequency for the asymmetric stretching higher than that in the spectrum of free acetate, while the band associated with the symmetric stretching appears at lower frequencies and it has structure (triplete). In our opinion a large fraction of acetate is forming monodentate complexes or asymmetric bridging with the Ca in the concrete. However, the presence of carbonate bands in this region does not allow us to be more precise on the type of acetates present in the system. So despite the varying measured fresh air content, potassium acetate can infiltrate the paste. (For CA on UT, CO on UT, WI on WI, and WY on WI the fresh air content was 3.6%, 3.2%, 7.7%, and 5.0% respectively.)

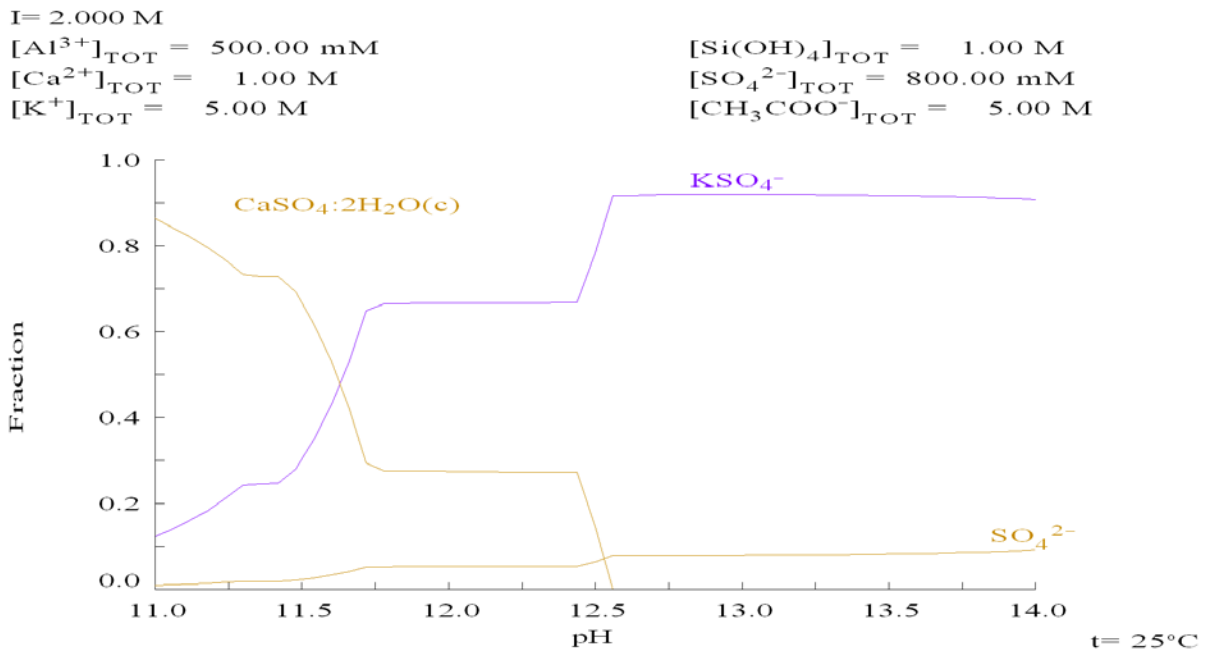
Figure A5.1. Thermodynamic simulation to show KSO₄⁻ forms over ettringite

The following thermodynamic simulations show possible products formed in concrete when potassium and acetate is in abundance. The figures show the simulation of an environment above a pH of 11 because this is likely the range of the pH seen in the concrete in our study. Fraction of the product is seen on the y axis while the pH range is seen on the x-axis. If the product is followed by a (c) or a (cr), the species exists as a solid otherwise the species exists in solution or as an ionic species. The information above the equilibrium diagram is the inputted concentrations of the included precursor species used in the simulation.

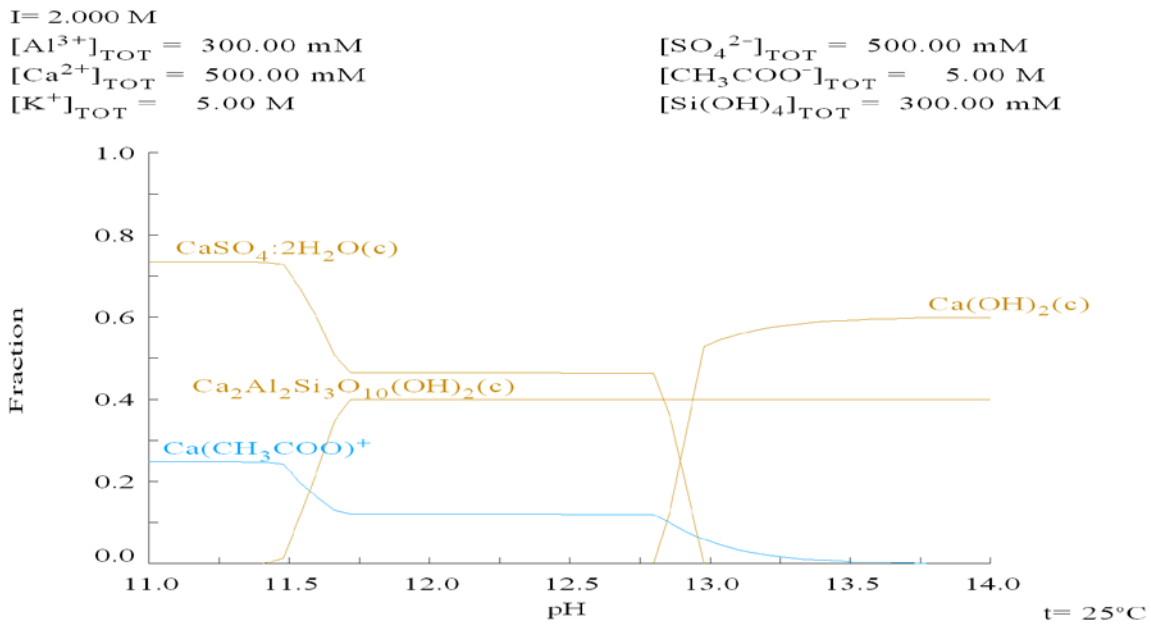
Figure A5.3 Thermodynamic simulation to show calcium hydroxide could be seen in the system

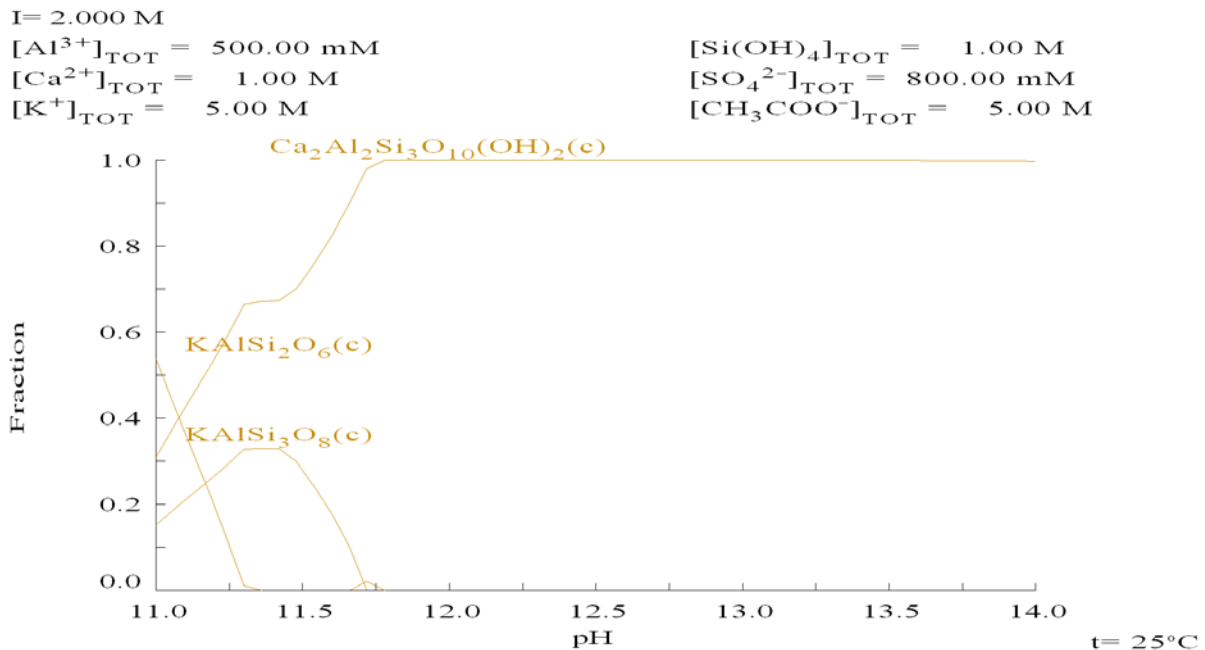
Figure A6.1. Alumino silicates (from clays) in combination with KAc can form $\text{Ca}_2\text{Al}_2\text{Si}_3\text{O}_{10}(\text{OH})_2$ which is a new solid formation. There are other solids formed, but at elevated pH levels the calcium species will dominate. The aluminum fraction is shown.

Expansion was present in the C1293-Deicer specimens which was due to new formation of solid phases in the bulk of the concrete matrix. With the destruction of the siliceous aggregates and the introduction of silica from the microfines in the presence of KAc, the system could transform to form $\text{Ca}_2\text{Al}_2\text{Si}_3\text{O}_{10}(\text{OH})_2$ and CaSiO_2 or Ca_2SiO_4 (we can see this in the WY on UT Deicer specimen.) When $\text{Ca}_2\text{Al}_2\text{Si}_3\text{O}_{10}(\text{OH})_2$ is formed, the formation of KAlSiO_3 as a solid is also seen from thermodynamics when there are low levels of calcium present. (Figure A6.1) This was present in the UT cont Deicer specimen. These new solid phases could cause expansion if the new formations occupy a larger volume than the aggregate. The following simulations show the formation of new solid phases present in the specimens.

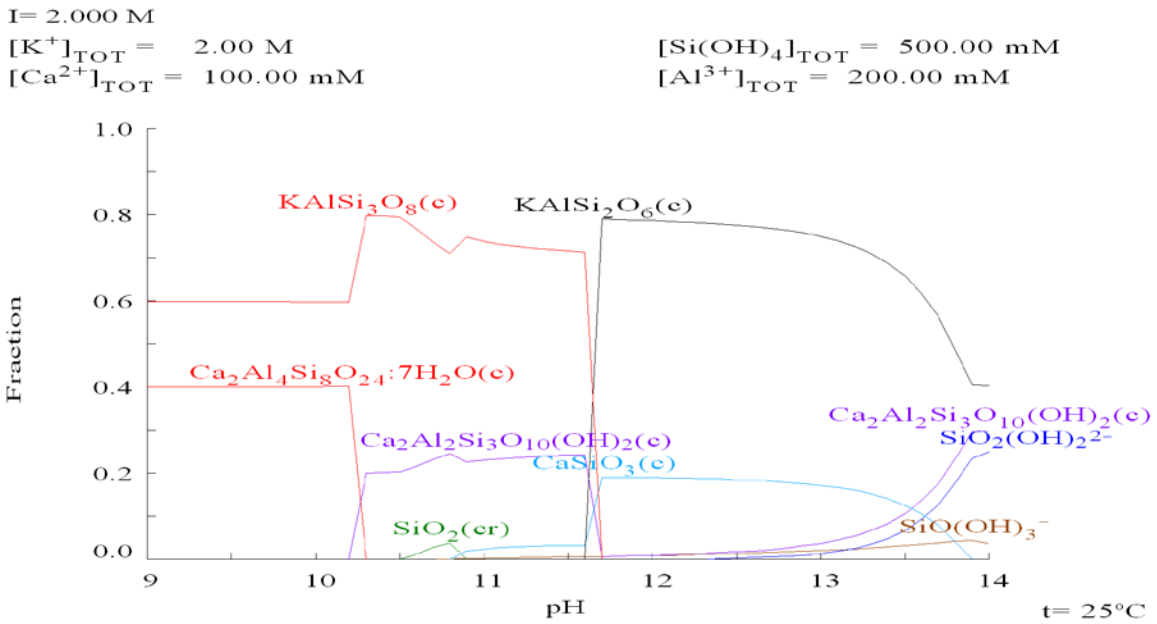
Figure A6.2. Silica fraction of a matrix with low levels of calcium and the formation of a solid species KAlSi_2O_6 .

It is possible that if the silica from the aggregate is being released into the bulk, the area near the aggregate may be rich in silica and low in calcium. If this is true, we could see the formation of new solids composed of potassium, aluminum, and silica. The Figures A6.2 and A6.3 show the silica fraction and the aluminum fraction respectively.

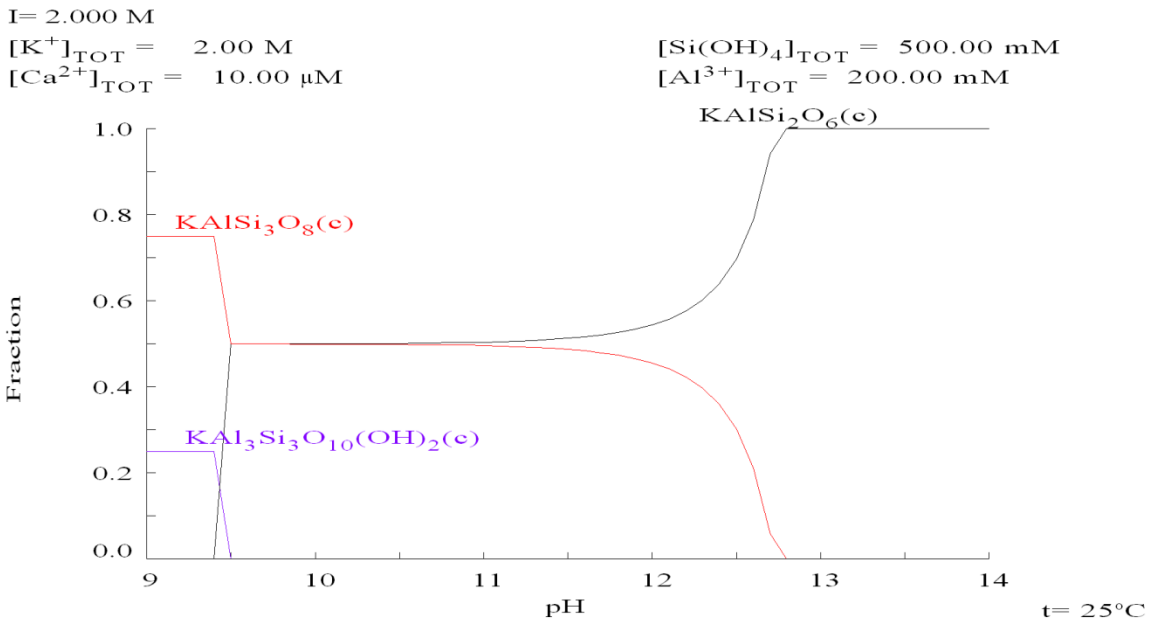
Figure A6.3. Aluminum fraction of a matrix with low levels of calcium and the formation of $\text{KAl}_3\text{Si}_3(\text{OH})_2$ along with KAlSi_2O_6 .

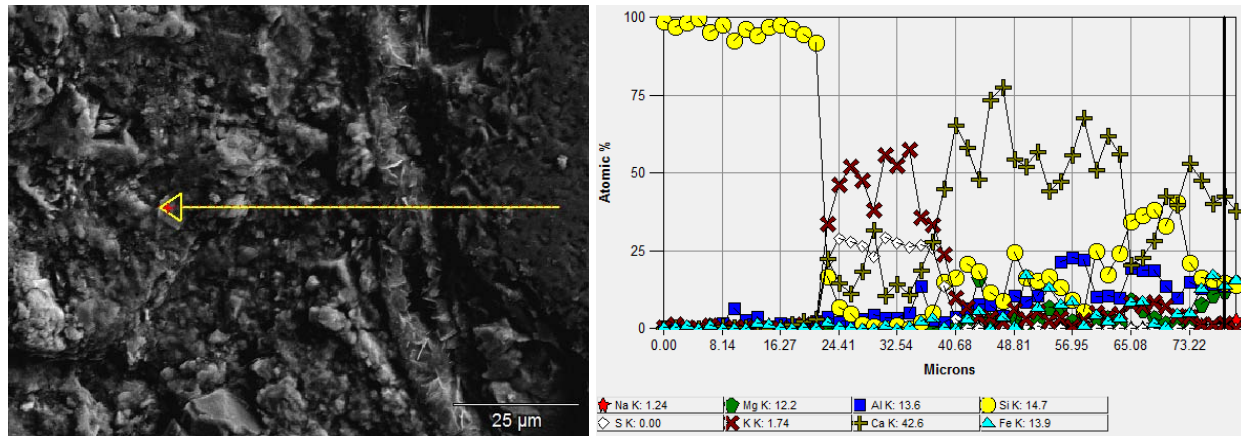
Figure A8.2. A microfine at the arrow tip with montmorillonite components.
