An ***IPRF*** Research Report
Innovative Pavement Research Foundation
Airport Concrete Pavement Technology Program

Report IPRF-01-G-002-4.1

Evaluation of Dowel Bars Installed Using Plastic Sleeves

September 2004

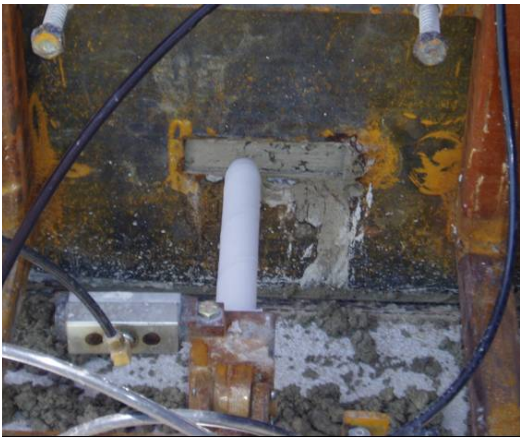
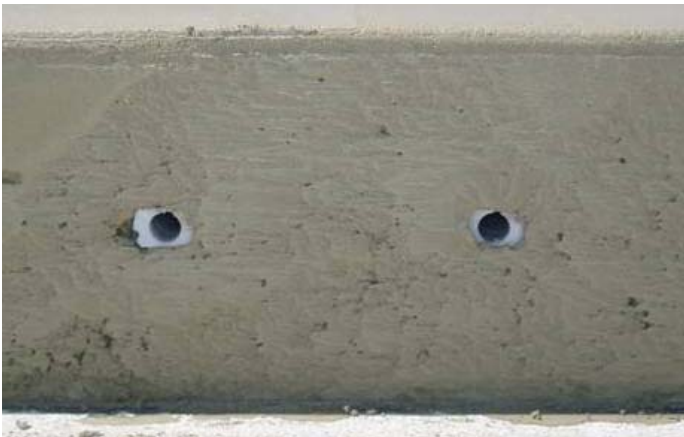
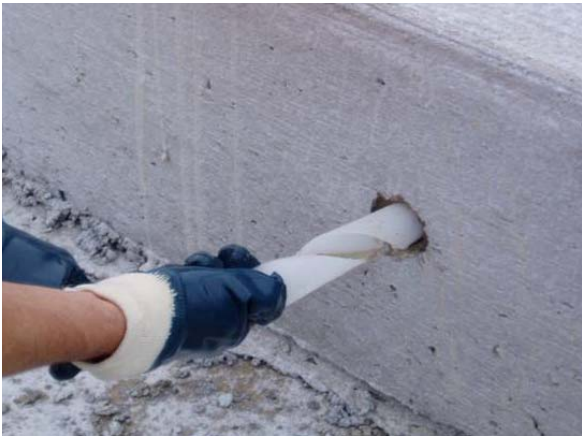
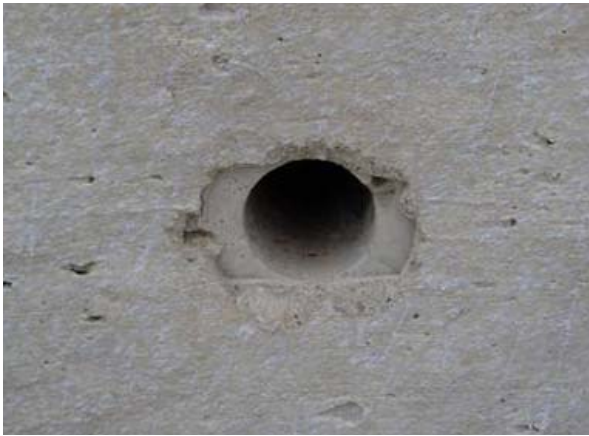
Figure 1. (a) A plastic sleeve being inserted into plastic concrete; (b) Plastic sleeves after the insertion; (c) Stripping the plastic insert; (d) A hole left behind after stripping the plastic sleeve.

The conventional procedure for inserting dowel bars at longitudinal construction joints involves drilling holes after the concrete has gained sufficient strength. A new, innovative dowel bar installation procedure has the potential to greatly facilitate concrete pavement construction by eliminating the drilling step. The procedure involves inserting plastic sleeves into plastic concrete (Figure 1). The plastic sleeves are later stripped (Figure 1c), and the dowels are installed in the holes left after the removal of the plastic sleeves. Plastic sleeves can be stripped without causing damage to concrete at a lower strength than for drilling. This early access to pavements can be important in time-critical projects.

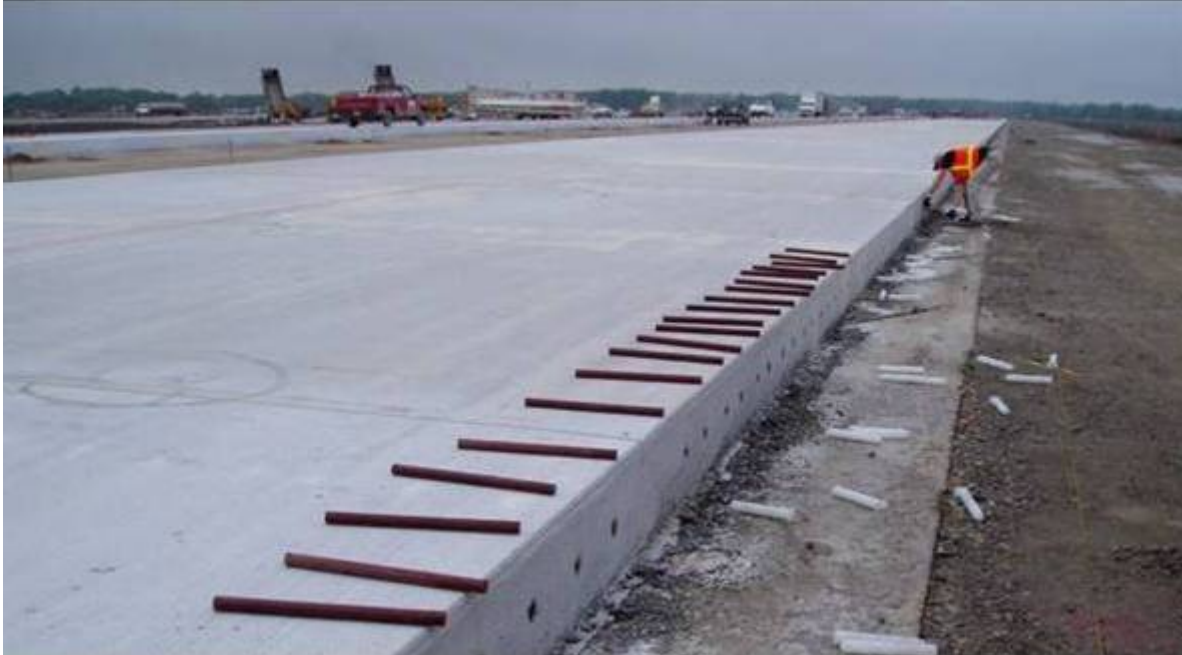
Figure 2. Test section for plastic sleeve at Hopkins International Airport in Cleveland, OH.

The test section was a short section of the outermost row of slabs in the Runway 6L-24R extension (Figure 2). The dowel bar alignment was evaluated by comparing the alignment of the dowel bars installed using plastic inserts and those installed by drilling (control section). The plastic sleeve section consisted of 20 joints, and the control section consisted of 2 replicates of 30 joints each. The length of the plastic sleeve section was limited to 20 joints because of logistical limitations.

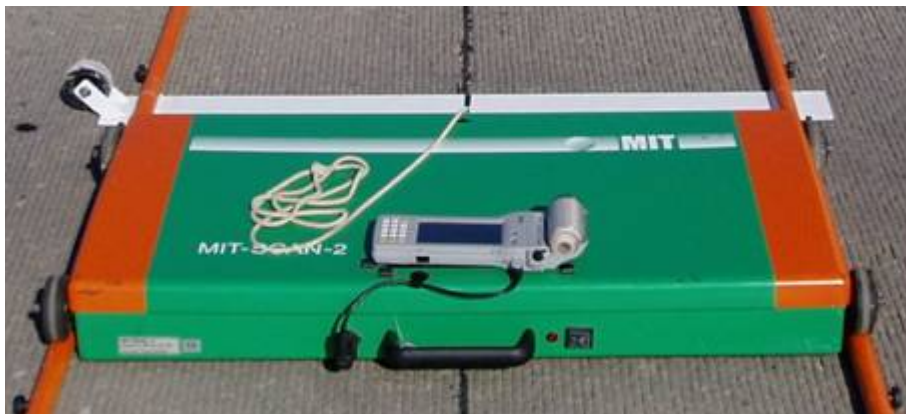
Figure 3. MIT Scan-2, a magnetic imaging device for measuring dowel bar alignment.

The dowel bar alignment for both the plastic sleeve and control sections was measured using MIT Scan-2 (Figure 3), an automated device that is designed specifically for measuring dowel bar alignment. MIT Scan-2 emits a weak electro-magnetic pulse and detects the transient magnetic response signal induced in metal bars using an array of sensitive detectors. The methods of magnetic tomography are then used to determine the position of the bars. An example of output from the fully automated data analysis program MagnoProof is shown in Figure 4. Because MIT Scan-2 was designed and optimized specifically for measuring dowel bar alignment, it produces very accurate results. The overall standard deviation of measurement error is less than 2 mm for horizontal and vertical alignment results.

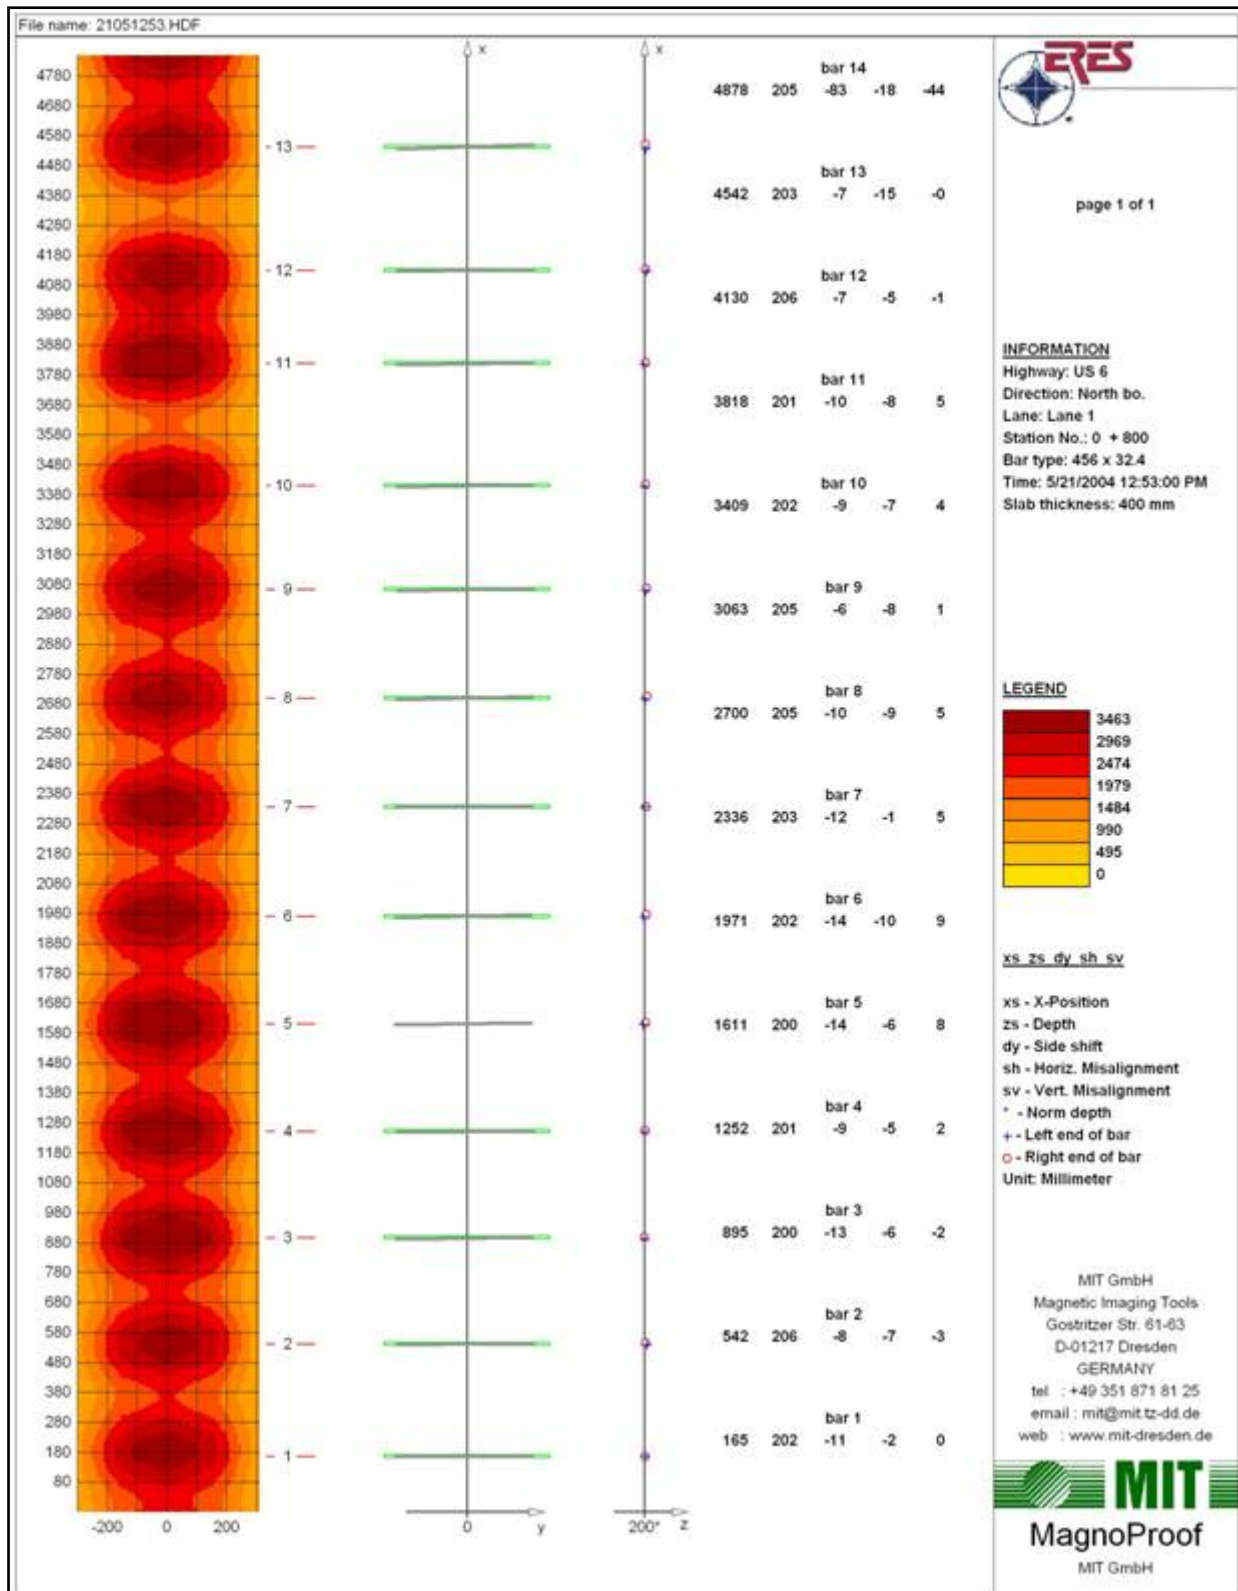
Figure 4. Example output of MIT Scan-2 showing the orientation of the detected bars.

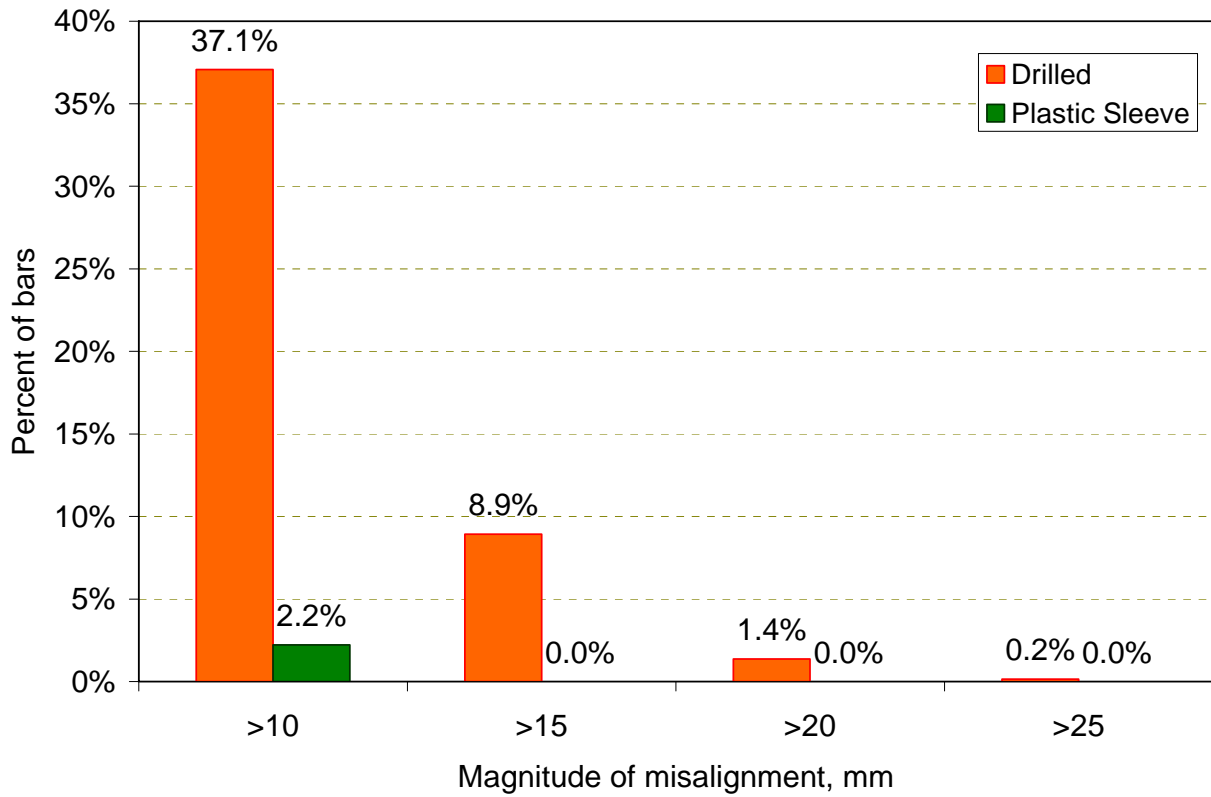
Figure 5. Comparison of vertical misalignment of dowel bars installed using the conventional method (drilled) and plastic sleeves.

In general, the quality of dowel alignment was excellent. Figure 5 shows a comparison of the vertical alignment obtained in the plastic sleeve section as compared to the control section. The dowel bars installed using plastic sleeves have better vertical alignment than that observed for the drilled-in bars. About 2% of the bars installed using plastic sleeves are out of spec for vertical alignment, but this level of misalignment is not likely to cause any performance problems. The results are as good as can be achieved in the field by the conventional method of dowel placement.

Figure 5 shows that a significant percentage (8.9%) of the drilled-in dowel bars have vertical misalignment greater than 0.6 in. (15 mm). This is not a concern. The misalignment is uniform. The MIT Scan-2 data indicate that the gang-drill that was used to drill the control sections may have been set with a 0.35 in (9-mm) tilt with the hole at the joint face being lower than the interior end. A study by Khazanovich et al. (2001) showed that a uniform misalignment is not detrimental, and that a significant amount of uniform misalignment (up to as much as 2 in [50 mm]) can be tolerated.

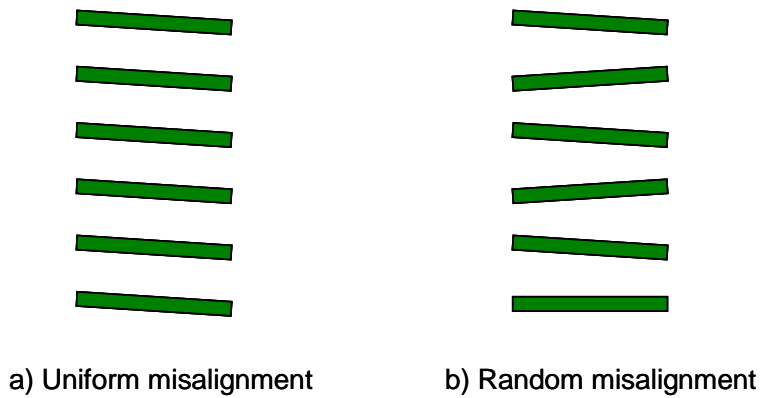
Figure 6. Uniform vs. random misalignment of dowel bars.

The difference between uniform and nonuniform misalignment is illustrated in Figure 6. If the uniform misalignment is taken out of consideration (by subtracting the average misalignment), only about 0.2% of drilled-in bars are misaligned by more than 15 mm (0.6 in). Based on available information, the vertical misalignments of the dowel bars in the control sections are not likely to cause joint performance problems.

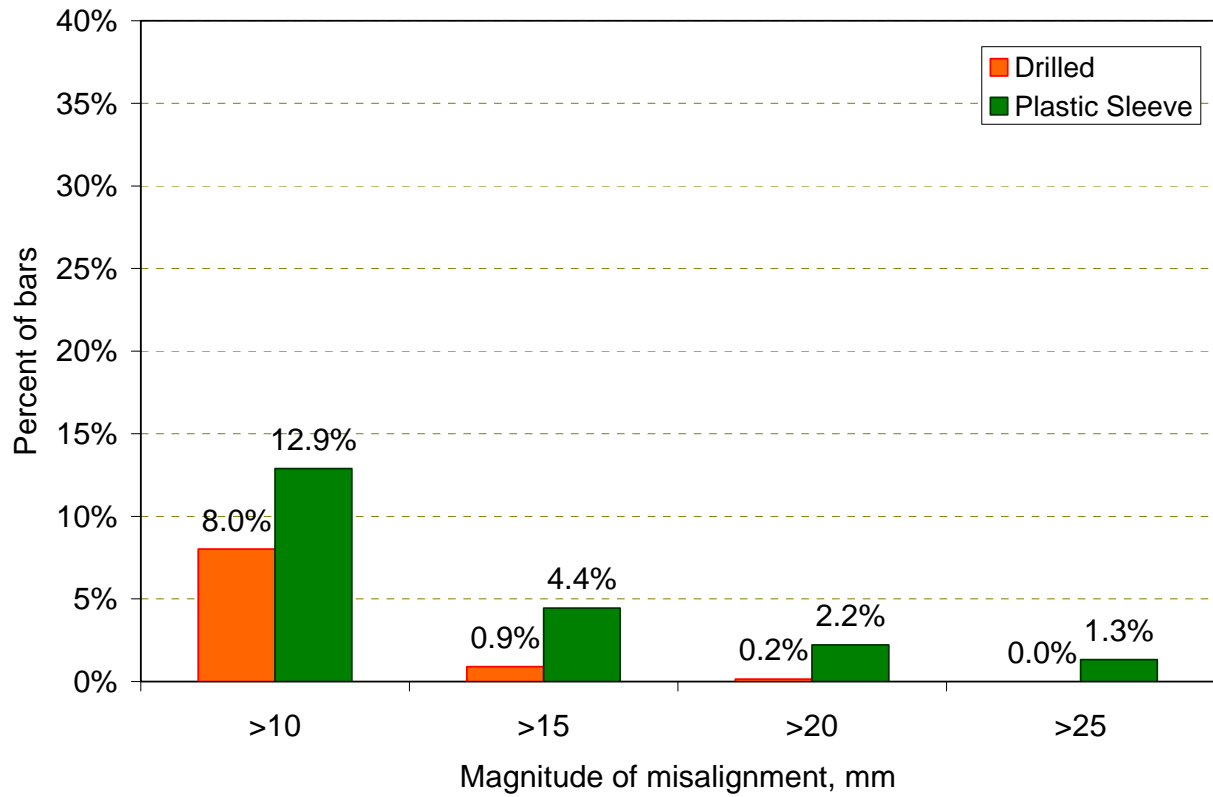
Figure 7. Comparison of horizontal misalignment of dowel bars installed using the conventional method (drilled) and plastic sleeves.

The results for horizontal alignment are shown in Figure 7. The control sections (drilled-in dowels) exhibited excellent horizontal dowel bar alignment. The results for the plastic sleeve section are not as good; however, the limitations of the prototype equipment used to insert the plastic sleeves, rather than the process itself, is responsible for the higher occurrences of more severe horizontal misalignments in the plastic sleeve section. The plastic sleeves are inserted in the free edge of newly paved lane using a mechanical inserter that is mounted on the side of the paver.

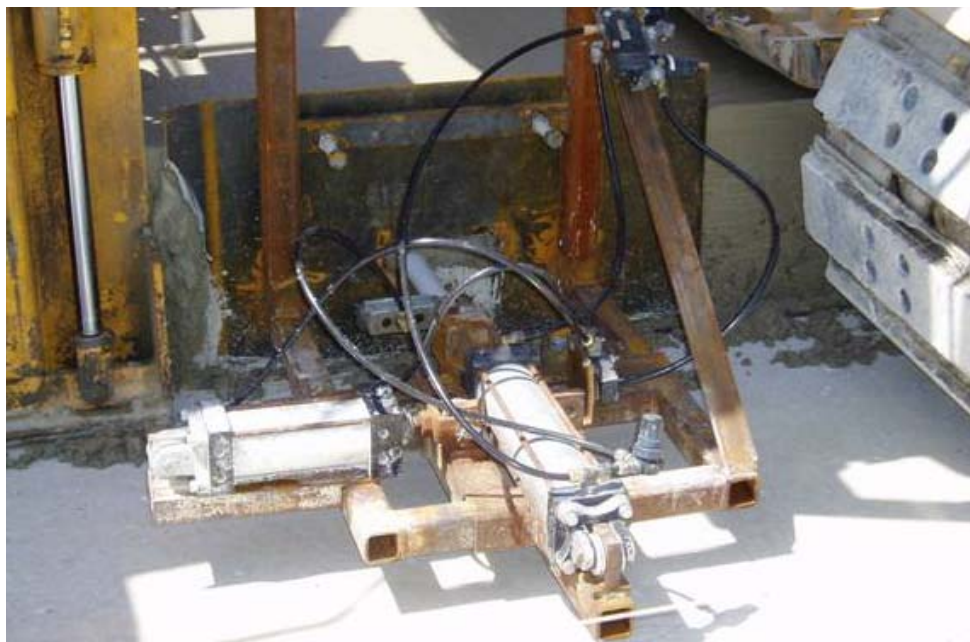
Figure 8. Plastic sleeve inserter attached to the paver.

To insert the plastic sleeve while the paver is moving, the inserter must remain stationary over the period that a plastic sleeve is being inserted. On the prototype equipment, this was accomplished using a simple hydraulic jack. A horizontal jack pushes the inserter within the inserter assembly, so that the inserter is stationary with respect to the concrete slab. The rate at which the inserter is pushed must match the advancing speed of the paver. On the prototype equipment, the rate at which the inserter was pushed was controlled by pneumatic pressure, rather than by a more sophisticated device with a positive control for matching the paver speed. Occasionally, the pneumatic jack was stuck, causing the plastic sleeve to drag. The results with and without the equipment problem are shown in Figure 9.

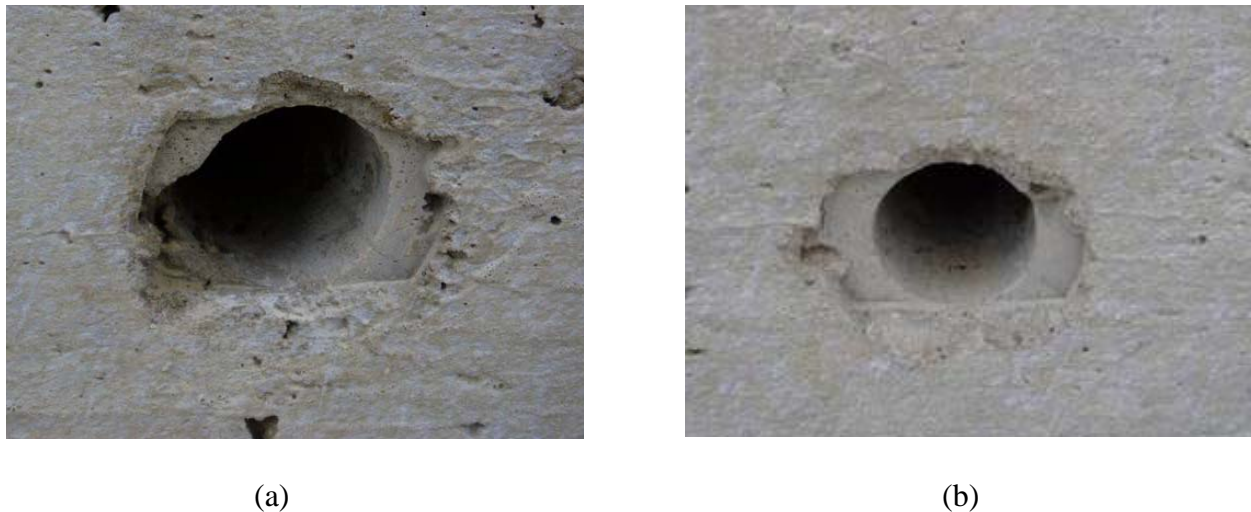
Figure 9. Dowel holes created using plastic sleeves: (a) result where the horizontal hydraulic jack snagged; (b) result where the equipment functioned properly.

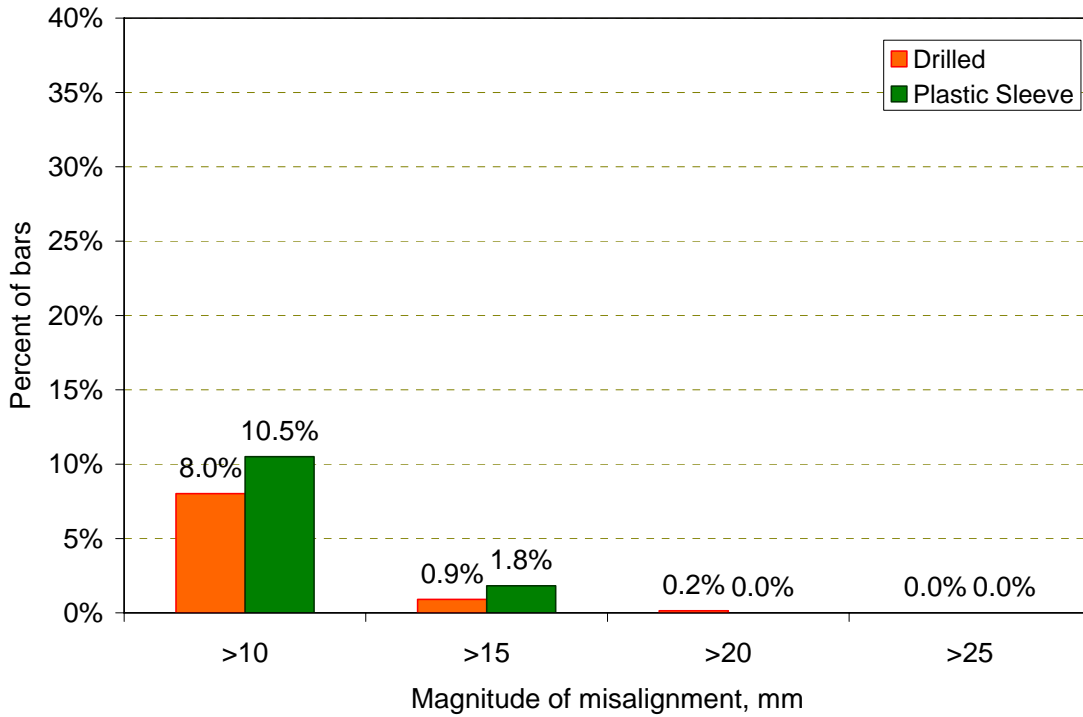
Figure 10. Comparison of horizontal misalignment, excluding the sleeves that experienced equipment problems.

The production equipment that would be used for plastic sleeve insertion should have positive controls for holding the inserter stationary during the insertion process and avoid the problems with horizontal alignment. As a proof of technology, the prototype device adequately demonstrated that the process works. The snagging occurred only a handful of times, and if the results from those incidences are taken out, the horizontal alignment results for the plastic sleeve section compares well with those of drilled-in bars (see Figure 10).

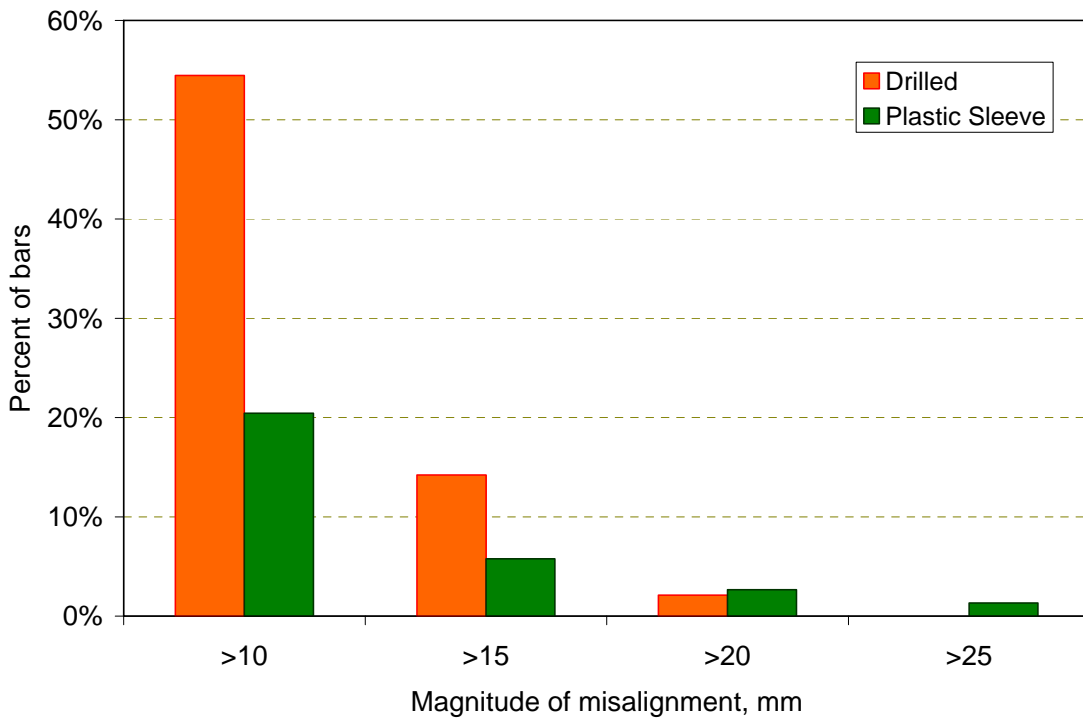
Figure 11. Comparison of resultant alignment.

Figure 11 shows the distribution of the resultant misalignment, combining the vertical and horizontal misalignments (square root of the sum of the squares). The resultant misalignment reflects the overall quality of dowel bar alignment. Figure 11 includes all bars for the plastic sleeve section. As shown in Figure 11, even with the results for the bars that have a large horizontal misalignment due to the equipment problem, the results for the plastic sleeve section compare well with the drilled-in bars. Without the results for the sleeves that were affected by the equipment problem, the plastic sleeve section would have no bars in the higher-degree of misalignment categories (0.79 in [>20 mm]).

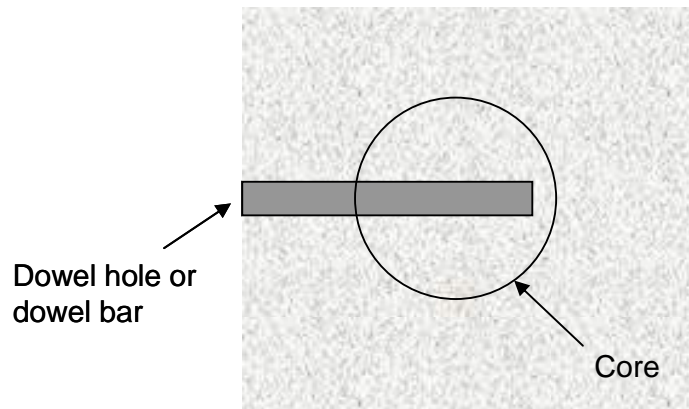
Figure 12. Illustration of coring location.

The consolidation around the dowels installed using plastic sleeves was evaluated by visual inspection of the cores retrieved from each section. Three cores each were taken from the plastic-sleeve and control sections from the ends of the dowels (Figure 12). The actual cores from the plastic sleeve section are shown in Figure 13, and those from the control section are shown in Figure 14.

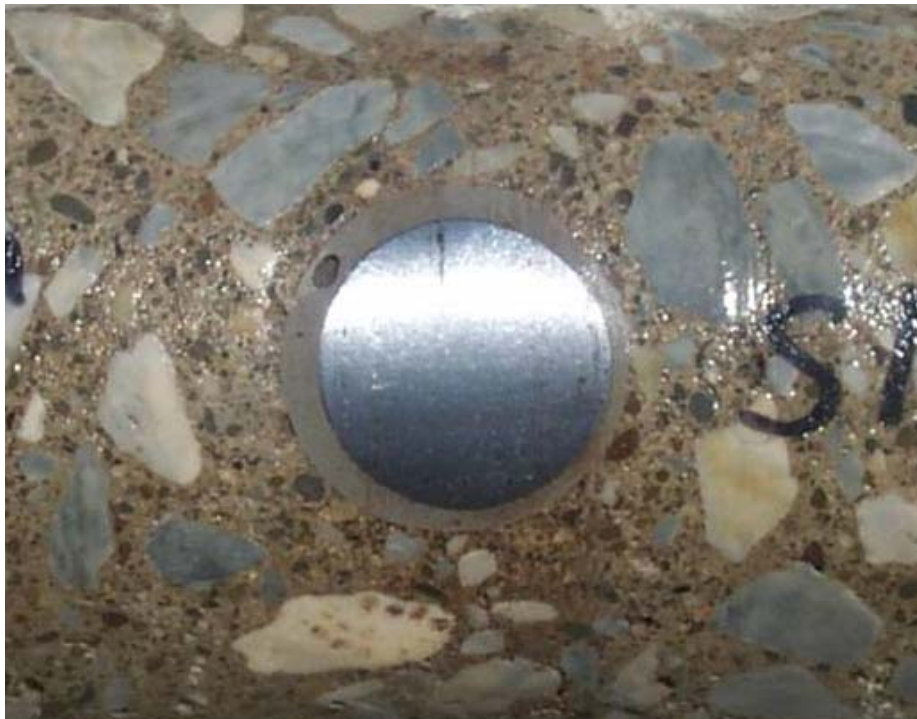
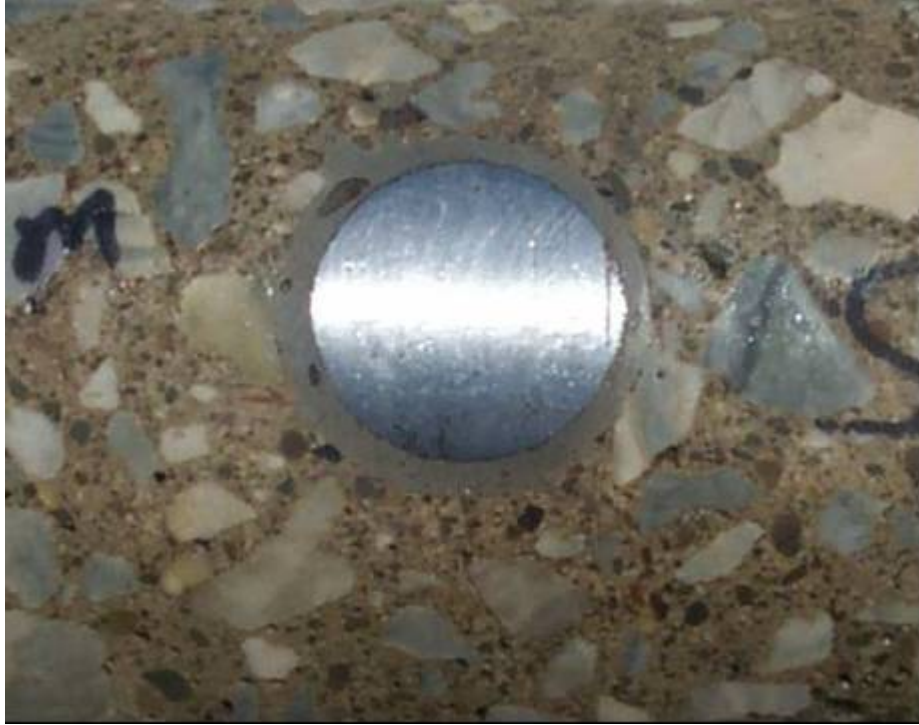
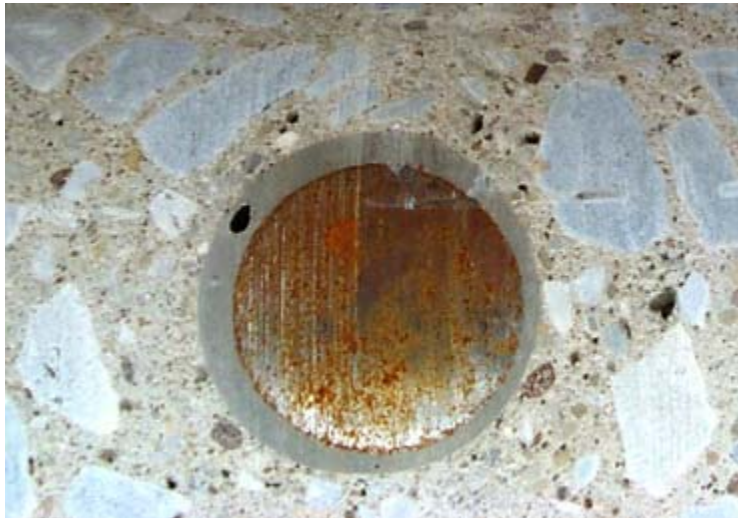
Figure 13a. Core 1 from the plastic sleeve section.

Figure 13b. Core 2 from the plastic sleeve section.

Figure 13c. Core 3 from the plastic sleeve section.

A visual inspection of the cores did not show any significant difference in the quality of consolidation around the dowel bars. At the joint face, the dowel holes created using the plastic sleeves can offer better support than the drilled holes. The drilling causes some spalling around the holes at the joint face, whereas the plastic sleeves can produce smooth, formed holes (Figure 15). Proper functioning of the plastic sleeve inserter is essential to obtaining the smooth finish around the dowel holes at the joint face. Some snagging of the plastic sleeves occurred during paving with the prototype inserter, but such problems could be easily eliminated by the use of a production-grade inserter.

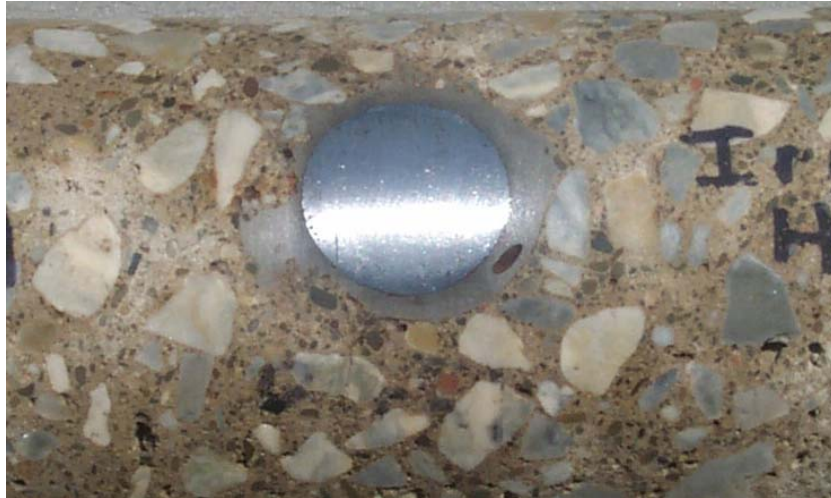
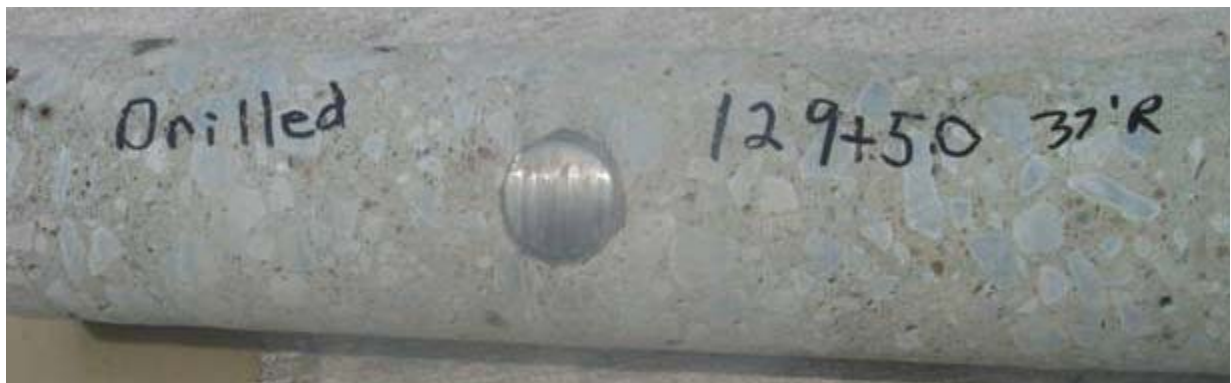
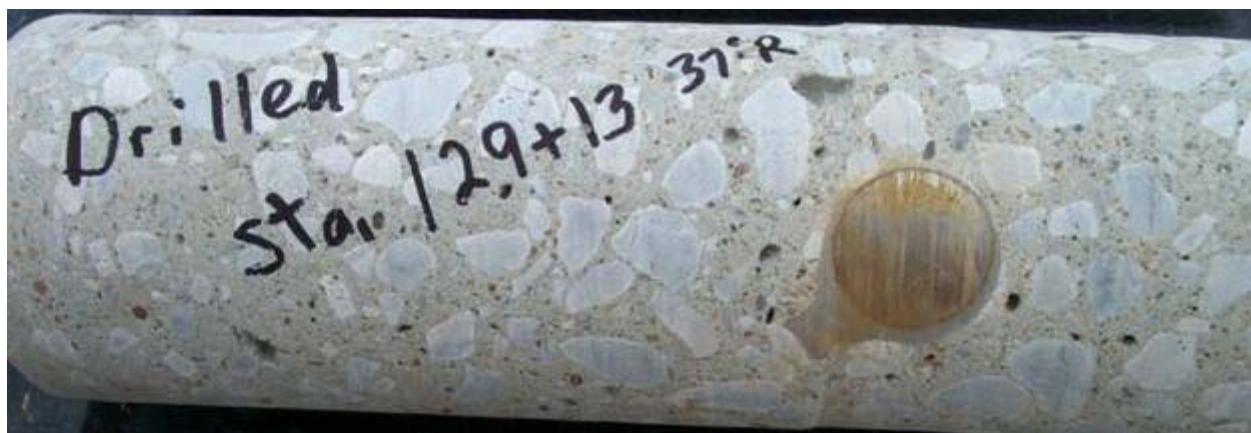
Figure 14a. Core 1 from the control section.

Figure 14b. Core 2 from the control section.

Figure 14c. Core 3 from the control section.

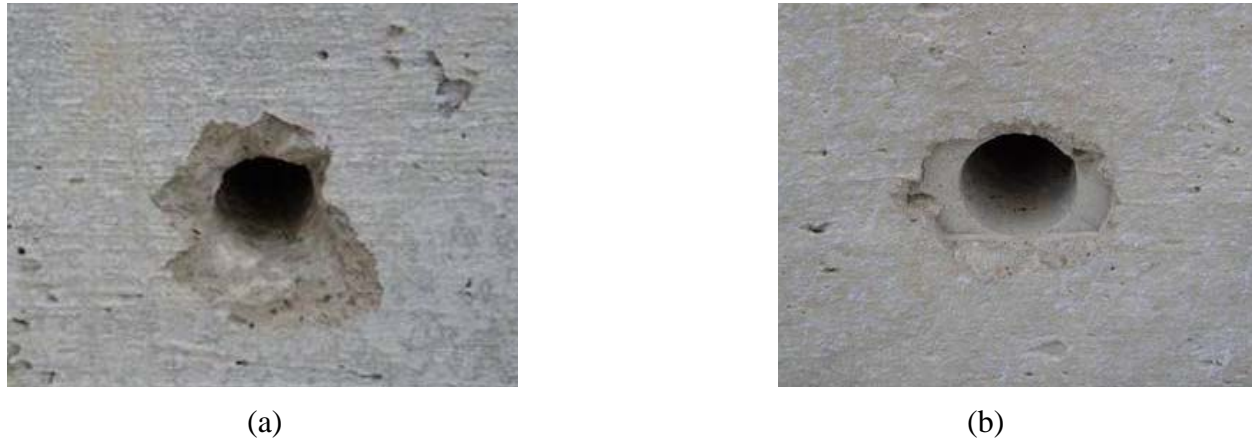
Figure 15. Quality of dowel support at the joint face: (a) typical spalling at the joint face of drilled holes; (b) smooth, formed hole produced by plastic sleeve.

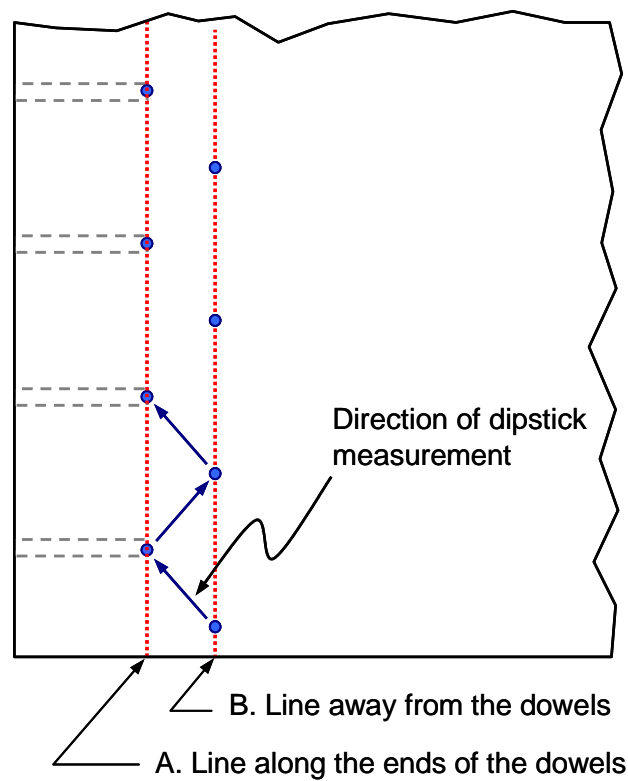
Figure 16. Measurement of elevation difference between points away from the dowels and over dowels using a Dipstick.

The possible presence of bumps on the pavement surface is a concern for the plastic sleeves because the plastic sleeves displace concrete as they are inserted. The presence of bumps over the dowel bars (plastic sleeves) was evaluated by measuring the elevation differences between a line away from the dowel bars and ends of the dowel bars using a Dipstick (Figure 16). The lines over which the Dipstick measurements were taken were selected such that the end of every dowel is hit as the Dipstick is “walked” between the two lines. The dowel locations were identified using MIT Scan-2 (Figure 17).

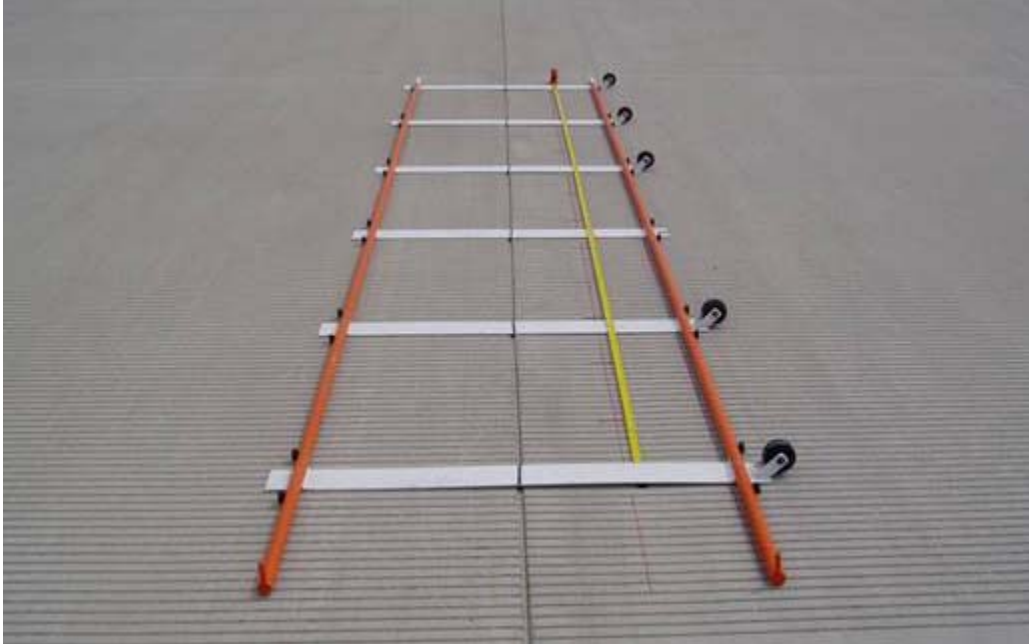
Figure 17. Identification of dowel location using MIT Scan-2.

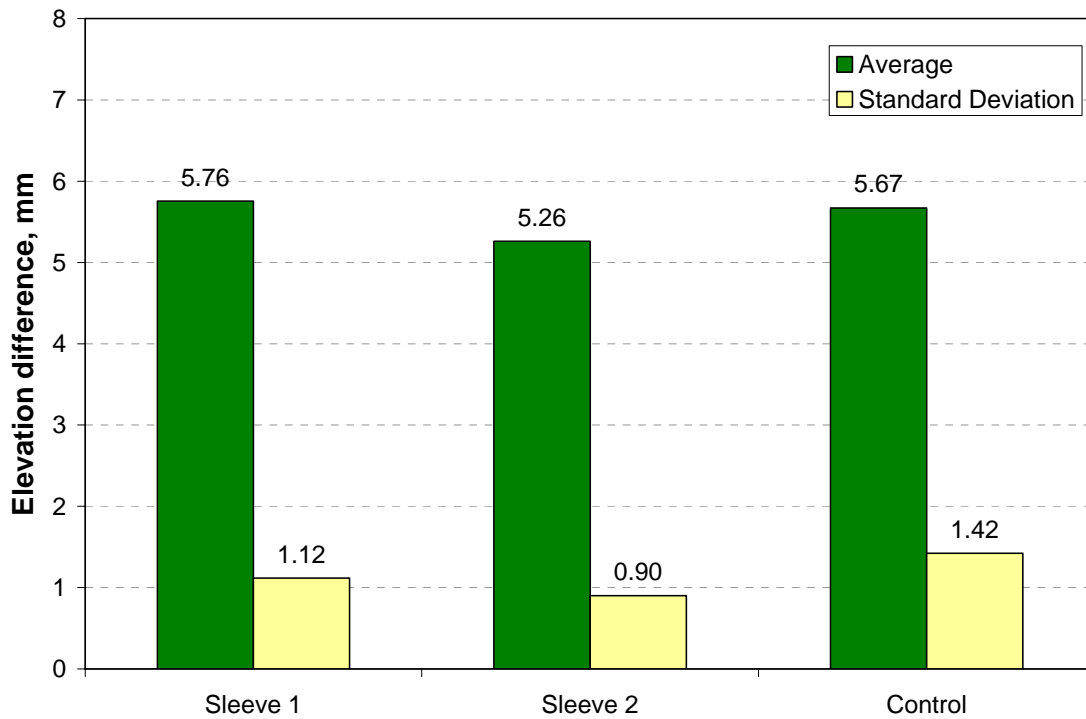
Figure 18. Elevation difference between Lines A and B shown in Figure 16.

Figure 18 shows that the elevation difference for the control section is between that for the two slabs where plastic inserts were used. This is a clear indication that any effect of plastic sleeves on pavement surface profile is insignificant compared to the effects of the pavement surface texture. The random variations in the pavement surface profile due to surface texture are shown in Figure 19. The slab-to-slab variation in the mean elevation difference shown in Figure 18 is very small relative to the standard deviation of the individual data points for each slab. An analysis of variance showed that the small differences in the mean elevation difference for the three test slabs shown in Figure 18 are statistically insignificant. Since the elevation difference in the control slab is due only to the pavement cross slope, the common value of the mean elevation differences for the three test locations means that the plastic sleeve inserts did not cause bumps on the pavement surface.

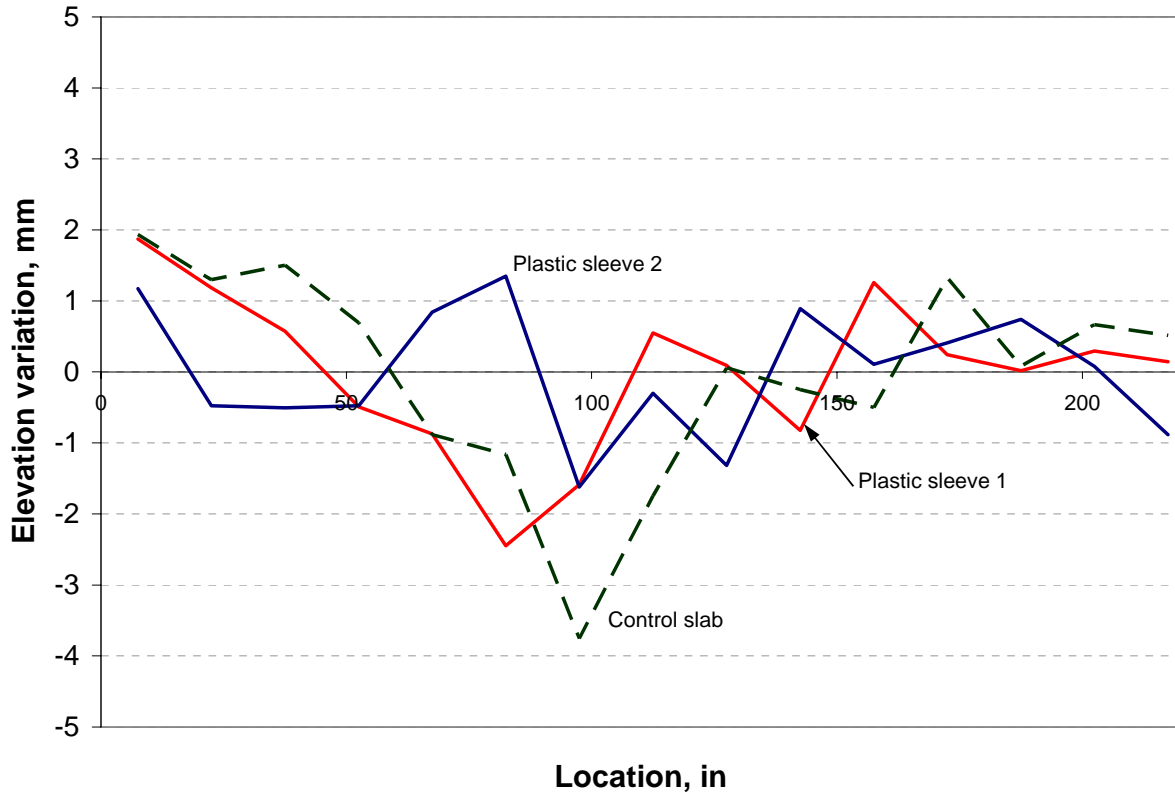
Figure 19. Variation of elevation differences between Lines A and B shown in Figure 16.
