Report IPRF-01-G-002-03-3

**Design and Construction of
Concrete Pavement for
Aircraft De-icing Facilities**

April 2006

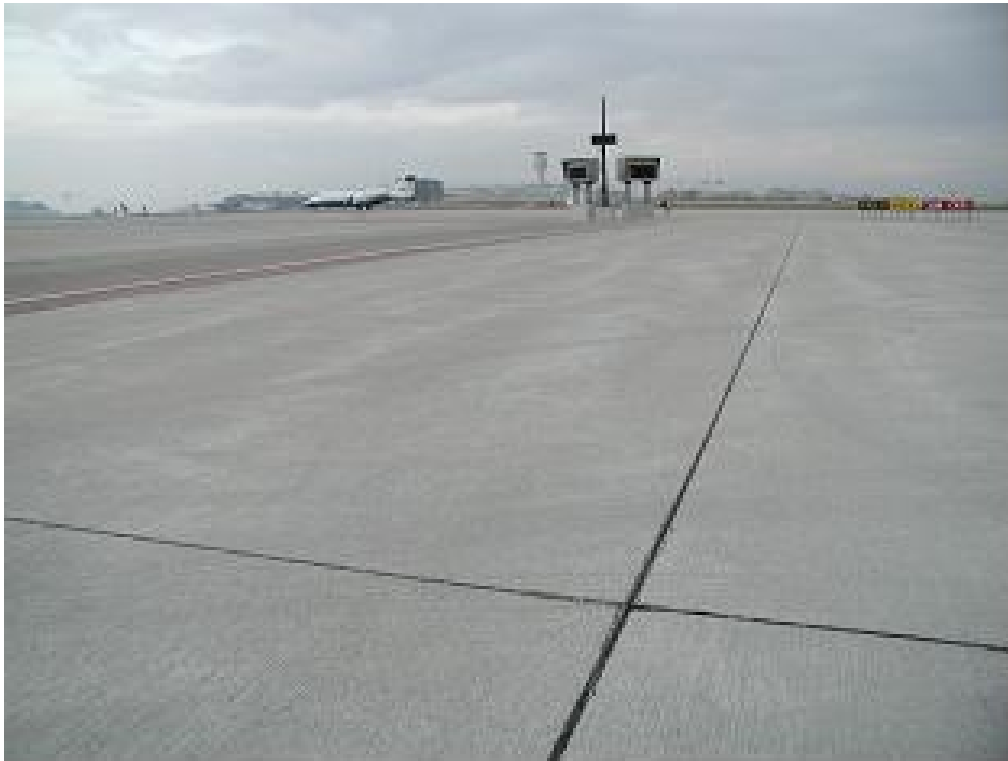
Two sample units were selected from one of the pads for the detailed surveys: sample unit 1 (in the central portion of the DDF) and sample unit 2 (in an outer portion of the DDF). Overall, both sample units were in very good condition, exhibiting no signs of structural distress or widespread deterioration. Figure 2 shows an overview of the deicing pad that was inspected.

FIGURE 2. OVERVIEW OF DEICING PAD INSPECTED AT AIRPORT ALPHA

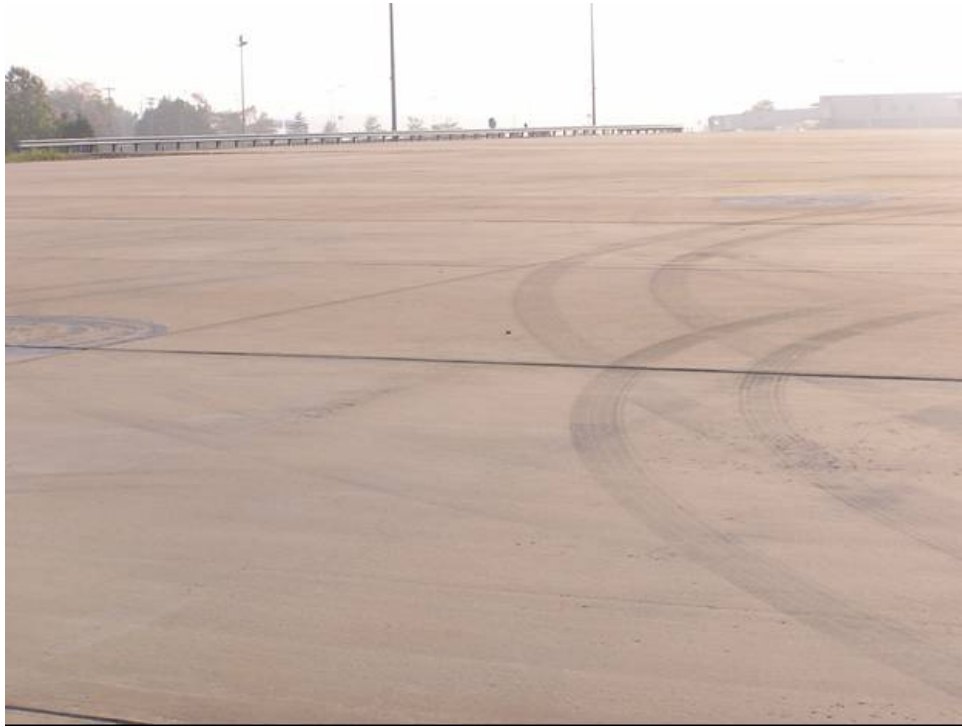
FIGURE 6. OVERVIEW OF DEICING FACILITY AT AIRPORT BETA

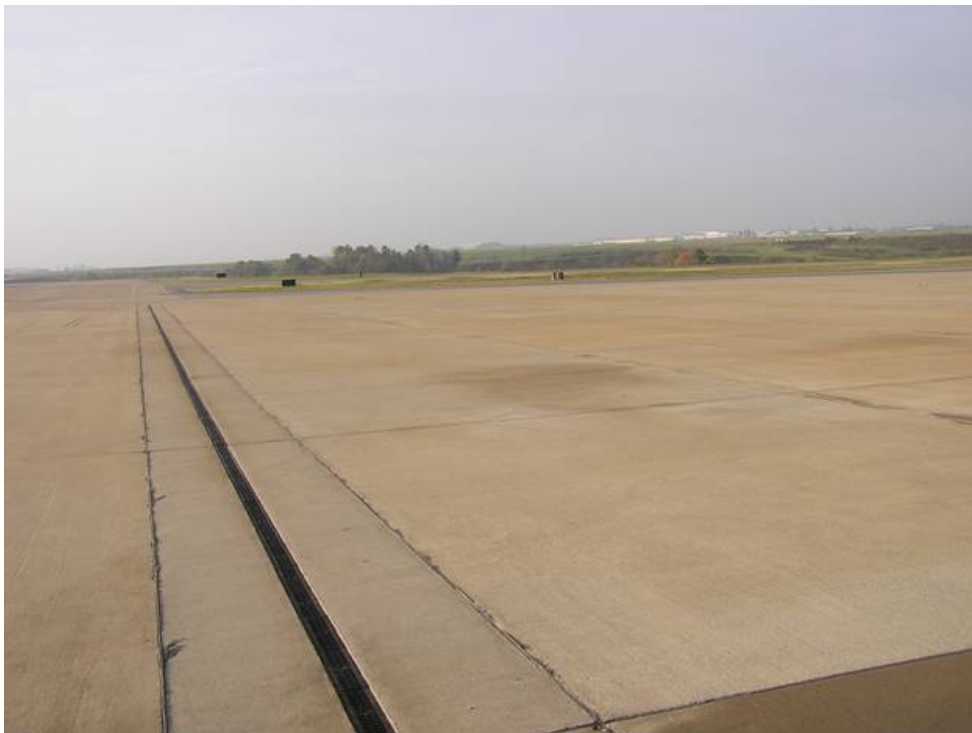
FIGURE 7. TRENCH DRAINS AROUND DEICING FACILITY AT AIRPORT BETA

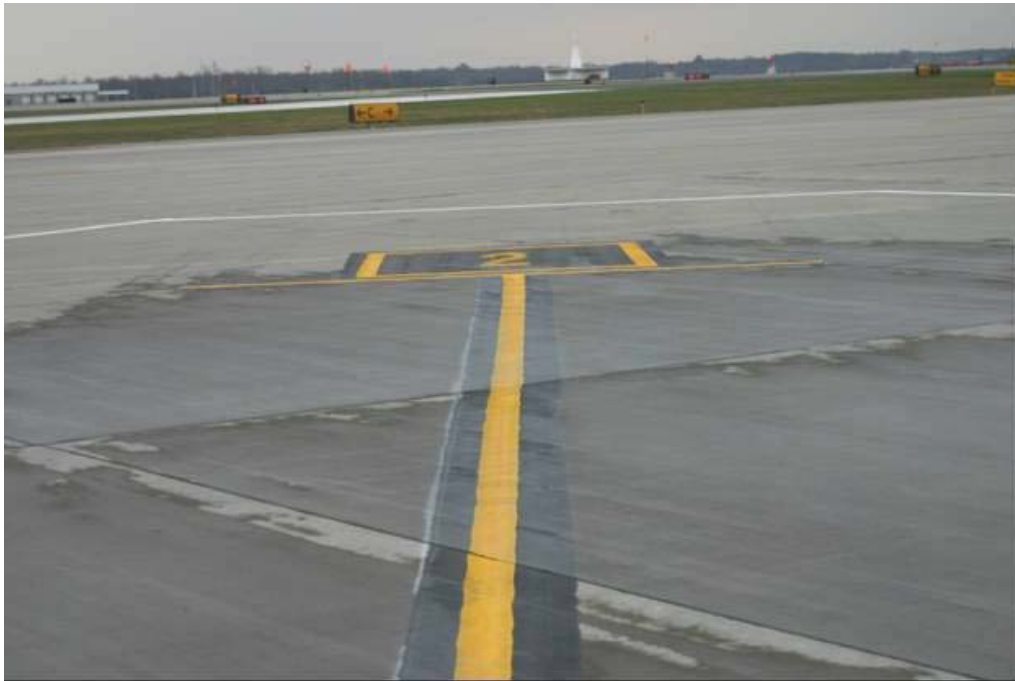
FIGURE 9. OVERVIEW OF DEICING FACILITY AT AIRPORT CHARLIE

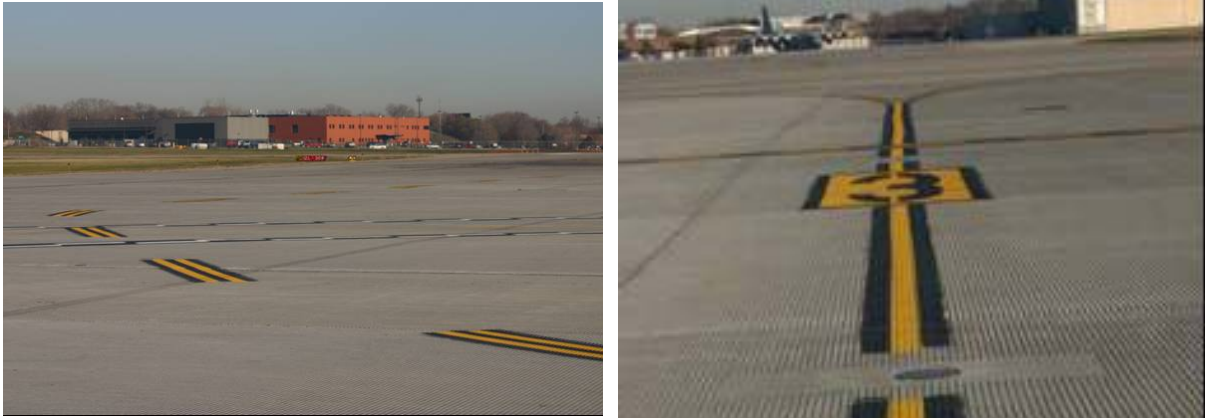
FIGURE 12. OVERVIEW OF DEICING FACILITY AT AIRPORT DELTA

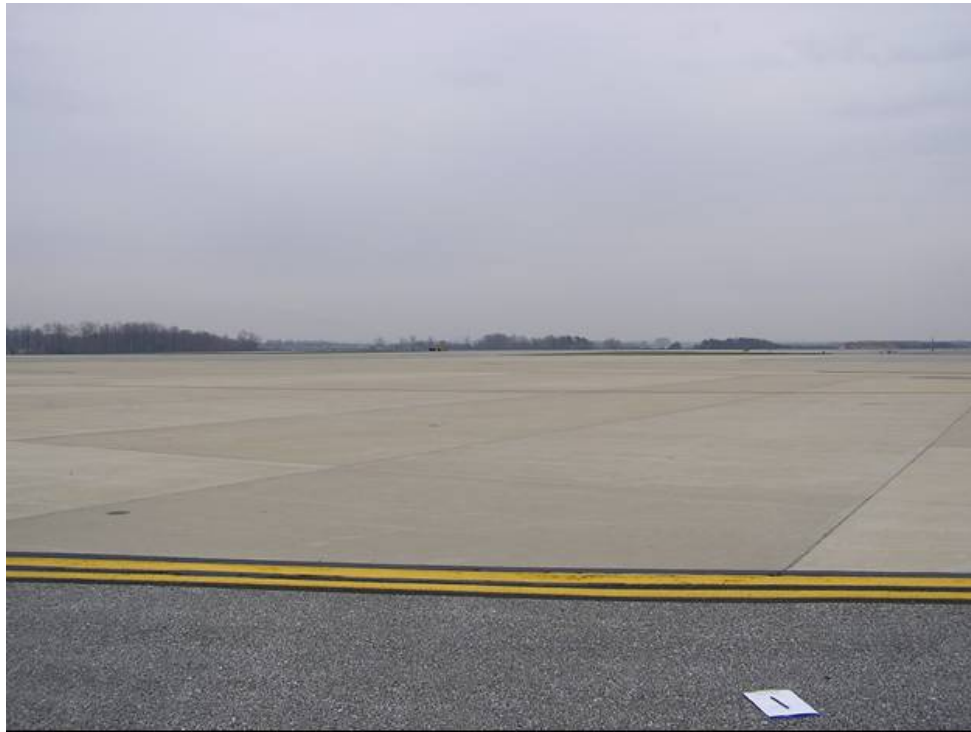
In a final walk-over of the entire deicing pad, it was observed that the hairline cracking was more apt to be present at the north end of the pad. Furthermore, some structural cracking was observed at the south end of the pad, although not located within either sample unit.

FIGURE 15. OVERVIEW OF DEICING FACILITY AT AIRPORT ECHO

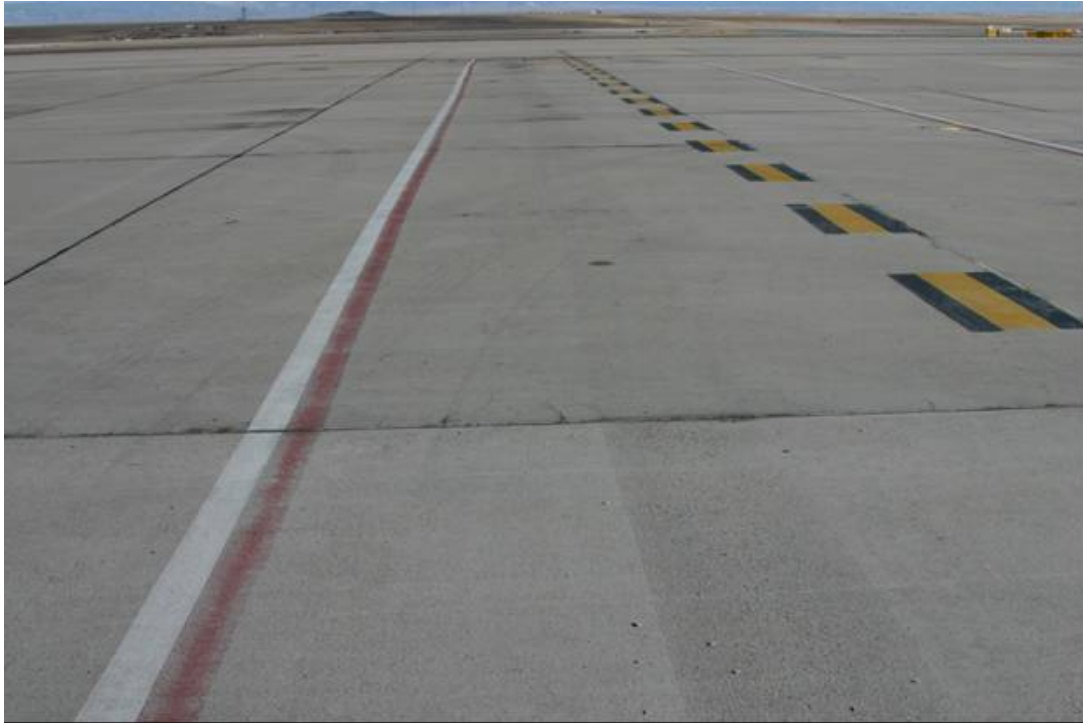
FIGURE 17. OVERVIEW OF DEICING FACILITY AT AIRPORT FOXTROT

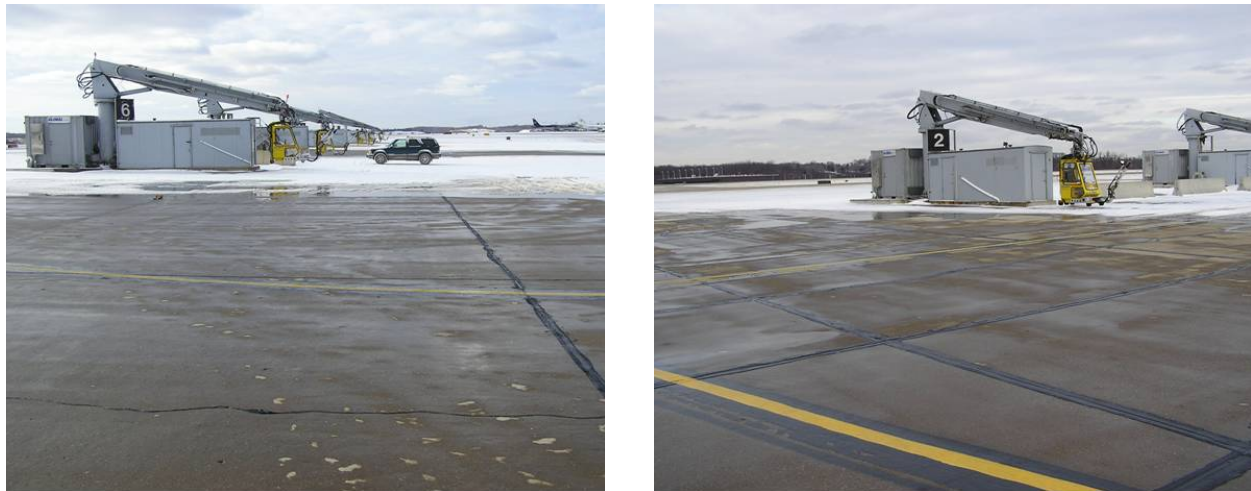
FIGURE 21. OVERVIEW OF DEICING PAD E (LEFT) AND DEICING PAD C (RIGHT) AT AIRPORT GOLF

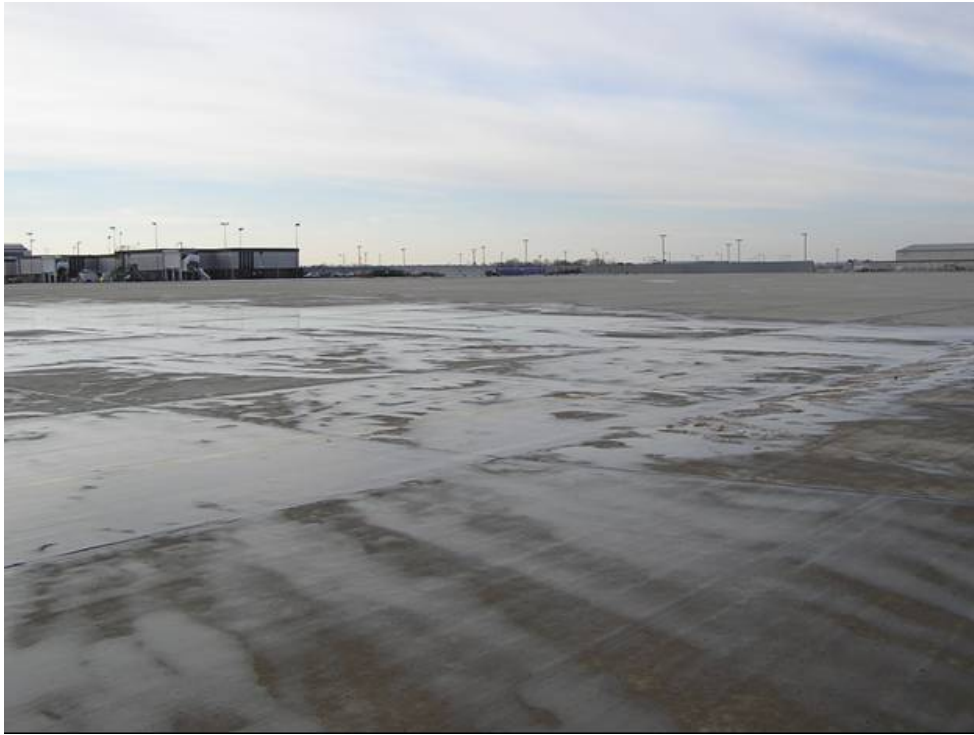
FIGURE 28. OVERVIEW OF DEICING FACILITY AT AIRPORT HOTEL

The first sample unit, located in an area of heavy deicer concentrations, was in good condition without any signs of cracking or spalling. The only observed distress was popouts on one slab (in order to be counted as a distress in the PCI procedure, popout density must exceed 3 popouts/yd²). The joint sealant was in fair condition, corresponding to a medium-severity rating, and had been placed in an overbanded configuration. No signs of map cracking, crazing, or MRD were evident.

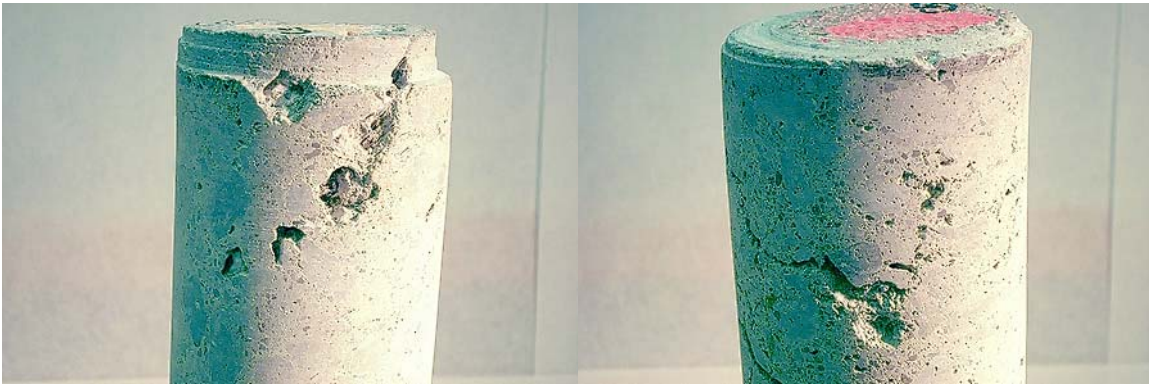
A total of seven 4-in diameter cores were received. All of the cores fully represented the entire depth of the concrete with a thickness of approximately 14.5 in. Cores A and B were taken directly over pavement joints. Core A, split in half lengthwise by the joint, exhibited a break at a depth of about 7 in through one half of the core, and another break at a depth of about 8.5 in through the other half of the core. The fracture surfaces of the breaks in core A appeared fresh and clean. Core B did not exhibit any breaks other than the fracture plane from the joint. The remaining cores, all taken away from joints, did not exhibit any breaks, with the exception of core G. The break in core G occurred at a depth of approximately 4 in through a region of large interconnected air voids. Figure 32 shows close-up views of regions of large interconnected air voids observed in both cores C and G. Cores C and G also exhibited fine cracks at the pavement surface.

FIGURE 32. CLOSE-UP OF IRREGULAR VOIDS FROM CORE C, (LEFT) AND CORE G, (RIGHT) AIRPORT ALPHA

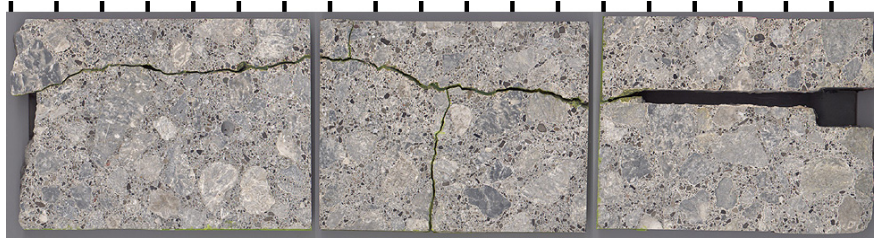
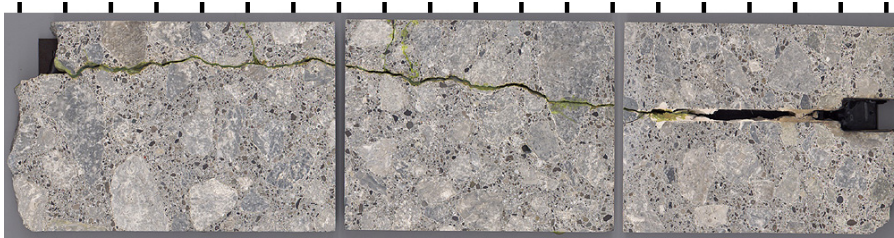
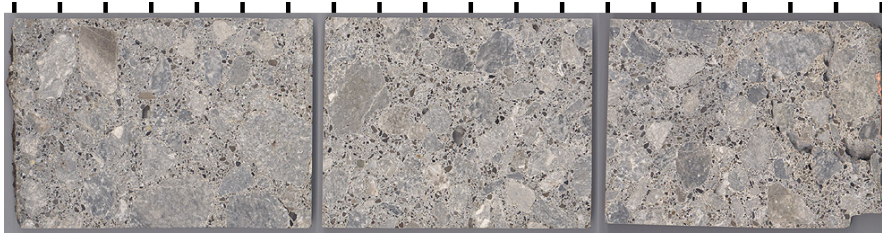
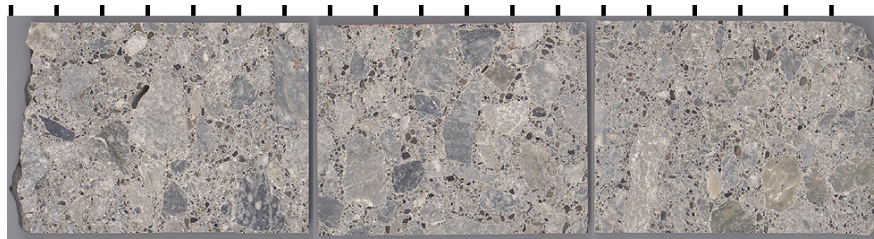
Figures 33 and 34 present flat-bed scanner images of the polished slabs. All of the slabs from cores B and C were stained with phenolphthalein and a carbonation depth of 0.5 to 0.75 mm² was observed with minor additional carbonation along the joint in core B, and along the perimeters of the large interconnected air void network of core C. The large interconnected air void network of core C is best observed in figure 35. The remaining cores B, D, and F did not exhibit the same large interconnected air void networks. All of the slabs from cores A and F were stained with sodium cobaltinitrite. The coarse aggregate throughout the cores picked up the yellow stain, which is normally an indicator for alkali-silica reactivity. Figure 36 shows close-up stereo-microscope images of yellow stained regions on polished slabs from cores A and F. The coarse aggregate, a relatively pure dolomite, did not appear to be alkali-silica reactive in spite of picking up the yellow stain. The yellow stained cracks near the pavement surface on the polished slab prepared from core F may be due to locally increased alkali (potassium) concentrations. Enrichment in alkalis at the pavement surface has been associated by some researchers with the evaporation of soluble-alkali laden mix water (Dobie, 1986).

FIGURE 33. POLISHED SLABS FROM AIRPORT ALPHA. SLABS ORIENTED TO SHOW CROSS-SECTION THROUGH PAVEMENT, PAVEMENT SURFACE AT RIGHT-HAND SIDE, TICK MARKS EVERY 2 CM

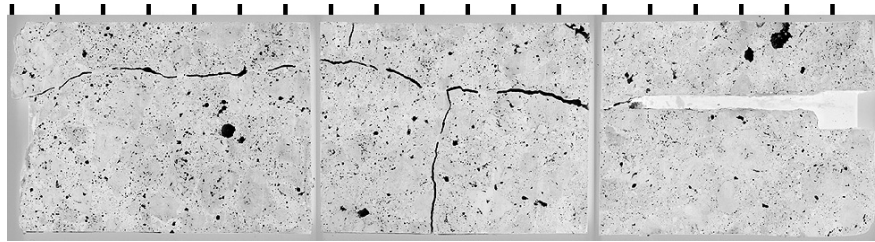
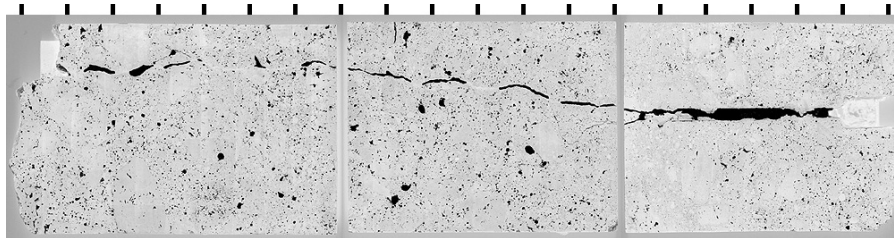
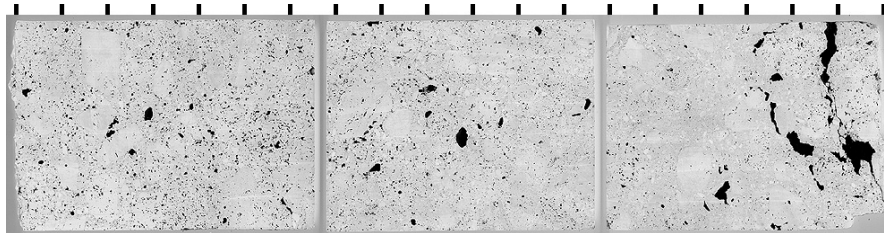
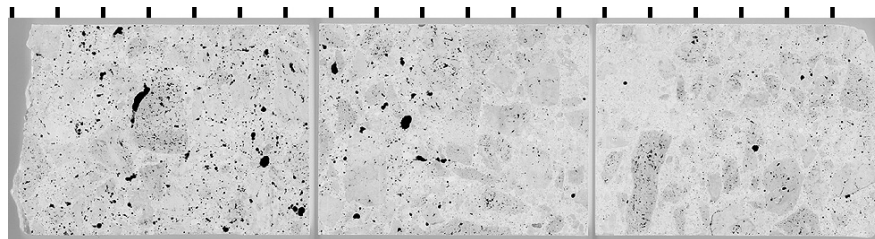
FIGURE 34. POLISHED SLABS FROM AIRPORT ALPHA SITE AFTER TREATMENT TO ENHANCE VISIBILITY OF AIR VOIDS AND CRACKS. SLABS ORIENTED TO SHOW CROSS-SECTION THROUGH PAVEMENT, PAVEMENT SURFACE AT RIGHT-HAND SIDE, TICK MARKS EVERY 2 CM

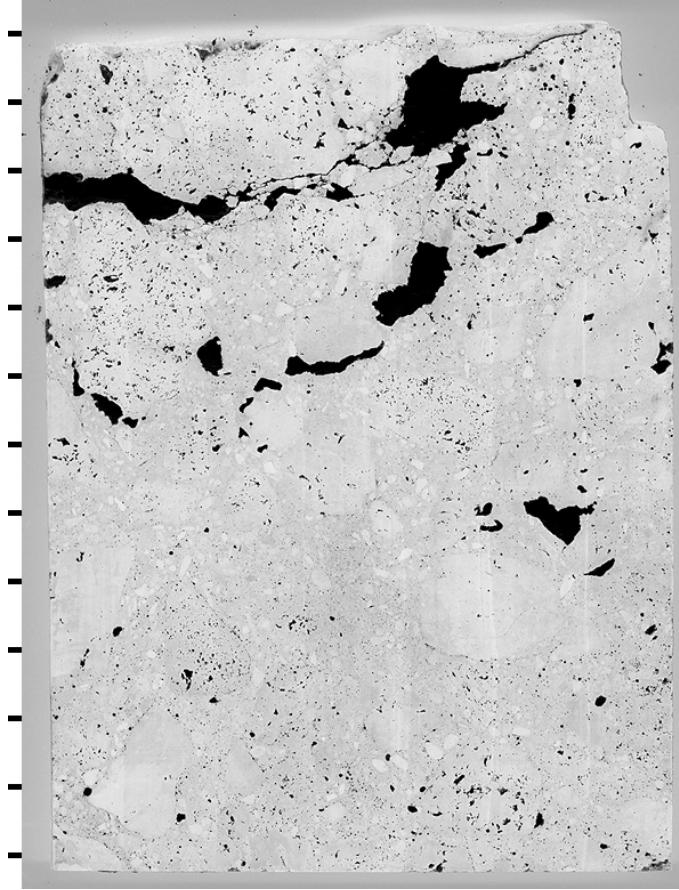
FIGURE 35. CLOSE-UP OF POLISHED SLAB PREPARED FROM TOP THIRD OF CORE C, AIRPORT ALPHA AFTER TREATMENT TO EMPHASIZE LOCATIONS OF AIR VOIDS AND CRACKS. TICK MARKS EVERY CM

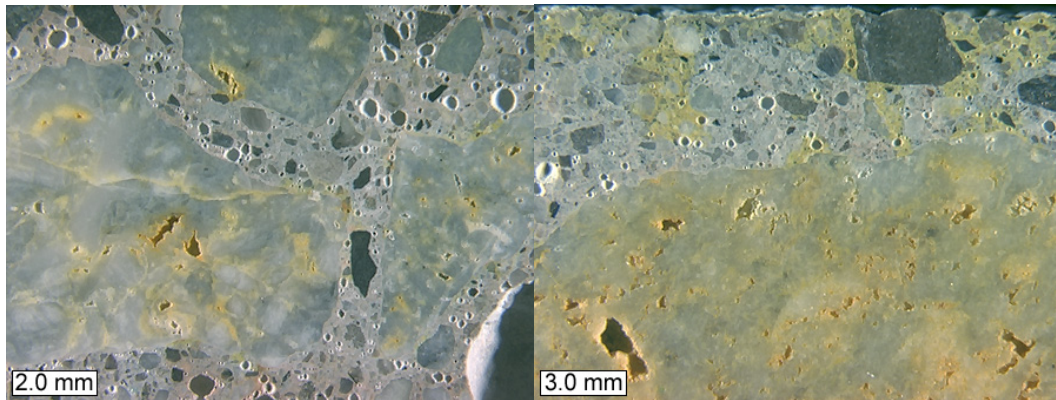
FIGURE 36. STEREO-MICROSCOPE IMAGES OF AGGREGATES AND CRACKS THAT PICKED UP YELLOW COLORATION FROM SODIUM COBALTINITRITE STAIN. IMAGE ON LEFT FROM POLISHED SLAB FROM BOTTOM THIRD OF CORE A; IMAGE ON RIGHT FROM PAVEMENT SURFACE ON THE TOP THIRD OF CORE F, AIRPORT ALPHA

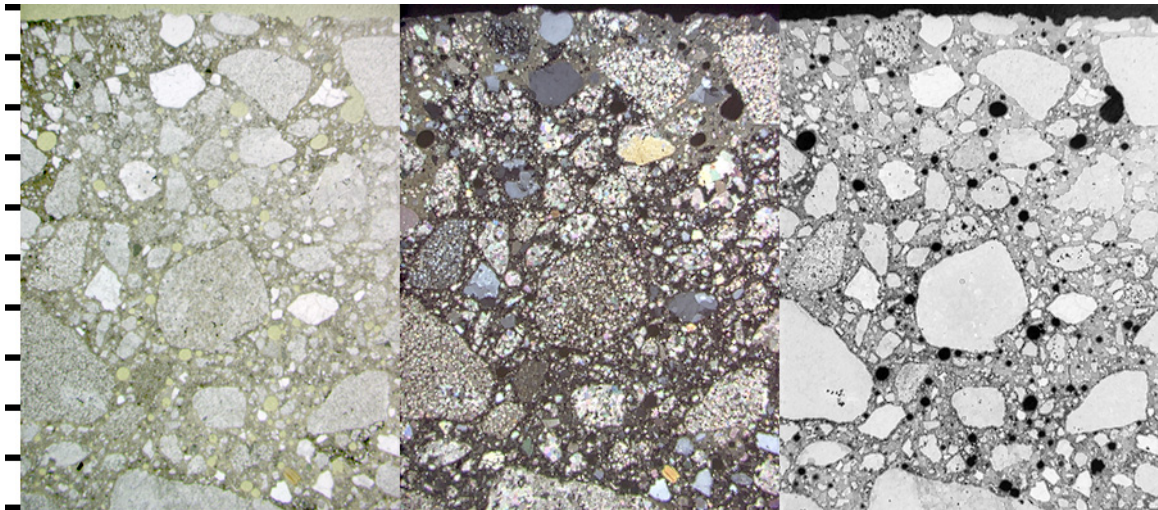
FIGURE 37. PETROGRAPHIC MICROSCOPE IMAGES TO SHOW CROSS-SECTION AT PAVEMENT SURFACE FROM CORE F, AIRPORT ALPHA. FROM LEFT TO RIGHT: PLANE POLARIZED LIGHT, CROSSED POLARS, AND EPIFLUORESCENT MODE. TICK MARKS EVERY MM

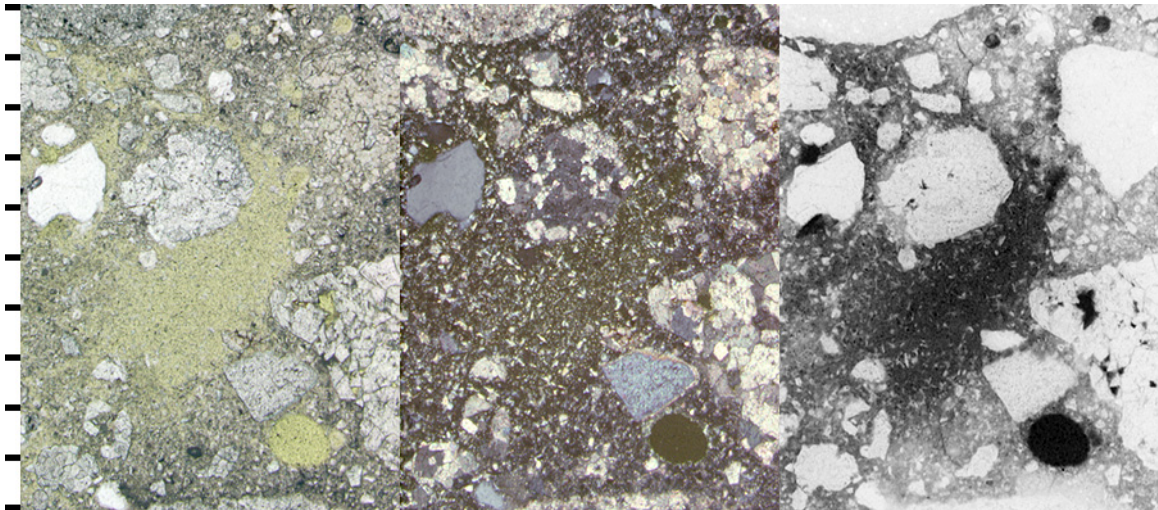
FIGURE 39. PETROGRAPHIC MICROSCOPE IMAGES OF LOCALIZED REGION IN CEMENT PASTE OF EXTREMELY HIGH POROSITY, POLISHED THIN SECTION FROM CORE C, AIRPORT ALPHA. FROM LEFT TO RIGHT: PLANE POLARIZED LIGHT, CROSSED POLARS, AND EPIFLUORESCENT MODE. TICK MARKS EVERY 250 MICROMETERS

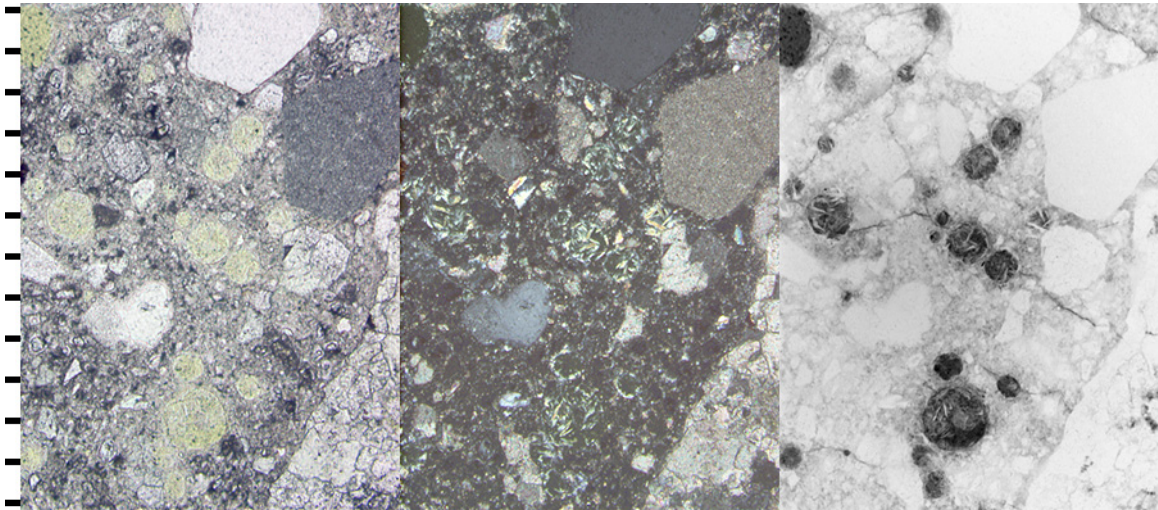
Figures 40 through 42 show BSE images, elemental maps, and petrographic microscope images of secondary calcium hydroxide crystals in the entrained air voids of a polished thin section from core C. Calcium hydroxide crystals were very common in the entrained air voids on all of the prepared thin sections from the Airport Alpha cores. In addition to the calcium hydroxide deposits, the elemental maps of figure 40 also show inert dolomite powder filler dispersed throughout the cement paste.

FIGURE 41. PETROGRAPHIC MICROSCOPE IMAGES OF CALCIUM HYDROXIDE DEPOSITS IN ENTRAINED AIR VOIDS FROM POLISHED THIN SECTION FROM CORE C, AIRPORT ALPHA. FROM LEFT TO RIGHT: PLANE POLARIZED LIGHT, CROSSED POLARS, AND EPIFLUORESCENT MODE. TICK MARKS EVERY 100 MICROMETERS

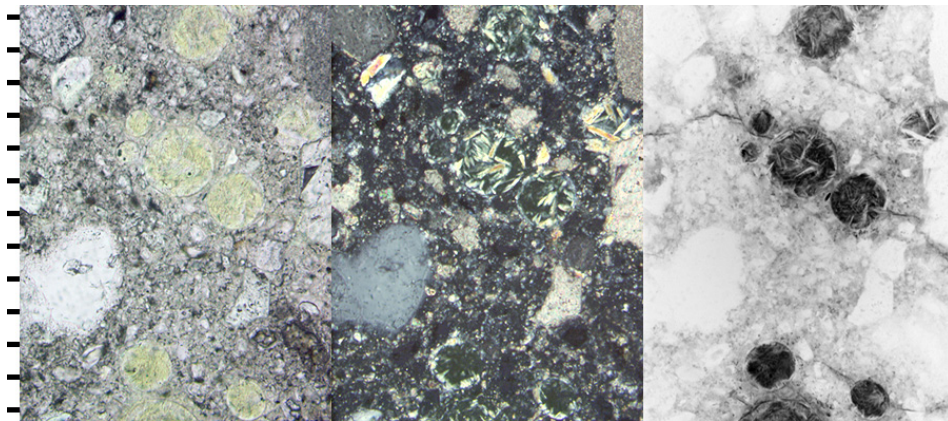
FIGURE 42. CLOSE-UP PETROGRAPHIC MICROSCOPE IMAGES OF CALCIUM HYDROXIDE DEPOSITS IN ENTRAINED AIR VOIDS FROM POLISHED THIN SECTION FROM CORE C, AIRPORT ALPHA. FROM LEFT TO RIGHT: PLANE POLARIZED LIGHT, CROSSED POLARS, AND EPIFLUORESCENT MODE. TICK MARKS EVERY 50 MICROMETERS

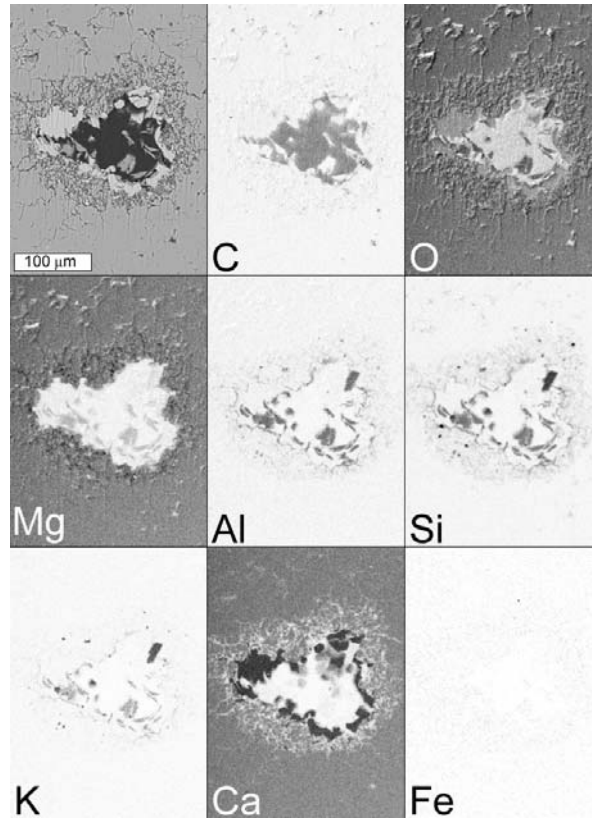
Figure 43 consists of a BSE image and elemental maps of a pore space in a dolomite coarse aggregate particle in polished thin section from core C. The pore space is lined by calcite and a potassium-bearing clay mineral. The potassium-bearing clay mineral is likely responsible for the strong uptake of the sodium cobaltinitrite indicator solution by the dolomite coarse aggregate. Figures 44 and 45 consist of petrographic microscope images to illustrate the constituents of the cementitious materials in the concrete. Dolomite powder filler can best be seen in the plane polarized image of figure 45.

FIGURE 43. BSE IMAGE (UPPER LEFT HAND CORNER) AND ELEMENTAL MAPS SHOWING CALCITE AND POTASSIUM-BEARING CLAY MINERALS IN PORE SPACE WITHIN DOLOMITE COARSE AGGREGATE PARTICLE ON POLISHED THIN SECTION FROM CORE C, AIRPORT ALPHA. IN ELEMENTAL MAPS, DARKER COLORED REGIONS CORRESPOND TO HIGHER X-RAY COUNTS

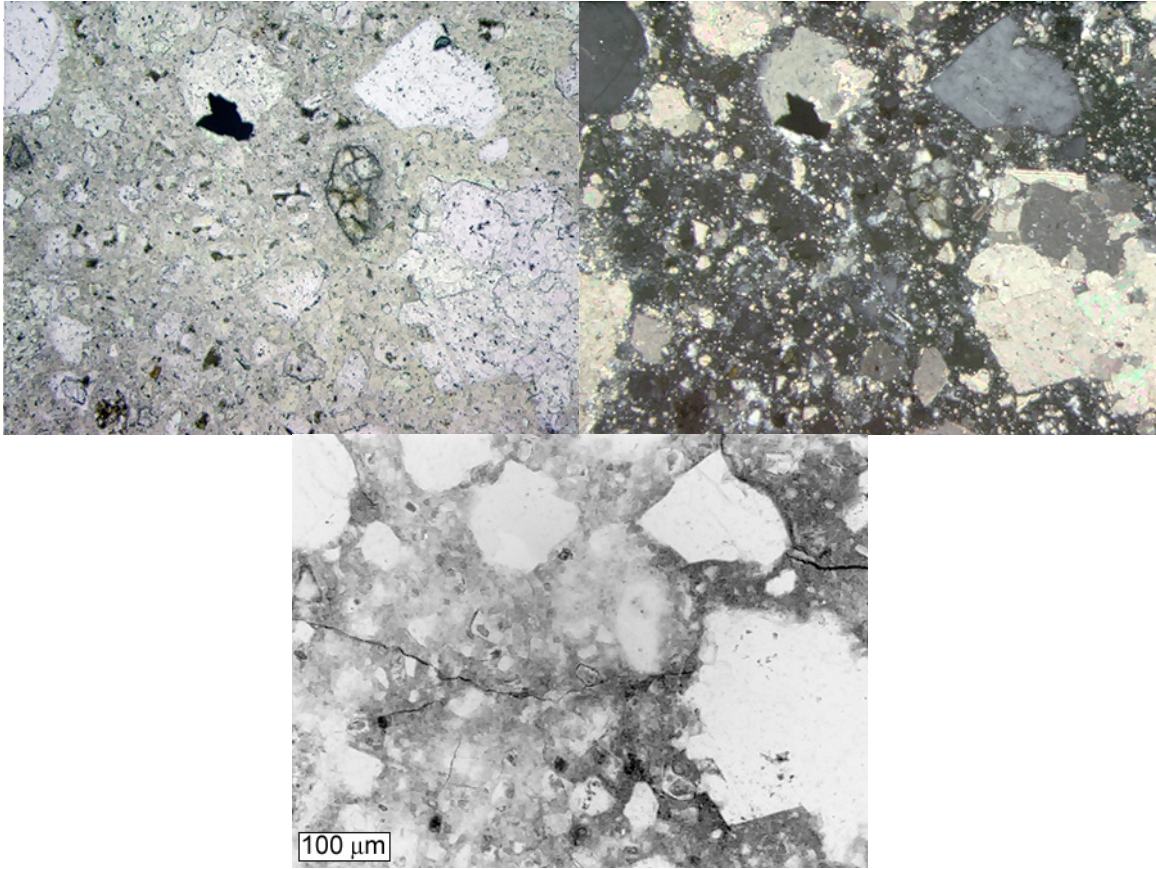
FIGURE 44. PETROGRAPHIC MICROSCOPE IMAGES TO SHOW CEMENT PASTE FRACTION FROM AIRPORT ALPHA. CLOCKWISE FROM UPPER LEFT HAND CORNER: PLANE POLARIZED LIGHT, CROSSED POLARS, AND EPIFLUORESCENT MODE

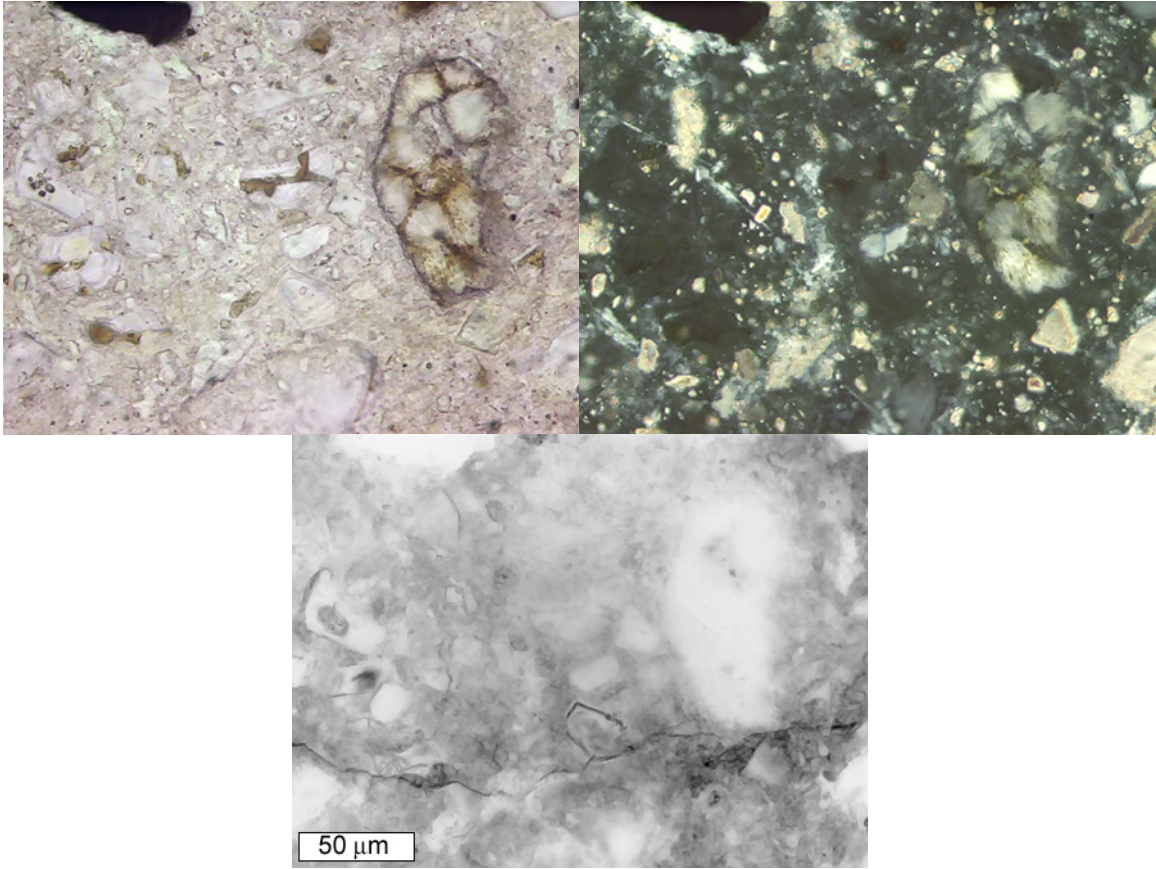
FIGURE 45. CLOSE-UP PETROGRAPHIC MICROSCOPE IMAGES TO SHOW CEMENT GRAINS AND DOLOMITE POWDER FILLER IN CEMENT PASTE FRACTION FROM AIRPORT ALPHA. THE DOLOMITE PARTICLES ARE CLEARLY VISIBLE IN THE CROSSED POLARS IMAGE. CLOCKWISE FROM UPPER LEFT HAND CORNER: PLANE POLARIZED LIGHT, CROSSED POLARS, AND EPIFLUORESCENT MODE

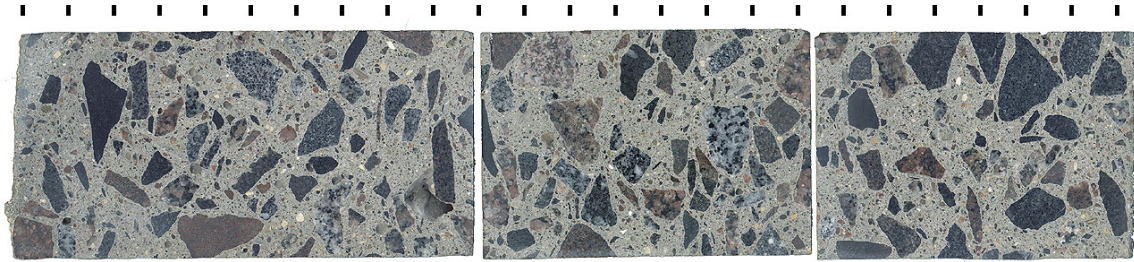
Core 44, away from joint, Airport Delta

All polished slabs were taken from core 44 as shown in figures 46 and 47. The carbonation depth is approximately 1.25 mm. The air-void system parameters of the polished slabs were measured according to ASTM C 457, having a measured spacing factor of 0.115 mm. Figure 48 shows stereo-microscope images of the air-void structure.

FIGURE 46. POLISHED SLABS FROM CORE 44, AIRPORT DELTA. SLABS ORIENTED TO SHOW CROSS-SECTION THROUGH PAVEMENT, PAVEMENT SURFACE AT RIGHT-HAND SIDE, TICK MARKS EVERY 2 CM

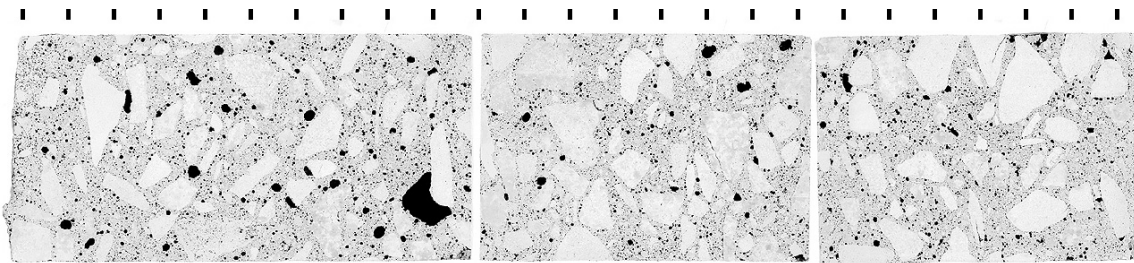
Core 44, away from joint, Airport Delta

FIGURE 47. POLISHED SLABS FROM CORE 44, AIRPORT DELTA AFTER TREATMENT TO ENHANCE VISIBILITY OF AIR VOIDS AND CRACKS. SLABS ORIENTED TO SHOW CROSS-SECTION THROUGH PAVEMENT, PAVEMENT SURFACE AT RIGHT-HAND SIDE, TICK MARKS EVERY 2 CM

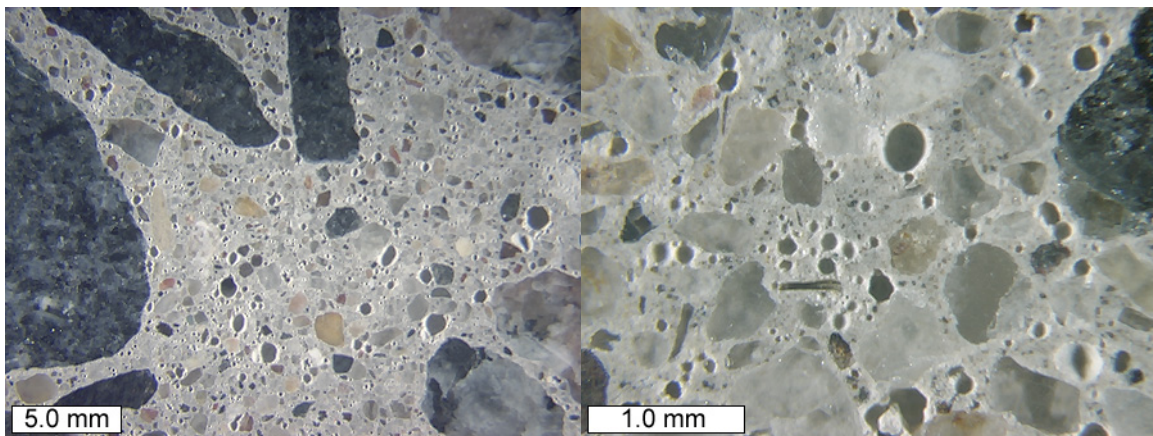
FIGURE 48. STEREO-MICROSCOPE IMAGES TO SHOW AIR VOID STRUCTURE ON POLISHED SLAB FROM TOP THIRD OF CORE 44 AWAY FROM JOINT, AIRPORT DELTA

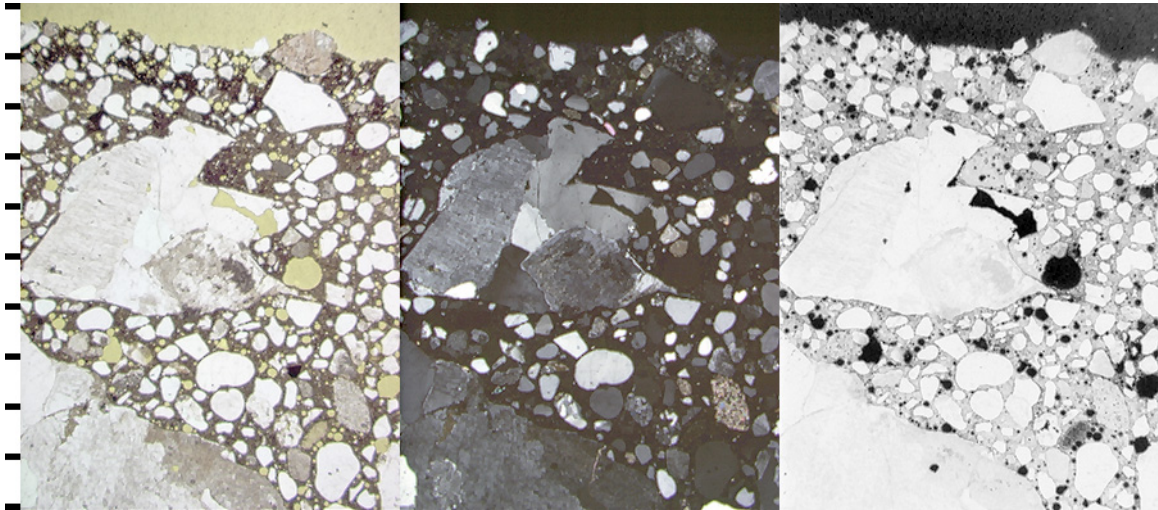
Figure 49 shows a cross section through the pavement surface of core 44. Figure 50 shows a petrographic microscope image to illustrate portland cement grains and fly ash in the cement paste.

FIGURE 49. PETROGRAPHIC MICROSCOPE IMAGES TO SHOW CROSS SECTION AT PAVEMENT SURFACE FROM CORE 44, AIRPORT DELTA. FROM LEFT TO RIGHT: PLANE POLARIZED LIGHT, CROSSED POLARS, AND EPIFLUORESCENT MODE. TICK MARKS EVERY MM

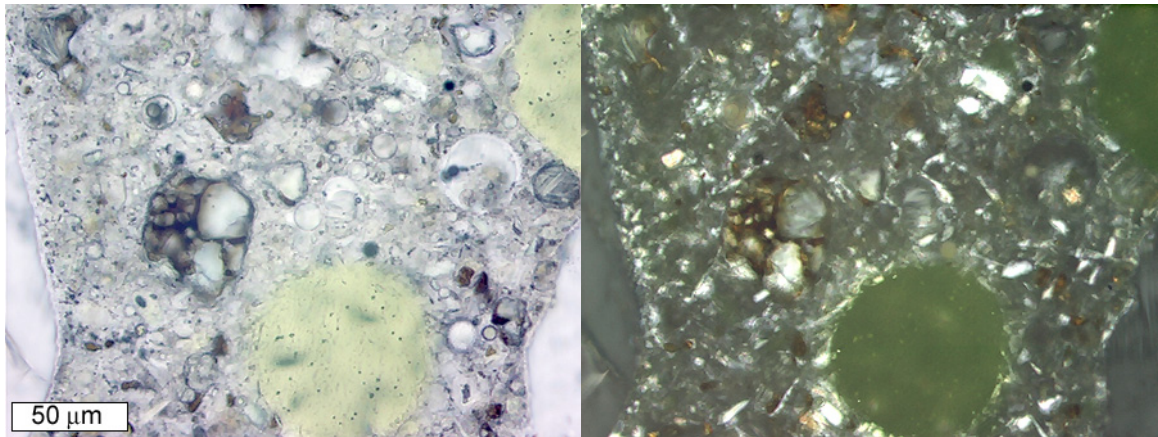
FIGURE 50. CLOSE-UP OF CEMENT PASTE IN THIN SECTION FROM AIRPORT DELTA TO SHOW CEMENT GRAINS AND FLY ASH PARTICLES IN CEMENT PASTE. FROM LEFT TO RIGHT, PLANE POLARIZED AND CROSSED POLARS

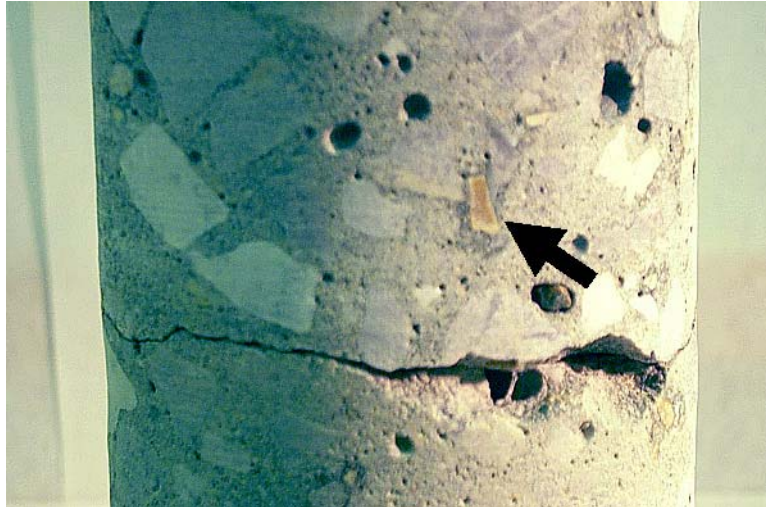
All of the cores exhibited visual signs of alkali silica-reactive fine aggregate particles; an example is shown in figure 51. Both the reactive fine aggregate particles and the surrounding hardened cement paste exhibited discoloration along the aggregate/cement paste interface. No associated cracks were observed in the aggregate or paste. Cores A, B, and C exhibited fine cracks at the pavement surface.

FIGURE 51. CLOSE-UP OF ALKALI-SILICA REACTIVE AGGREGATE (BLACK ARROW) EXPOSED ON EXTERIOR OF CORE D, AIRPORT ECHO

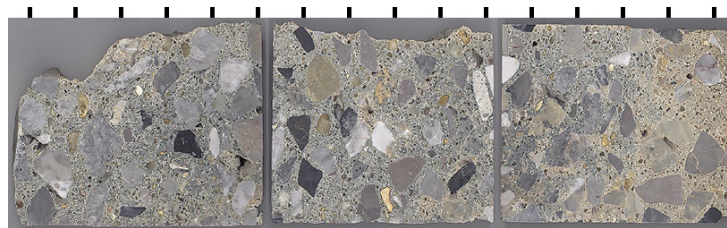
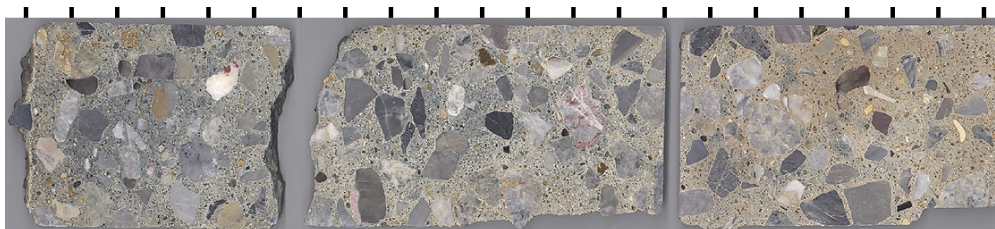
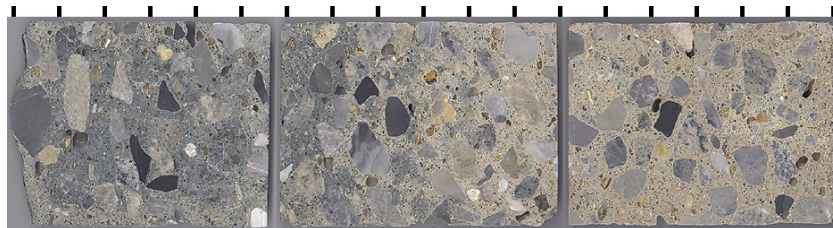
Cores A, B, and C exhibited cracks at the pavement surface. These cracks can be observed in cross section on the polished slabs in figures 52 and 53. The cracks extend to depths of 1 to 2 cm in cores A and B, and to depths of 1 to 4 cm in core C. The depth of carbonation can be observed in phenolphthalein-stained slabs, with carbonation depths of 1 to 2 mm in cores A and C, with carbonation penetrating farther along the depth of the cracks. Reactive fine aggregate particles can best be seen in the sodium cobaltinitrite-stained slab representing the top third of core B (figure 54) where the reactive fine aggregate particles are stained yellow.

FIGURE 52. POLISHED SLABS FROM AIRPORT ECHO. PAVEMENT SURFACE AT RIGHT-HAND SIDE; TICK MARKS EVERY 2 CM. ONLY CORE B SAMPLED THE ENTIRE DEPTH. DARK DISCOLORATION OF DUE TO REDUCTION OF IRON IN CEMENT GRAINS BY SULFUR IN GROUND GRANULATED BLAST FURNACE SLAG

All of the cores show a trend of dark discolored cement paste with increasing depth. The discoloration becomes pronounced at depths greater than 3 cm for core A, and at depths greater than 15 cm for cores B and C. The dark discoloration of the cement paste is due to reduction of ferric iron (Fe^{3+}) present in the cement to ferrous iron (Fe^{2+}) by reduced sulfur (S^{2-}). Reduced sulfur is present in ground-granulated blast furnace slag (GBFS), which is a constituent of the cementitious material used in this concrete. Closer to the pavement surface, the reduced sulfur is oxidized by oxygen in the atmosphere, so no reduction of iron or discoloration is observed.

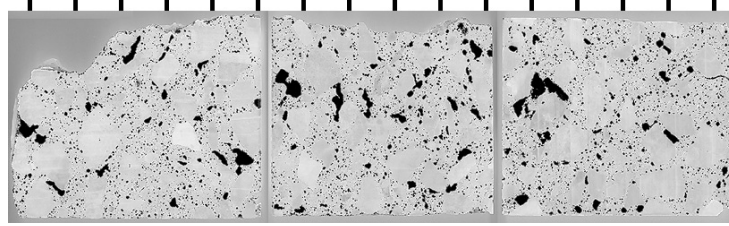
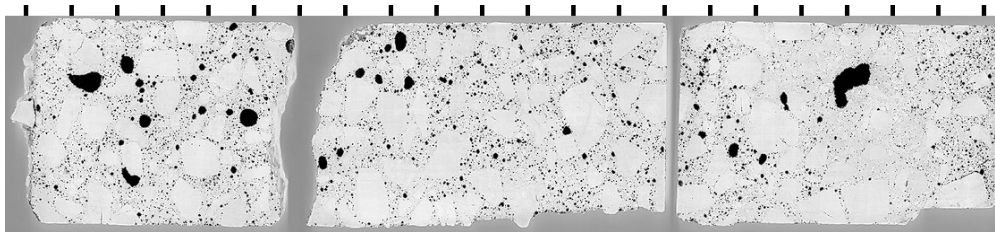
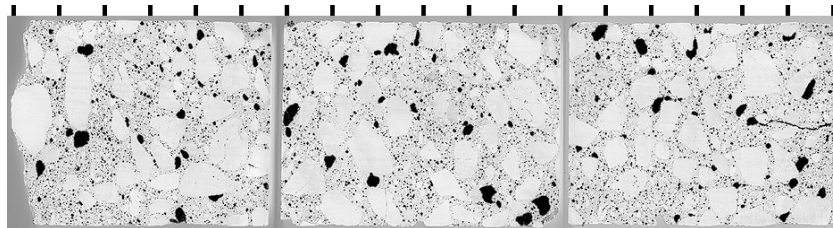
FIGURE 53. POLISHED SLABS FROM AIRPORT ECHO AFTER TREATMENT TO ENHANCE VISIBILITY OF AIR VOIDS AND CRACKS. SLABS ORIENTED TO SHOW CROSS-SECTION THROUGH PAVEMENT, PAVEMENT SURFACE AT RIGHT-HAND SIDE; TICK MARKS EVERY 2 CM. ONLY CORE B SAMPLED THE ENTIRE PAVEMENT DEPTH

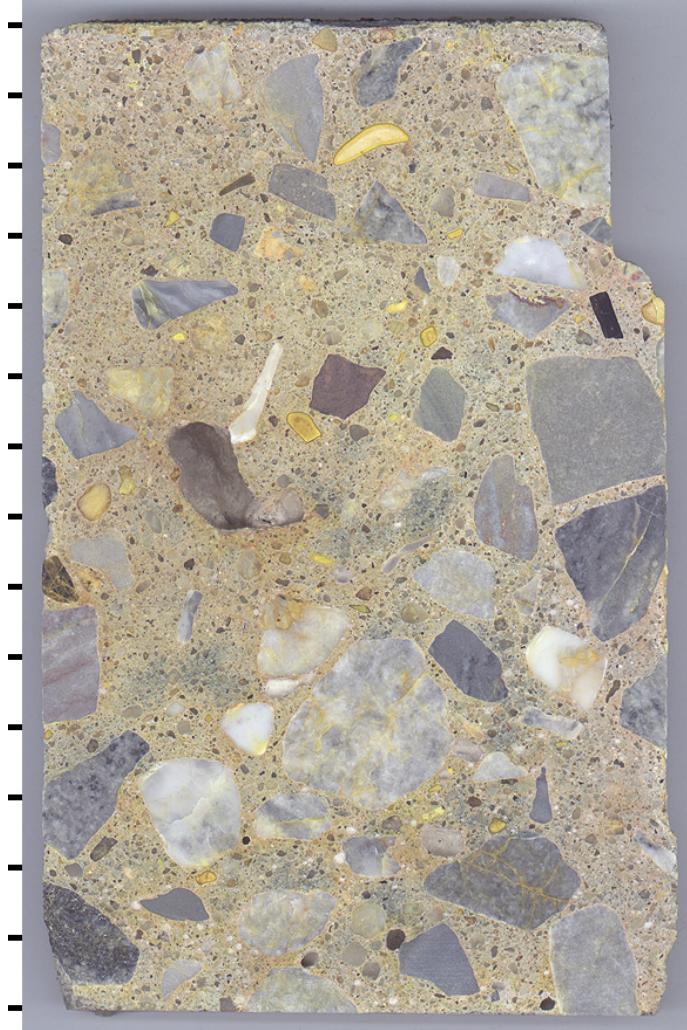
FIGURE 54. CLOSE-UP OF POLISHED SLAB PREPARED FROM TOP THIRD OF CORE B, AIRPORT ECHO, AFTER STAINING WITH SODIUM COBALTNITRITE SOLUTION. TICK MARKS EVERY CM

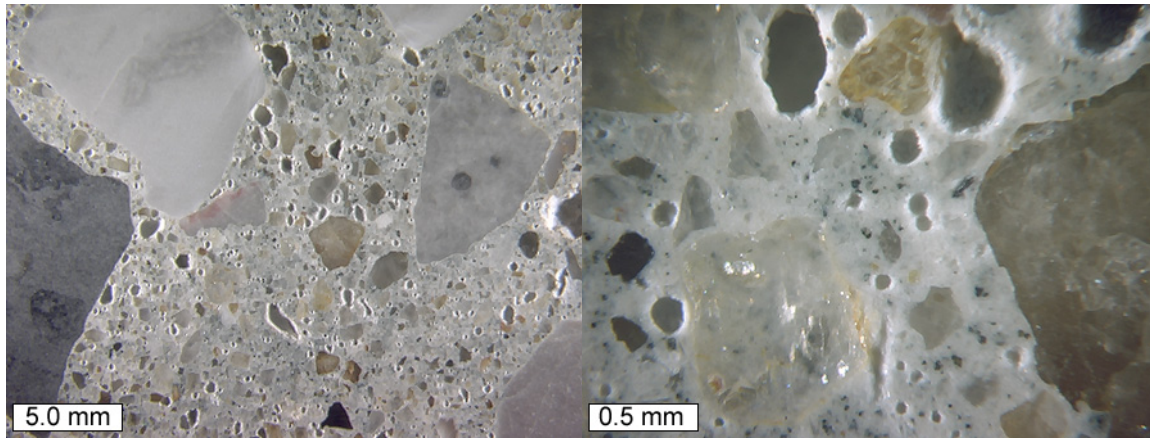
The air-void system parameters of the polished slabs were measured according to ASTM C 457. The measured spacing factors were 0.203, 0.214, and 0.161 mm for cores A, B, and C, respectively. Figure 55 shows a stereo-microscope image of the air-void structure typical cores A, B, and C.

FIGURE 55. STEREO-MICROSCOPE IMAGES TO SHOW AIR VOID STRUCTURE ON POLISHED SLAB FROM MIDDLE THIRD OF CORE A ADJACENT TO JOINT, AIRPORT ECHO

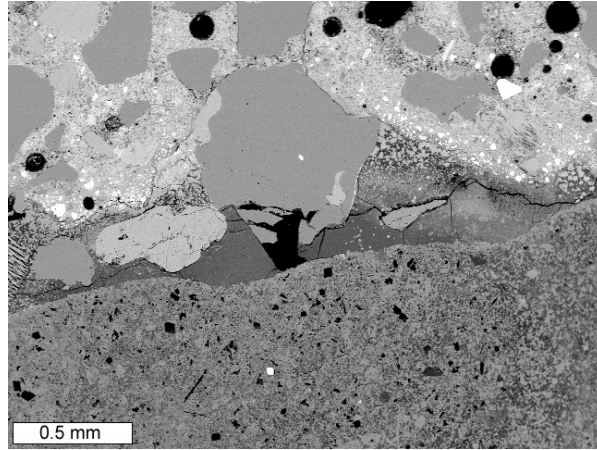
Figure 56 shows a cross section through a crack at the pavement surface of core C. The crack morphology is typical of a plastic shrinkage crack. Figure 57 shows a petrographic microscope image of a reactive fine aggregate particle. The epifluorescent mode image on the right hand side of figure 57 shows no cracking associated with the reactive particle. The BSE in figure 58 shows a close-up of the alkali-silica reaction product adjacent to the reactive particle. Other non-reactive fine aggregate particles are incorporated into the reaction product, suggesting that the reaction may have occurred before the concrete had set.

FIGURE 58. CLOSE-UP BSE IMAGE TO SHOW PERIMETER OF REACTIVE FINE AGGREGATE PARTICLE IN POLISHED THIN SECTION FROM CORE C, AIRPORT ECHO. INCORPORATION OF OTHER FINE AGGREGATE PARTICLES INTO GEL REACTION PRODUCT SUGGESTS GEL PRODUCTION OCCURRED BEFORE THE CONCRETE HAD SET
