Report IPRF-01-G-002-03-3

**Design and Construction of
Concrete Pavement for
Aircraft De-icing Facilities**

April 2006

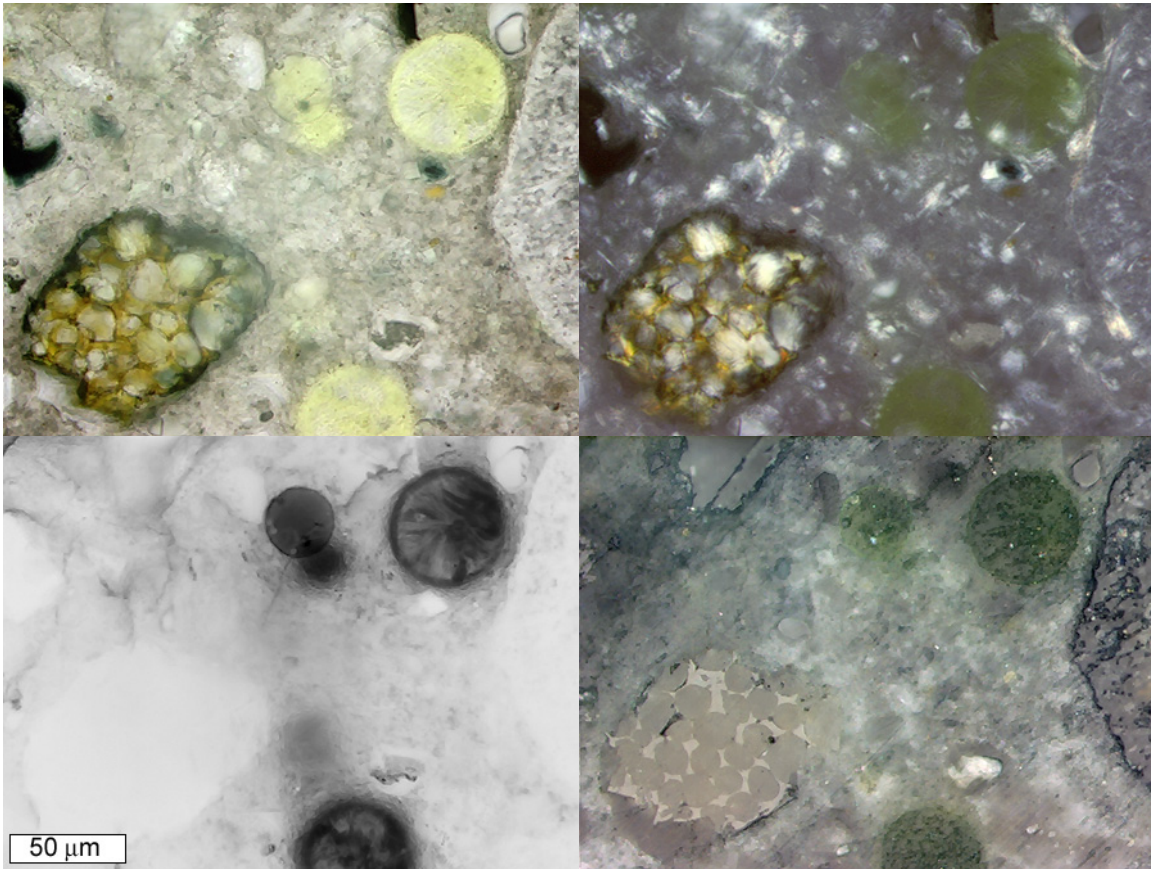
Figure 59 is a petrographic microscope image that illustrates the constituents of the cementitious materials in the concrete. The large cement grain in the lower left hand corner of the images in figure 59 exhibits a red coloration in the interior of the grain due to the ferric iron content of the interstitial phase (C4AF). The dark coloration around the exterior of the large cement grain is due to the reduction of the ferric iron in the interstitial phase by reduced sulfur available from the GBFS. A partially hydrated GBFS fragment is visible in the upper right hand corner of the images in figure 59.

FIGURE 59. CLOSE-UP PETROGRAPHIC MICROSCOPE IMAGES TO SHOW CEMENT GRAINS AND GBFS FRAGMENTS IN CEMENT PASTE FRACTION FROM AIRPORT ECHO SITE. CLOCKWISE FROM UPPER LEFT HAND CORNER: PLANE POLARIZED LIGHT, CROSSED POLARS, REFLECTED LIGHT, AND EPIFLUORESCENT MODE

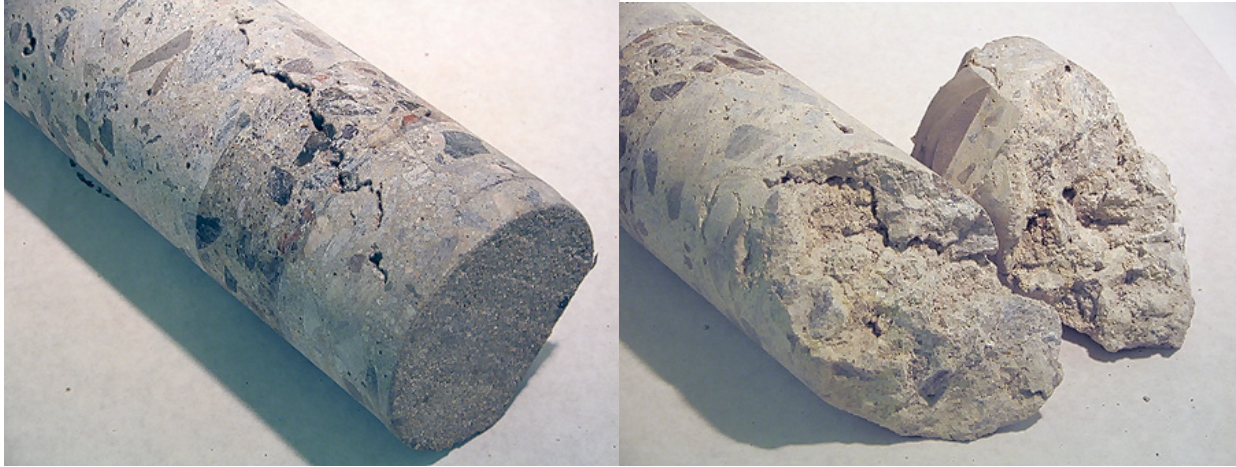
Seven 4-in diameter cores were received. All of the cores fully represented the entire depth of the concrete with a thickness of approximately 18 in. Adhering to the base of each core was an asphalt-saturated felt mat of approximately $\frac{1}{16}$ -in thickness. Cores D, F, and G each had a single break across each core. The fracture surfaces of the breaks in cores D and F appeared fresh and clean, and were at depths of 6 in and 12 in, respectively. The break on core G was in a plane oriented approximately 45 degrees to the long axis of the core. The fracture surface along the break on core G was interrupted by large interconnected air voids, as shown in figure 60. Core A exhibited a similar network of large interconnected air voids (also shown in figure 60), but the core was intact. In both cores A and G, fine cracks were visible at the pavement surface above the large interconnected air void networks. Core C also exhibited a fine crack at the pavement surface, part of a crack plane running along the entire length of the core.

FIGURE 60. CLOSE-UP IMAGES OF IRREGULAR VOIDS, CORE A ON LEFT, CORE G ON RIGHT

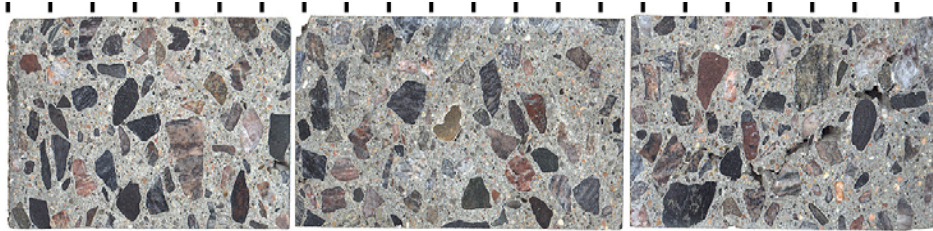
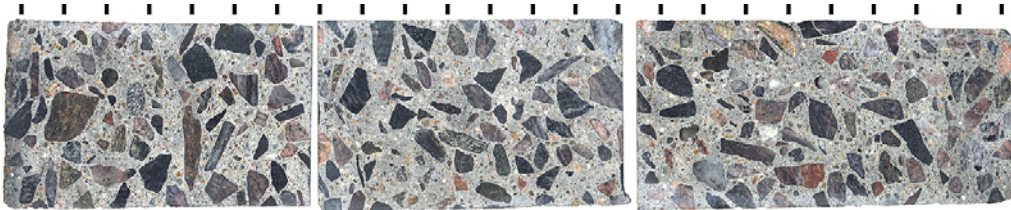
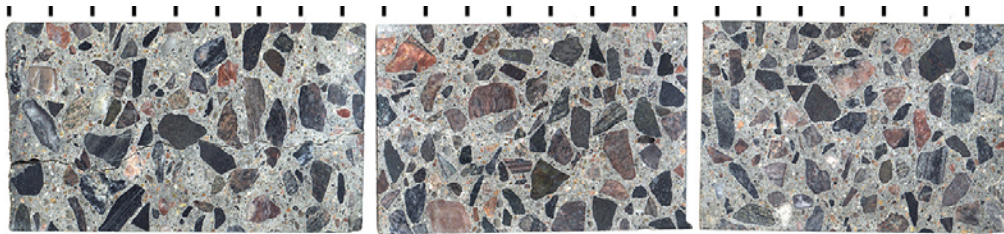
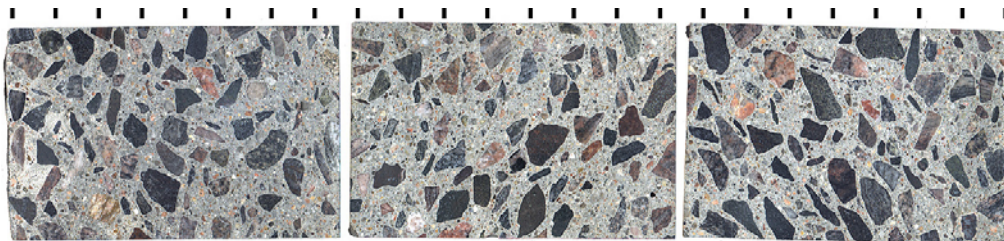
Figures 61 and 62 show overviews of all the polished slabs from cores A, B, C, and F. The large interconnected air void network of Core A is readily observed. The remaining cores—B, C, and F—did not exhibit the same kind of large interconnected air void networks, but core C had a crack plane splitting the entire long axis of the core. The top thirds of cores A and B were stained with phenolphthalein and a carbonation depth of 0.5 to 1 mm was measured with minor additional carbonation noted along the perimeters of the large interconnected air void network of core A. All of the slabs from cores C and F were stained with sodium cobaltinitrite. As shown in figure 63, cracks present in the top third of core C picked up the yellow stain. A large, dark aggregate particle at the bottom of the slab from the middle third of core C also strongly picked up the yellow stain, but this was likely due to weathered potassium-bearing feldspar phenocrysts present in the particle and not due to alkali-silica reactivity. The sodium cobaltinitrite stained slabs from core F did not pick up the yellow stain to the same degree as core C. Figure 64 shows close-up stereo microscope images of yellow-stained regions from the top third of core C.

The air-void parameters of the polished slabs were measured according to ASTM C 457. The measured spacing factors were 0.290, 0.244, 0.167, and 0.269 mm for cores A, B, C, and F respectively, compared to a maximum recommended value of 0.200 mm.

FIGURE 61. POLISHED SLABS FROM AIRPORT FOXTROT. SLABS ORIENTED TO SHOW CROSS-SECTION THROUGH PAVEMENT, PAVEMENT SURFACE AT RIGHT HAND SIDE, TICK MARKS EVERY 2 CM

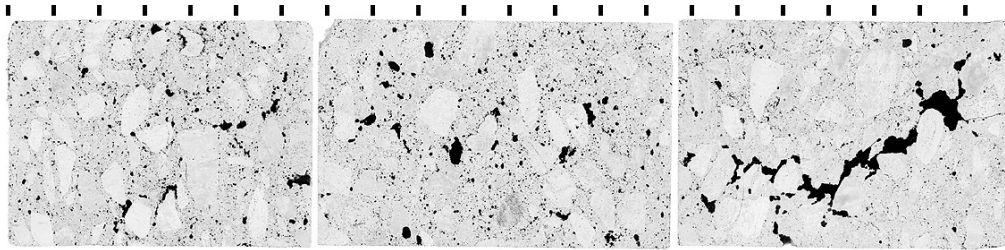
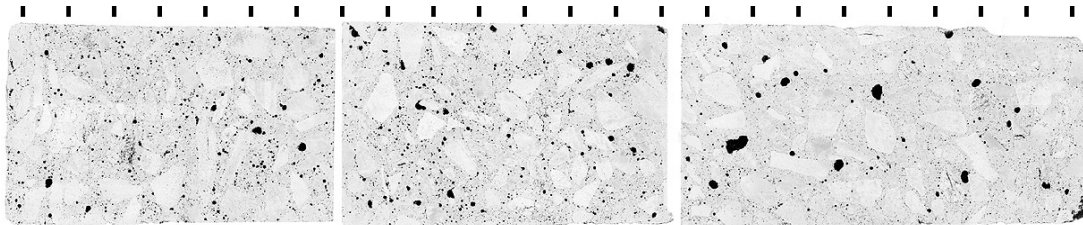
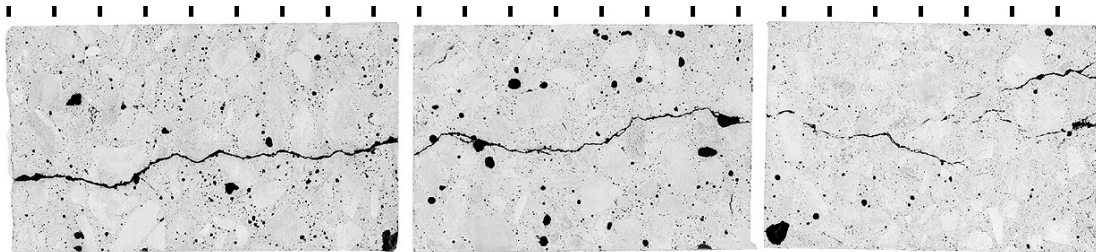
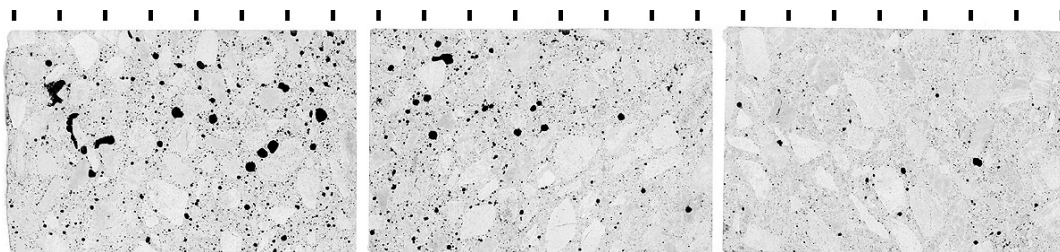
FIGURE 62. POLISHED SLABS FROM AIRPORT FOXTROT AFTER TREATMENT TO ENHANCE VISIBILITY OF AIR VOIDS AND CRACKS. SLABS ORIENTED TO SHOW CROSS-SECTION THROUGH PAVEMENT, PAVEMENT SURFACE AT RIGHT-HAND SIDE, TICK MARKS EVERY 2 CM

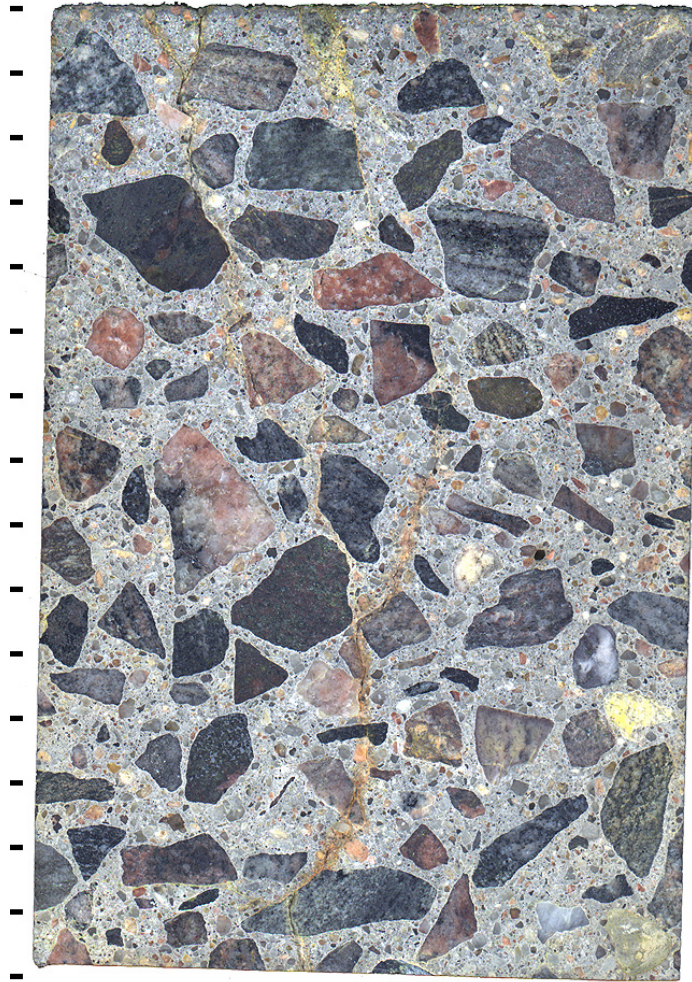
FIGURE 63. CLOSE-UP OF POLISHED SLAB PREPARED FROM TOP THIRD OF CORE C, AIRPORT FOXTROT, AFTER STAINING WITH SODIUM COBALTINITRITE SOLUTION. TIC MARKS EVERY CM

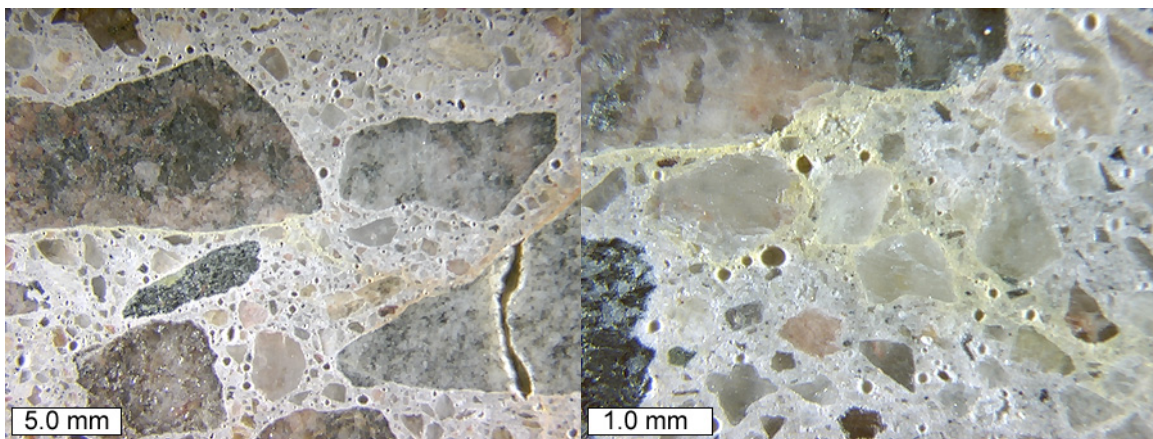
FIGURE 64. STEREO-MICROSCOPE IMAGES TO CRACK THAT PICKED UP YELLOW COLORATION FROM SODIUM COBALTINITRITE STAIN ON THE TOP THIRD OF CORE C AWAY FROM JOINT, AIRPORT FOXTROT

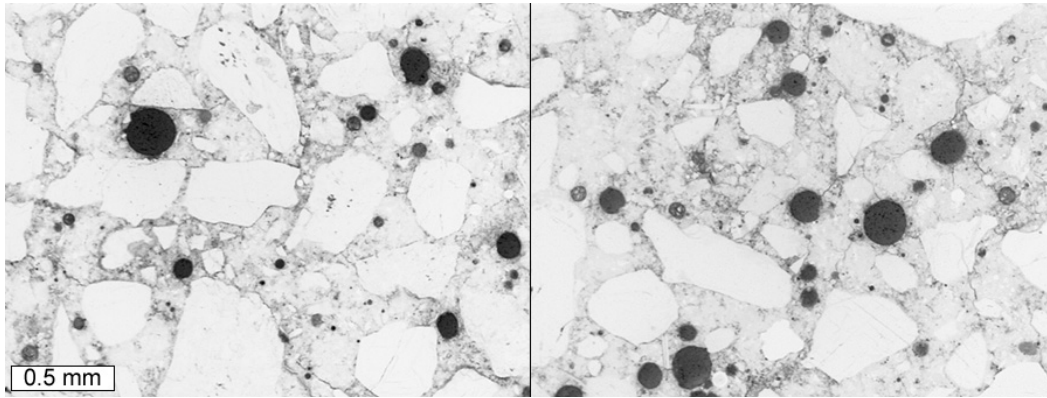
Figure 65 shows petrographic microscope images of a cross section through a crack at the pavement surface of core C. The crack propagates through the cement paste and through aggregate particles. Figures 66 and 67 compare and contrast epifluorescent mode images of the texture of the cement paste in a region from core B to that of a region of core A near the network of large interconnected air voids. In figure 67, the cement paste of core A has irregularly shaped entrained air voids, and small sub-entrained air sized gaps in the paste.

FIGURE 66. EPIFLUORESCENT MODE PETROGRAPHIC MICROSCOPE IMAGES FROM POLISHED THIN SECTION FROM CORE B, AIRPORT FOXTROT. NOTE FAIRLY UNIFORM CEMENT PASTE, AND ROUND ENTRAINED AIR VOIDS

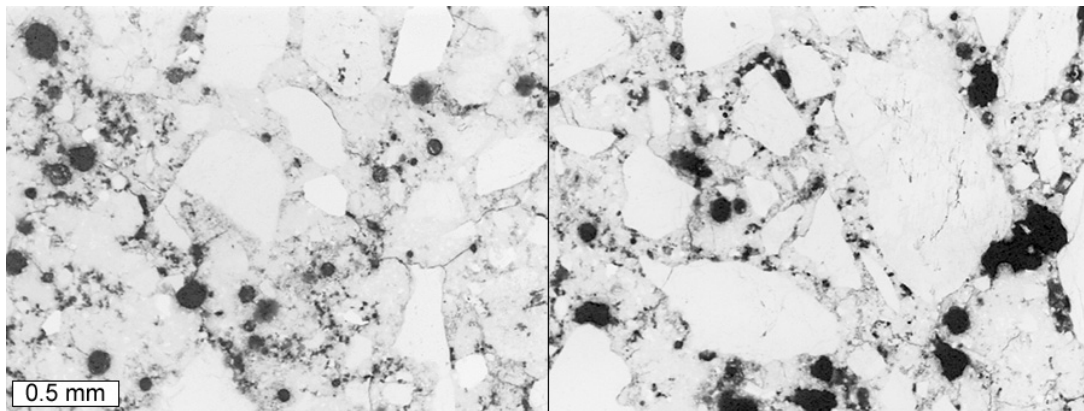
FIGURE 67. EPIFLUORESCENT MODE PETROGRAPHIC MICROSCOPE IMAGES FROM POLISHED THIN SECTION FROM CORE A, AIRPORT FOXTROT. NOTE SLIGHTLY MORE IRREGULARLY SHAPED ENTRAINED AIR VOIDS, AND SUB-ENTRAINED AIR SIZED GAPS IN THE CEMENT PASTE

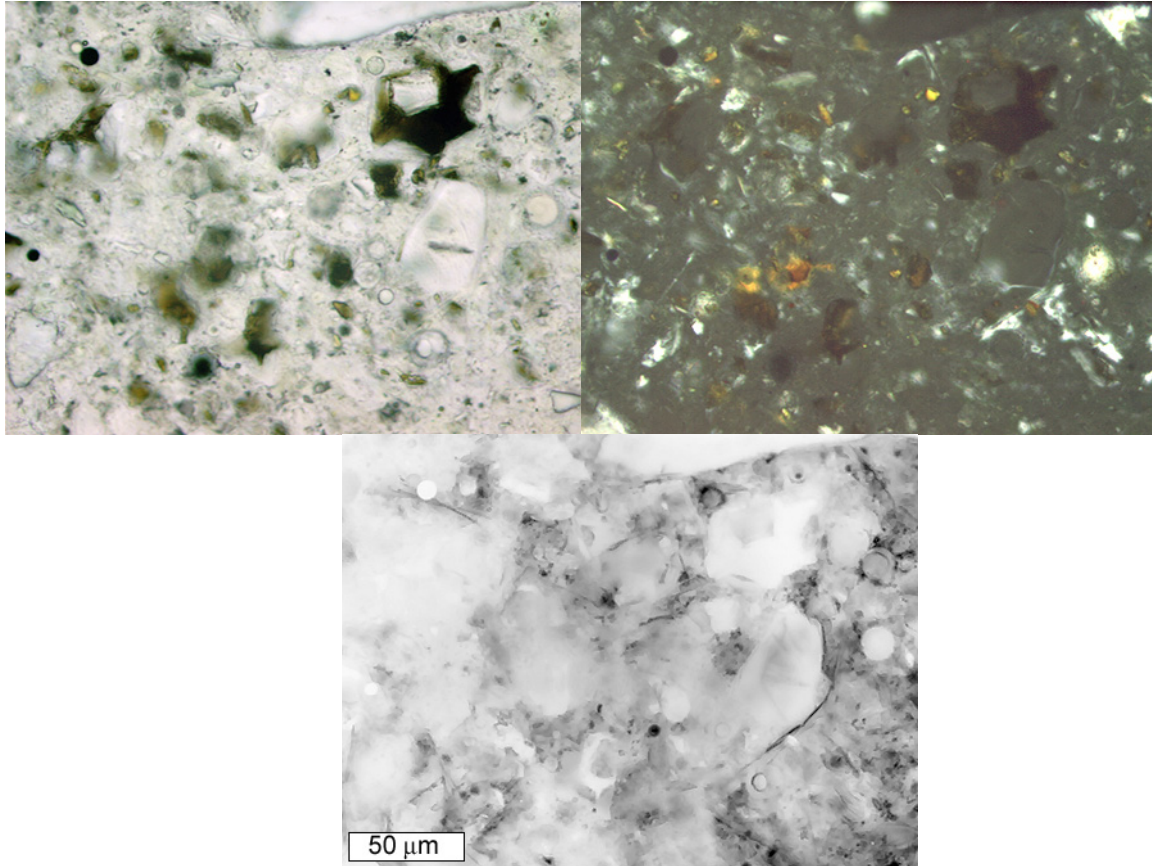
Figures 68 and 69 show BSE images, elemental maps, and petrographic microscope images of a potassium-bearing alkali-silica reaction deposit along the large crack in core C. X-ray energy dispersive spectrum (EDS) collected from the deposit had large peaks for oxygen, silicon, and calcium, and minor peaks for carbon, sodium, aluminum, and potassium. The small carbon peak is due to carbon coating prior to examination with the SEM. Secondary ettringite deposits were also identified along the large crack in core C. The ettringite deposit transitions into another aluminum and calcium-bearing phase halfway down the crack that contains appreciable amounts of carbon and silicon, minor amounts of sodium and chlorine, and less sulfur as compared to the ettringite phase. It is speculated that the phase may represent a CO_3^{-2} and Si-substituted ettringite. No quantitative EDS chemical composition measurements were made from any of the deposits. Figure 70 is a petrographic microscope image that illustrates the constituents of the cementitious materials in the concrete. Fly ash spheres can clearly be seen in the plane polarized image.

FIGURE 70. CLOSE-UP PETROGRAPHIC MICROSCOPE IMAGES TO SHOW CEMENT GRAINS AND FLY ASH IN CEMENT PASTE FRACTION FROM AIRPORT FOXTROT. CLOCKWISE FROM UPPER LEFT HAND CORNER: PLANE POLARIZED LIGHT, CROSSED POLARS, AND EPIFLUORESCENT MODE

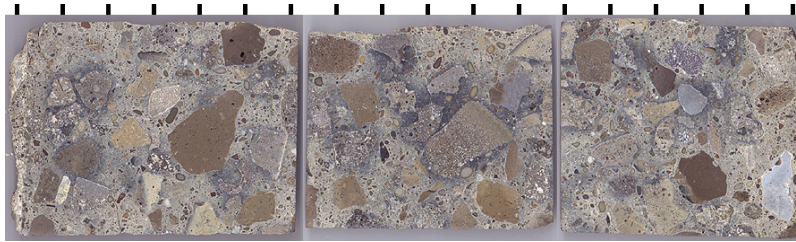
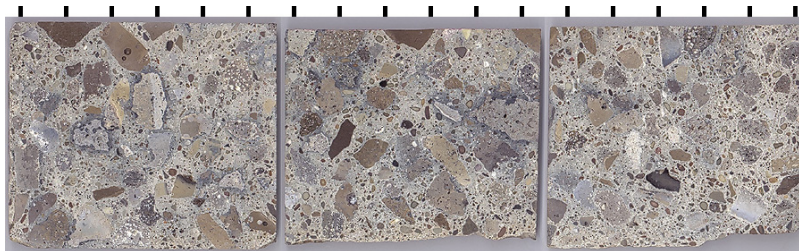
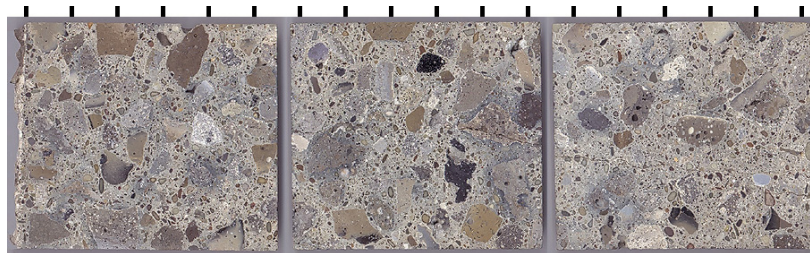
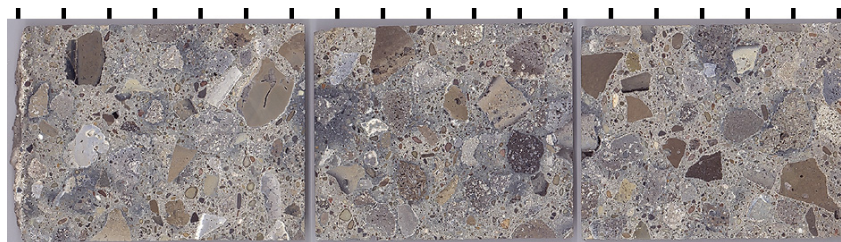
Six 4-in diameter cores were received. All of the cores fully represented the entire depth of the concrete with a thickness of approximately 13 in (note that this is 2 in thinner than the design thickness). Figures 71 and 72 show scanned images of polished slabs for cores A, B, C, and D. In some cases, portions of the cement-stabilized recycled concrete aggregate base remained adhered to the core bottom. A 1.25-in diameter, non-coated dowel bar was intersected in core A at a depth of about 5.5 in. The dowel was in good condition. The pavement surface near the joint on core B was covered with an asphalt patch material. A similar patch material may have been applied to the pavement surface of core A, but appears to have been removed. Fine cracks were observed at the pavement surface of both cores A and B running perpendicular to the pavement joint. Core C, taken away from the joint, exhibited a fine crack at the pavement surface, part of a crack plane running almost the full depth of the core.

FIGURE 71. POLISHED SLABS FROM AIRPORT GOLF. SLABS ORIENTED TO SHOW CROSS-SECTION THROUGH PAVEMENT, PAVEMENT SURFACE AT RIGHT-HAND SIDE, TICK MARKS EVERY 2 CM. DARK DISCOLORATION OF CEMENT PASTE DUE TO REDUCTION OF IRON IN CEMENT GRAINS BY SULFUR PRESENT IN AIR-COOLED BLAST FURNACE SLAG COARSE AGGREGATE

All of the cores prepared for petrographic examination exhibited dark, discolored cement paste adjacent to the air-cooled blast furnace slag coarse aggregate particles at depths greater than 2 cm. The dark discoloration of the cement paste, shown in figure 73, is due to reduction of ferric iron (Fe^{3+}) in the cement and fly ash to ferrous iron (Fe^{2+}) by reduced sulfur (S^{2-}). Reduced sulfur is present in the blast furnace slag coarse aggregate. At depths less than 2 cm, the reduced sulfur is oxidized by atmospheric oxygen, so no reduction of iron or discoloration is observed.

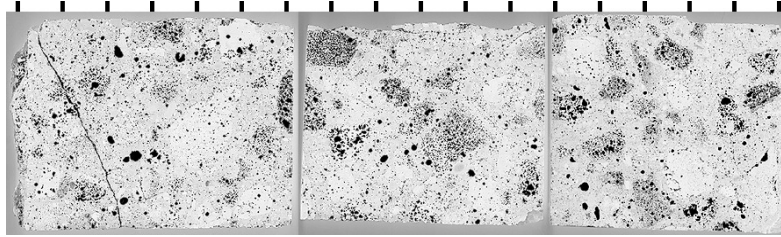
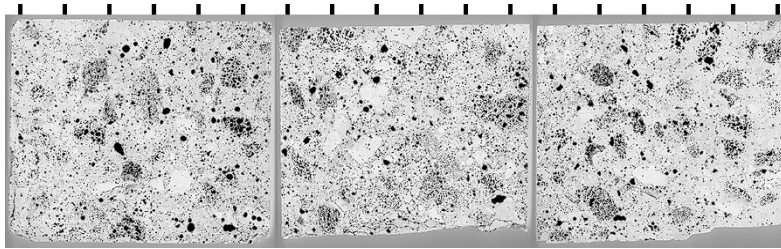
FIGURE 72. POLISHED SLABS FROM AIRPORT GOLF AFTER TREATMENT TO ENHANCE VISIBILITY OF AIR VOIDS AND CRACKS. SLABS ORIENTED TO SHOW CROSS-SECTION THROUGH PAVEMENT, PAVEMENT SURFACE AT RIGHT-HAND SIDE, TICK MARKS EVERY 2 CM

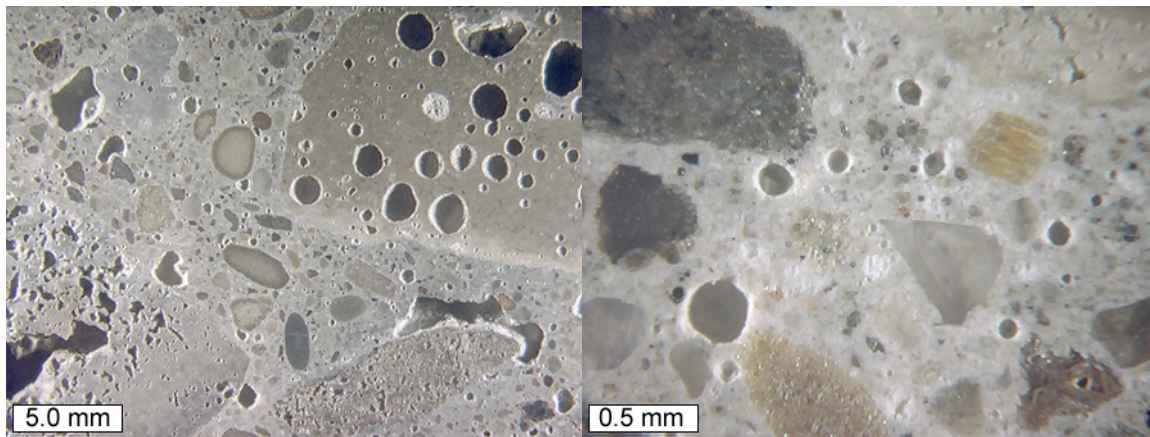
A solution of barium sulfate and potassium permanganate was used to stain a small region on a polished slab from the middle third of core B. Figure 74 shows the region both before and after staining. The deposits in the entrained air voids picked up the purple stain for sulfate-bearing minerals. Figure 75 shows stereo-microscope images of the air-void structure typical of the concrete sampled at Airport Golf. Note the infilling of some of the smaller voids.

FIGURE 75. STEREO-MICROSCOPE IMAGES TO SHOW AIR-VOID STRUCTURE ON POLISHED SLAB FROM TOP THIRD OF CORE C AWAY FROM JOINT, AIRPORT GOLF

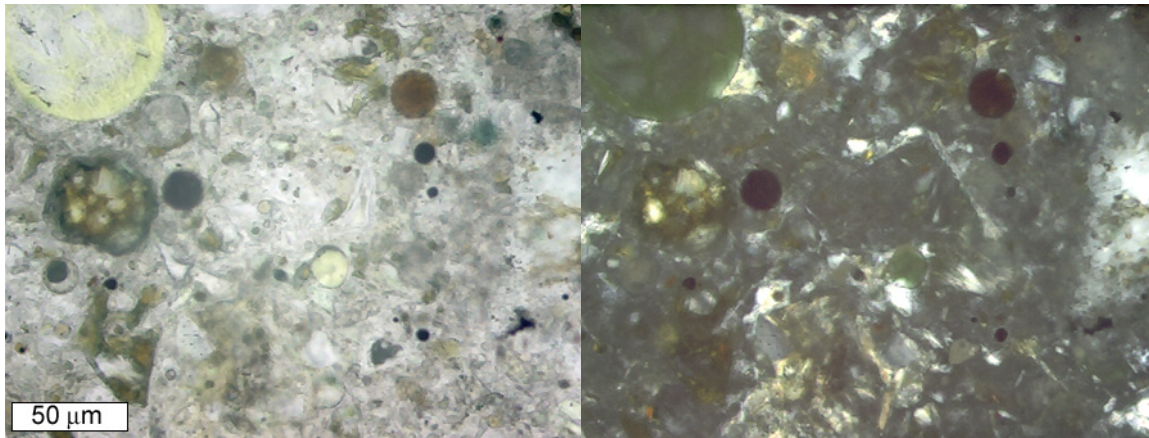
FIGURE 79. CLOSE-UP OF CEMENT PASTE IN THIN SECTION FROM AIRPORT GOLF TO SHOW CEMENT GRAINS AND FLY ASH PARTICLES IN CEMENT PASTE. FROM LEFT TO RIGHT, PLANE POLARIZED AND CROSSED POLARS

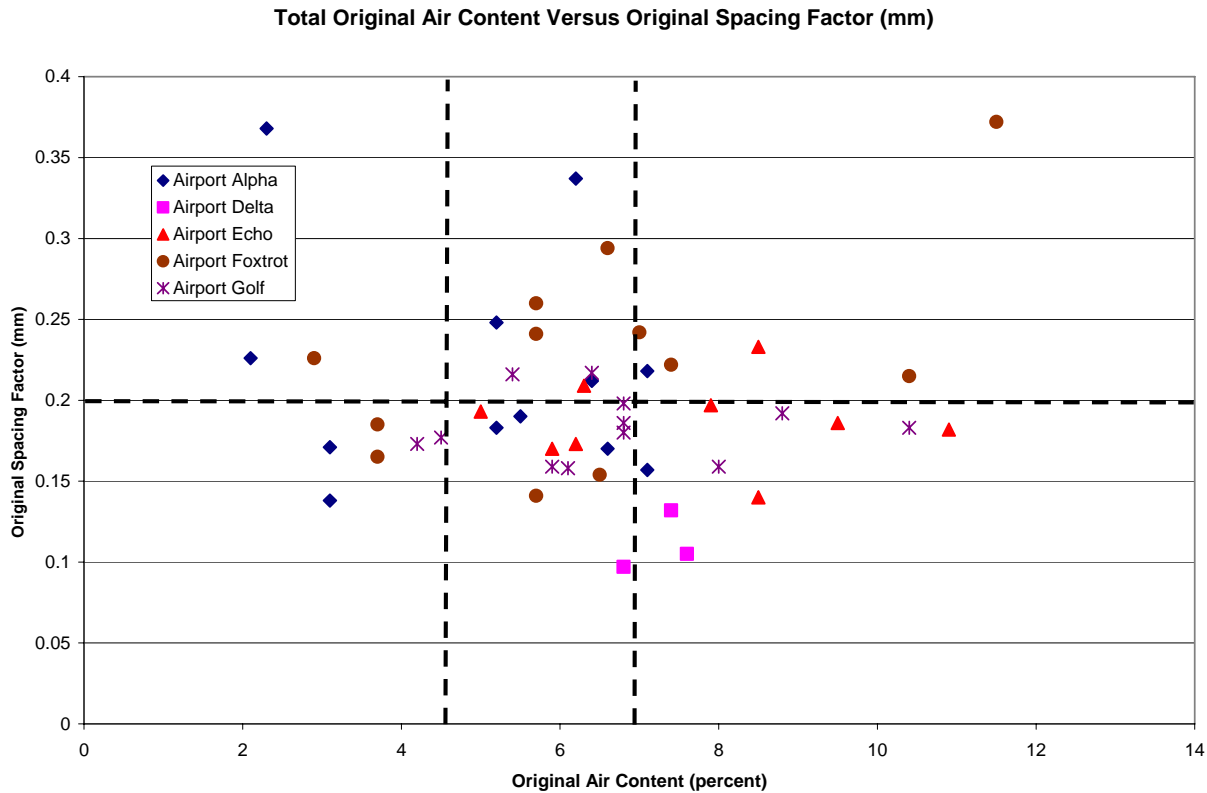
Another potential problem that was observed in this study was the entrained air-void systems, which were marginal to poor in many instances as indicated by the high spacing factors. Figure 80 illustrates the total original air content versus the original spacing factor for every specimen evaluated, including the top, middle, and bottom of each core. This plot illustrates a very important point: that the total air content (which is the parameter typically measured in fresh concrete) has little direct correlation to the spacing factor. It is also evident that nearly 40 percent of the measured spacing factors exceed the maximum recommended value of 0.200 mm, and that all four distressed airports had some concrete that exceeded this limit. Only Airport Delta, which was included as an example of a good performing pavement, had all measured spacing factors well below the limit (note that only a single core from this airport was evaluated). Although little distress can be linked directly to paste freeze-thaw damage at this time, these data suggest that it may be a problem in the future, especially since three of the four airports of interest were under 7 years old at the time the data were collected.

Although it is known that an adequate air-void system in concrete is desirable, ensuring that one is produced is a more intractable problem. Entrained air is created through the addition of either naturally derived or synthetically produced air entraining admixtures, which are basically surfactants that act at the air-water interface to form spherical microscopic bubbles in the fresh cement paste. Many factors contribute to the efficacy of the admixture, including mixture constituents (particularly the properties of the cementitious materials), other admixtures, temperature, and time of mixing. Of less importance is the placement and consolidation, as an acceptable air-void system in well proportioned concrete is not easily removed through normal levels of internal vibration during placement. In modern pavement construction, the air-void system is not directly assessed during construction, but instead measurements are made to determine the total air content of the fresh concrete. As noted previously in figure 80, a direct correlation does not exist between total air and the quality of the air-void system (as assessed by the spacing factor), and thus the current practice is inadequate.

FIGURE 80. TOTAL ORIGINAL AIR CONTENT VERSUS ORIGINAL SPACING FACTOR FOR ALL CONCRETE TESTED USING ASTM C 457

This is of particular relevance to the focus of this study as the DDF environment is believed to be very harsh for concrete due to the availability of moisture and multiple freeze-thaw cycles. An adequate air-void system is thus essential to protect the concrete from paste freeze-thaw damage. Currently, there is no generally accepted method for measuring the characteristics of the air-void system in fresh concrete. Until such a method is developed, the testing of the air-void system in hardened concrete using ASTM C 457 should be considered as part of the mixture design process, especially for new construction of DDFs.
