Report IPRF-01-G-002-3

Innovative Rehabilitation of Pavement for Light Load Aircraft

September 2004

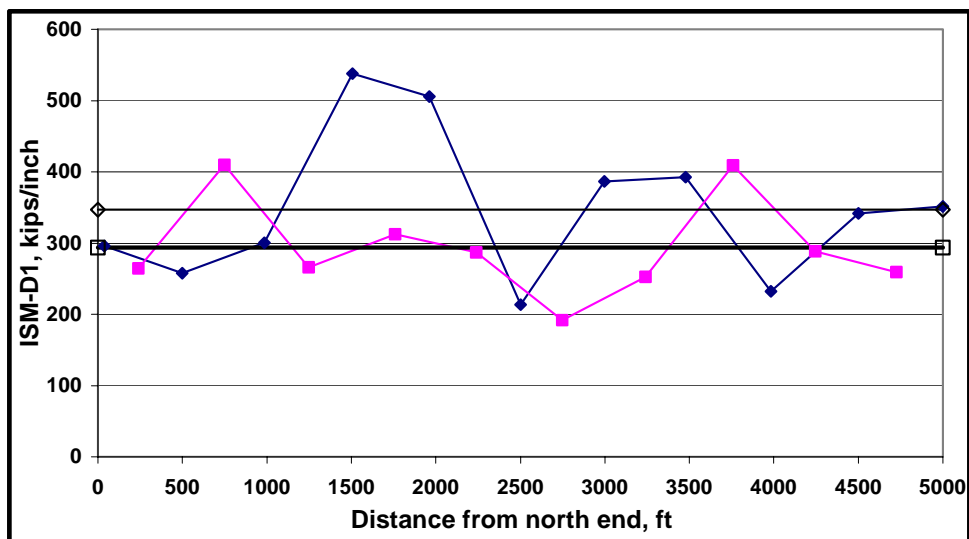
Impulse stiffness moduli (ISM) were calculated by dividing the FWD impulse load by corresponding deflections. The ISM provides a relative indication of the overall strength variation in pavement structure, as shown in Figure 2.4. The FWD data were entered into a software tool called MODULUS to backcalculate the layer moduli (see Table 2.3). AC layer thicknesses from extracted cores were used during backcalculation of moduli.

Figure 2.4. ISM of existing AC pavement.

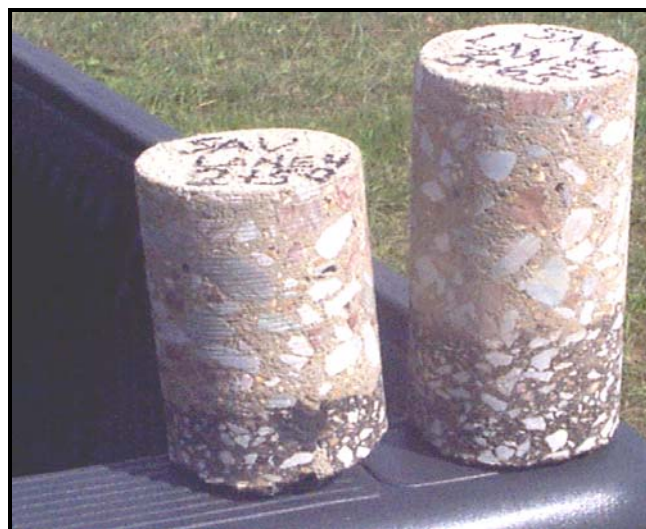
Figure 2.6. Cores extracted at SNH during construction indicated a good bond.

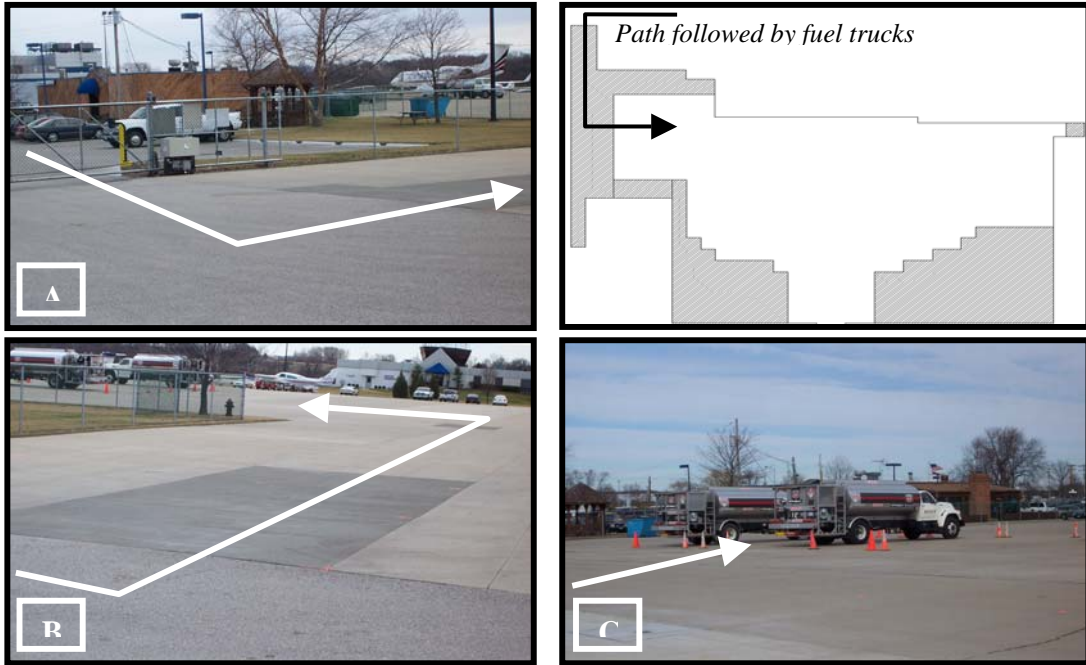
The UTW apron area is designated for aircraft less than 12.6 kips (5.7 Mg), but fuel trucks use a portion of the UTW apron from the entrance gate to their designated parking location. Figure 2.13 shows the path taken by the fuel trucks after entering through the apron access gate.

After entering the apron area, trucks make a left turn on the UTW pavement (Figure 2.13-A). All PCC slabs along the path of the trucks, shown in Figure 2.14, have corner cracks. The fuel trucks make the second left turn (Figure 2.13-B) into the parking area. All slabs in this area are shattered or fractured into three or more pieces as shown in Figure 2.15. Corner breaks and shattered slabs are load-related, not climate or durability-related. Another problem noticed at SUS was cracking of slabs containing aircraft tie downs, shown in Figure 2.16. These slabs were retrofitted with tie down anchors, which are PCC columns extending about 18 inches (457 mm) into the ground below the slab. Stress build-up due to temperature swings have resulted in the cracking shown in Figure 2.16.

Figure 2.13. Fuel truck path over the UTW apron pavement.

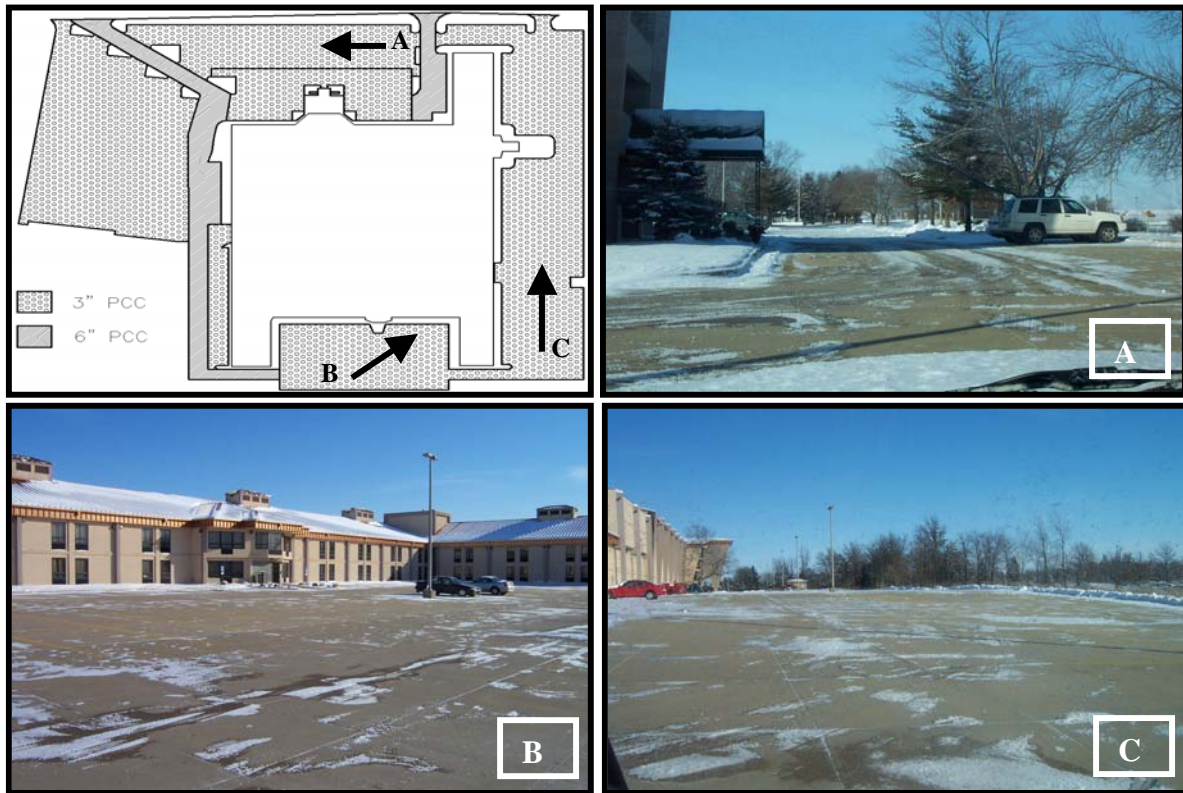
At the time of site visit in February 2002, the area was partially covered with snow. A cursory survey was made and information was obtained from the groundskeeper. No distresses were found during the survey; Figure 2.37 shows the overall pavement condition.

Figure 2.37. Adequate area was snow free to assess the parking lot condition.

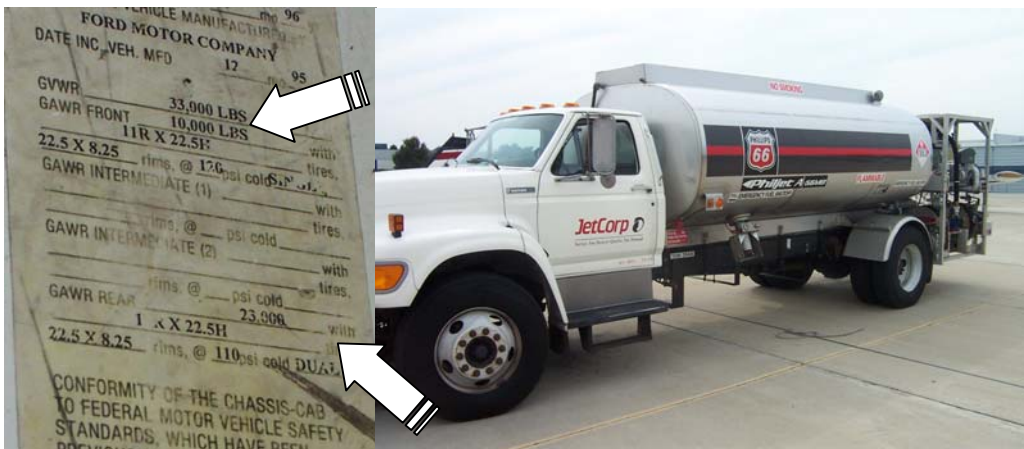
PCC slabs will crack, even when bonded to the underlying AC, if the UTW design load is exceeded. An example of this was observed at SUS, where fuel trucks use a portion of the UTW pavement designed for 12.6-kip (5.7-Mg) gross weight aircrafts; Figure 3.1 shows the fuel truck and the gross vehicle weight rating (GVWR). The UTW distresses are shown in Figure 2.14 and Figure 2.15.

Figure 3.1. Photograph of fuel truck at SUS with GVWR.

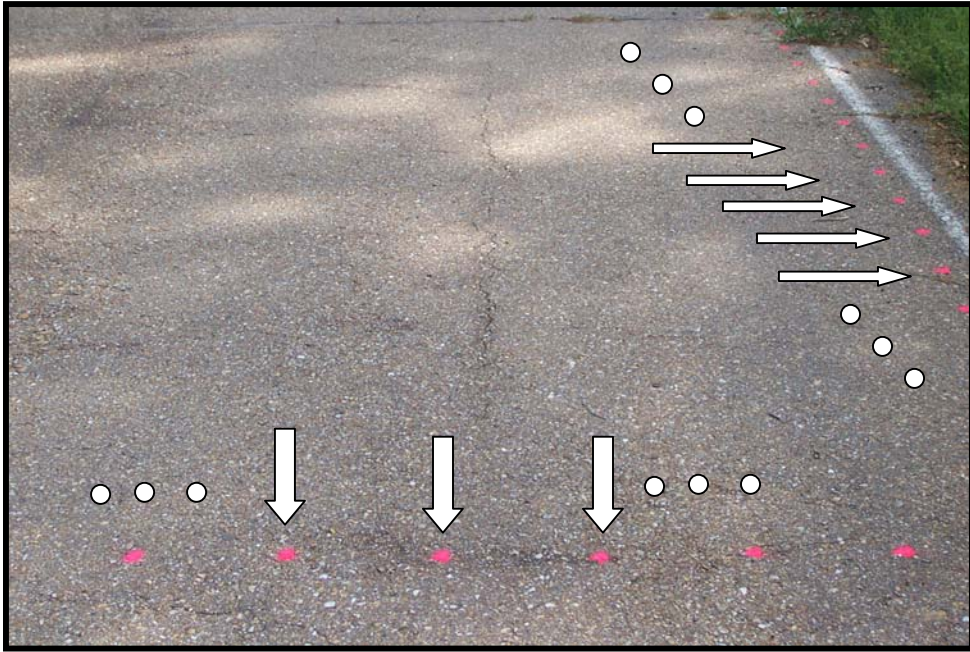
The old AC pavement at the site for the UTW test section contained longitudinal cracks that run the length of the old pavement in both wheel paths (at about 4.5 ± 0.5 ft [1.37 ± 0.15 m] from each edge) as shown in Figure 4.3. The UTW test section was placed such that the cracks are not included in test samples, as indicated in Figure 4.4.

Figure 4.3. Test section distresses were mapped on a 0.3-m square grid.

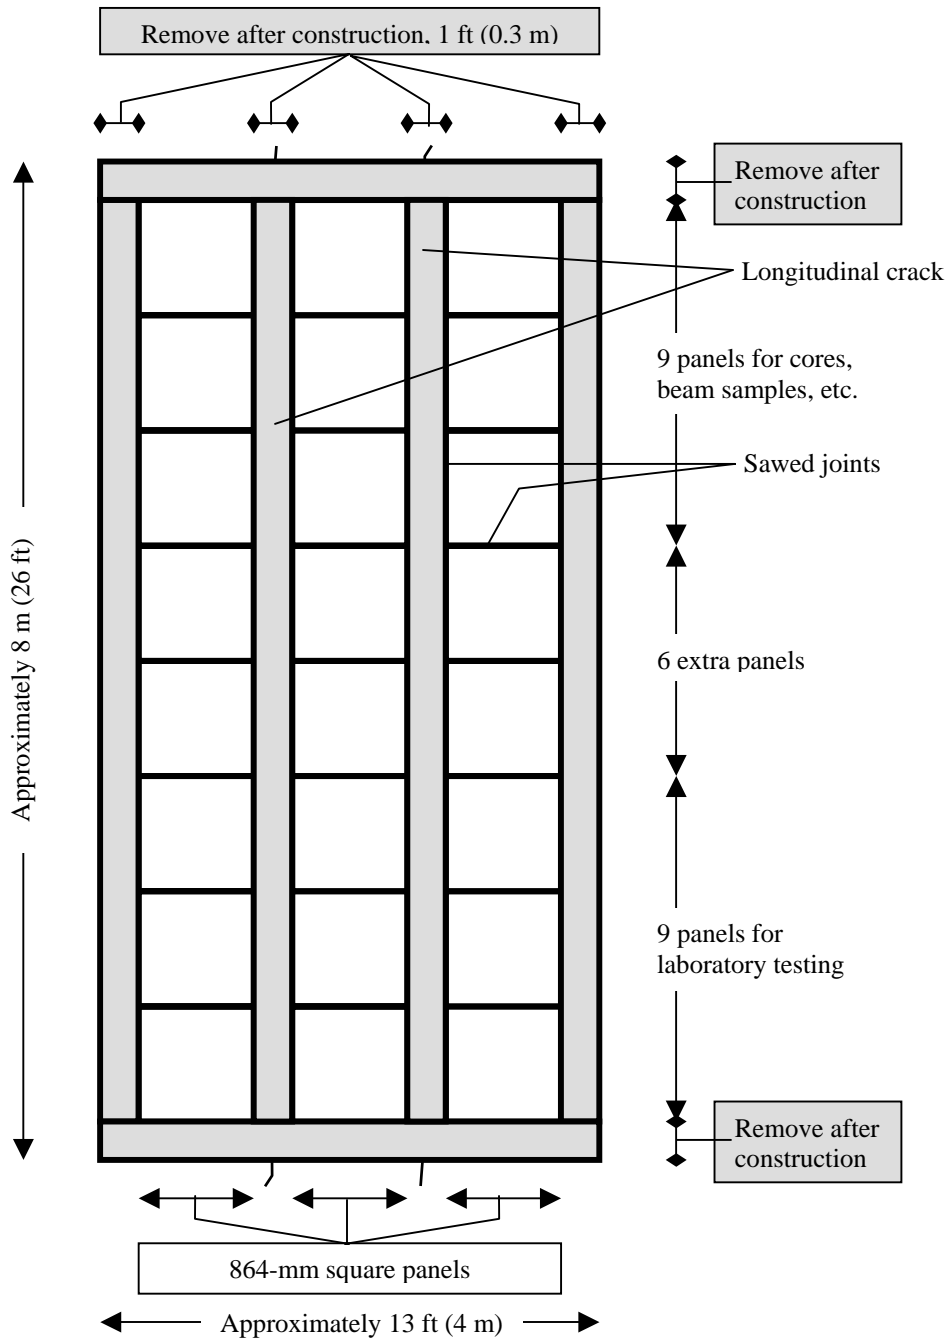
Figure 4.4. Test sample layout avoided longitudinal cracks in AC pavement.
