Report IPRF-01-G-002-06-6(G)

**Field Guide for Identification of
Materials Related Distress and
Projected Pavement Life
Concrete Airfield Pavement**

November, 2009

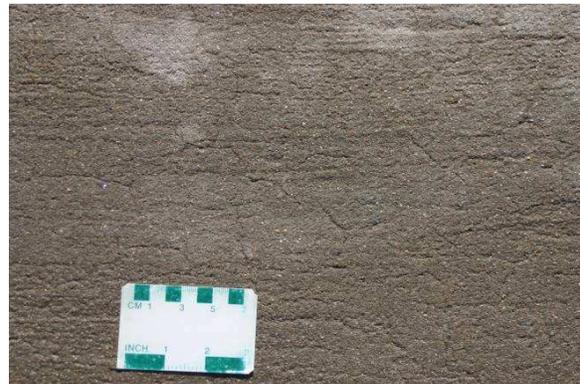
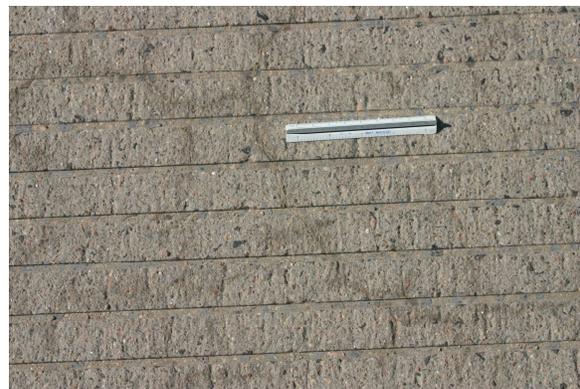
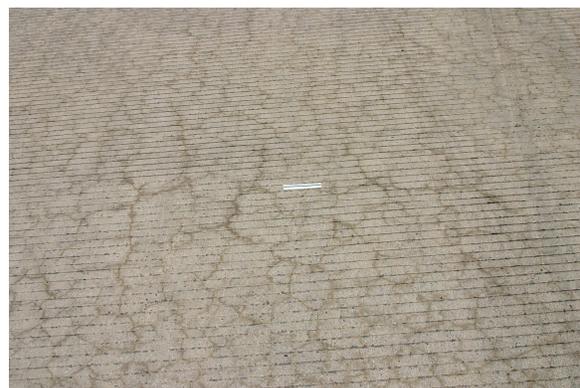
Figure 4. Pattern cracking.

(a) Pattern cracking (low-severity) – Very fine pattern cracking that is barely visible and may only be seen when wetted.

(b) Pattern cracking (low-severity) – Fine, tightly closed, cracking that is readily visible when dry. This cracking also has discoloration.

(c) Pattern cracking (medium-severity) – Well-defined pattern and some of the cracks have opened. Discoloration is also present.

Pattern cracking is only recorded in interior locations (location 3) whereas perpendicular cracking and parallel cracking are only recorded at corners (location 1) and joints (location 2). If the cracks are spalling or pieces missing, it is classified as scaling.

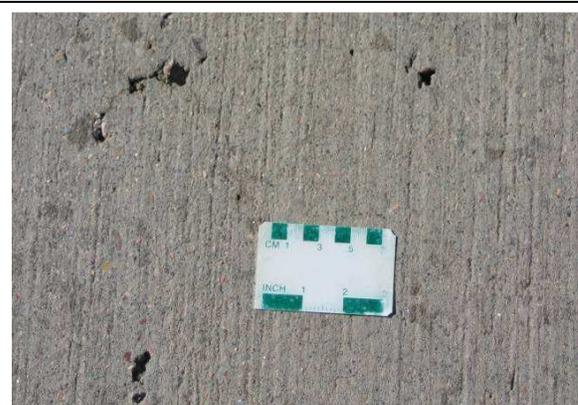
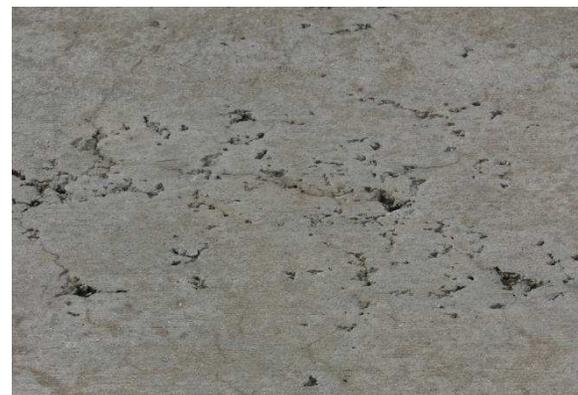
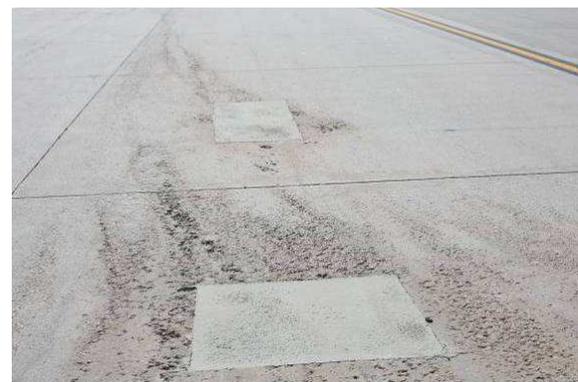
Figure 7. Surface honeycombing.

- Low-severity is a localized area of less than 1 yd² (figure 7(a)).
- Medium-severity is recorded for areas greater than 1 yd² but less than half the slab (figure 7(b)).
- High-severity is recorded when more than half the slab is affected (figure 7(c)).

(a) Surface honeycombing (low-severity) – Small areas less than 1 yd² in size where minor openings in the surface resemble small popouts.

(b) Surface honeycombing (medium-severity) – Isolated areas between 1 yd² and half the slab area where the surface is not closed.

(c) Surface honeycombing (high-severity) – Large areas (greater than half the slab) in which the surface is open. Note patching is also present.

Surface honeycombing is the presence of voids on the concrete surface that are clearly the result of construction. Figure 7 shows several photos of honeycombing.

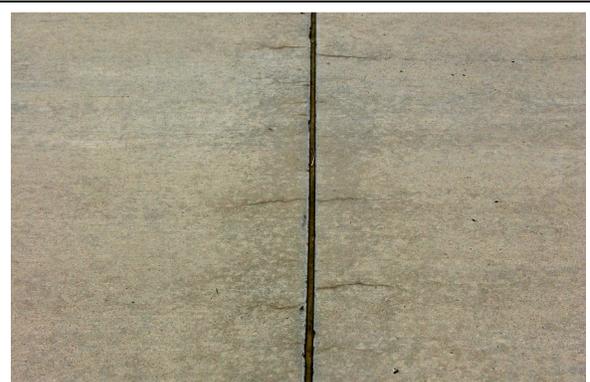
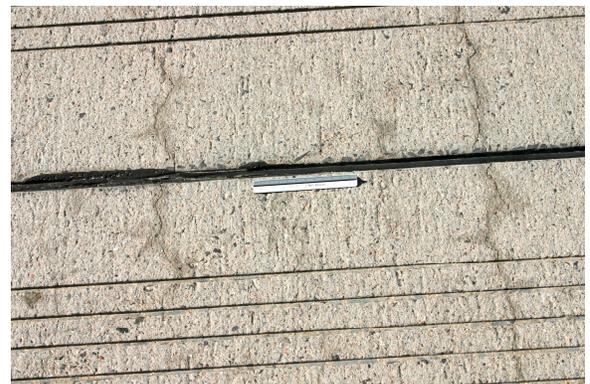
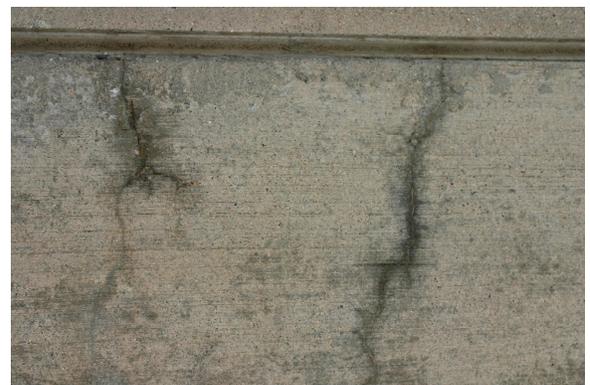
Figure 9. Perpendicular cracking.

- Low-severity perpendicular cracking is defined as fine cracks with no visible opening (see figures 9(a) and 9(b)).
- Medium-severity perpendicular cracking is defined as cracks that are visibly opened (see figure 9(c)).

(a) Perpendicular cracking (low-severity) – Fine cracks perpendicular to a joint with discoloration (D).

(b) Perpendicular cracking (low-severity) – Fine cracks perpendicular to a joint with discoloration (D).

(c) Perpendicular cracking (medium-severity) – Cracks are open and discoloration (D) is observed, but no FOD potential exists.

Perpendicular cracking (see figure 9) propagates perpendicularly outward from a joint. These cracks can be located at either longitudinal or transverse joints.

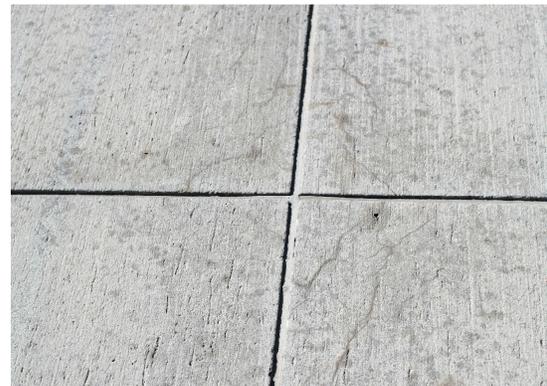
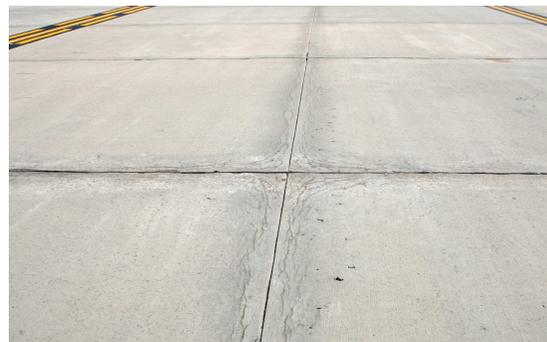
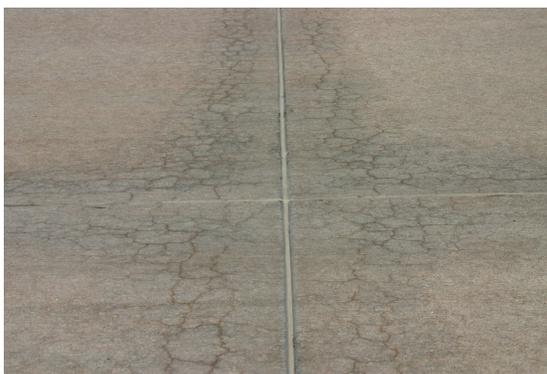
Figure 10. Parallel cracking.

- Low-severity parallel cracking is defined as fine cracks with no visible opening (see figure 10(a)).
- Medium-severity parallel cracking is defined as cracks that are visibly opened (see figure 10(b)) or may have formed a network (see figure 10(c)).

(a) Parallel cracking (low-severity) – Tightly closed cracking running parallel to joint and around corner. Discoloration (D) would be noted, as would staining (I).

(b) Parallel cracking (medium-severity) – Open cracks running parallel to joint and around corner. In this case, exudate is present so Discoloration (D) would also be noted.

(c) Parallel cracking (medium-severity) – Open, parallel cracking at joints and around corner. Medium-severity perpendicular cracking is also present. Discoloration (D) would also be noted.

Parallel cracking are cracks running roughly parallel to joints and/or running around corners. Several examples of parallel cracking are shown in figure 10.

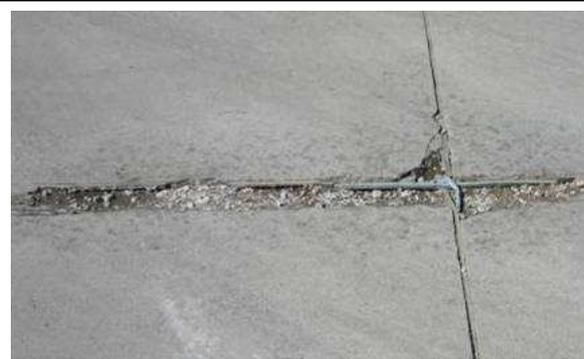
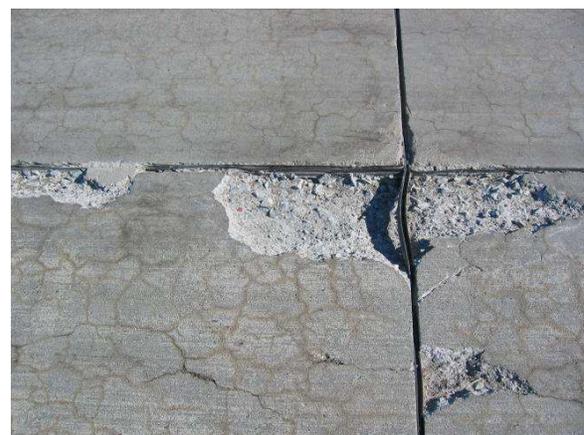
Figure 11. Joint disintegration.

(a) Joint disintegration – Areas along joints are crumbling. Note that cracking is not parallel cracking.

(b) Joint disintegration – Concrete along joint is crumbling/falling apart due to progression of parallel cracking. Note the visual difference between this distress and sliver spalling (no additional cracking).

(c) Joint disintegration – High FOD potential over a large area.

Joint disintegration must be differentiated from sliver spalling and expansion. Location differentiates it from scaling.

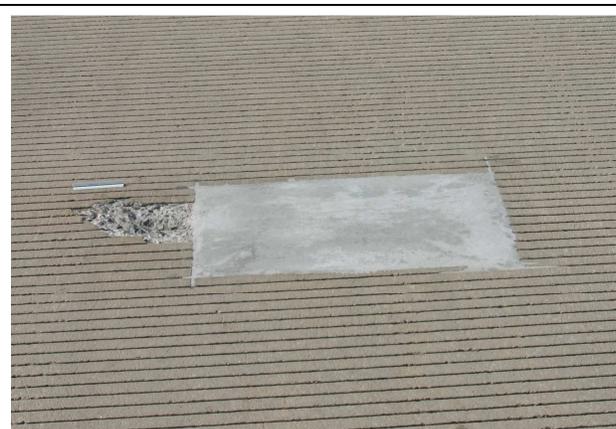
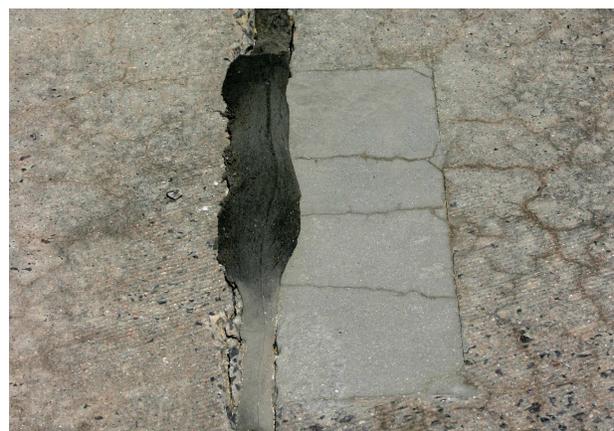
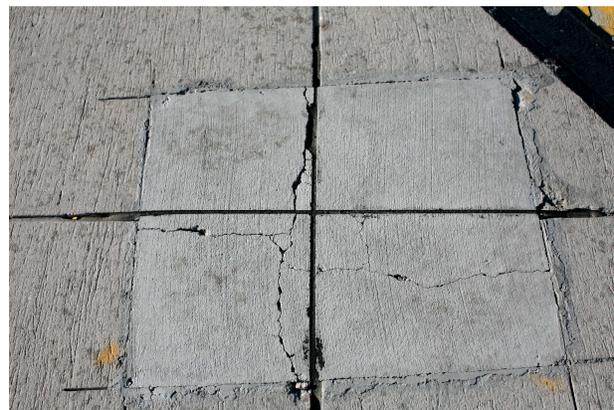
Figure 13. Patching.

- Low severity is a patch in good condition and free of distress, being used primarily to note the presence of the repair (see figure 13(a)).
- Medium severity is when cracking in the patch is observed, but no FOD potential currently exists, as shown in figure 13(b).
- High-severity is when the distress in the patch poses a FOD potential, requiring repair (see figure 13(c)).

(a) Patching (low-severity) – The patch is present with no observable distress. Note that scaling (B) would also be recorded for this location.

(b) Patching (medium severity) – Patch is intact, but cracked. Note that there is no current FOD potential.

(c) Patching (high-severity) – Distress in patch has begun to spall and poses FOD potential.

Patching is the replacement of a failed area of the pavement with a repair material. Patching is noted in all locations where a repair has been made. Severity is based solely on the condition of the patch. Deterioration in the slab area adjacent to the patch is defined independently. Figure 13 shows patches in various stages of deterioration.

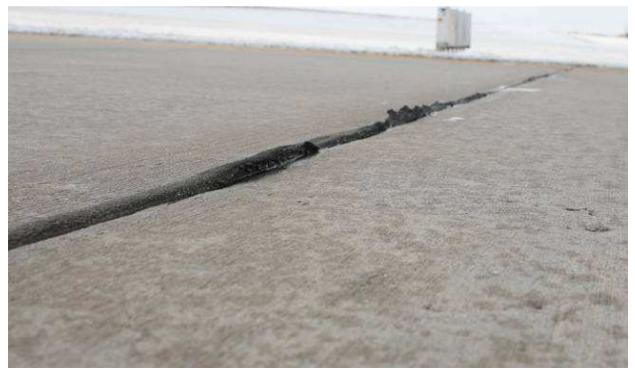
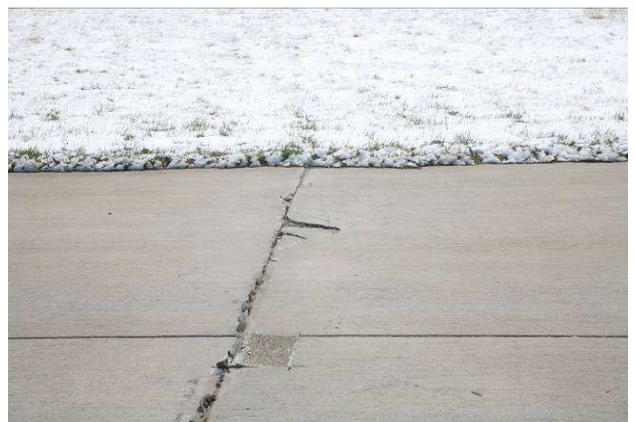
Figure 14. Expansion.

(a) Expansion – Shown in the circle is joint misalignment, which indicates an expansive movement, but the rater should confirm that the joints were originally aligned.

(b) Expansion – Expansion has closed the joint and caused sealant to bulge out.

(c) Expansion - Adjacent slabs pushing against each other along joint caused this blow-up.

Expansion describes a series of pavement conditions that have developed due to movement of the slabs. Examples include misalignment of adjacent joints (where differential movements are occurring, see figure 14(a)), excessive closure of joints (see figure 14(b)), or shoving of (or damage to) in-pavement fixtures or adjacent structures (see damage to light marker in figure 14(a)). Another example includes the development of blow-ups (see figure 14(c)), which occur at joints and result in an uplift of broken pieces, producing a high potential for FOD and tire damage.

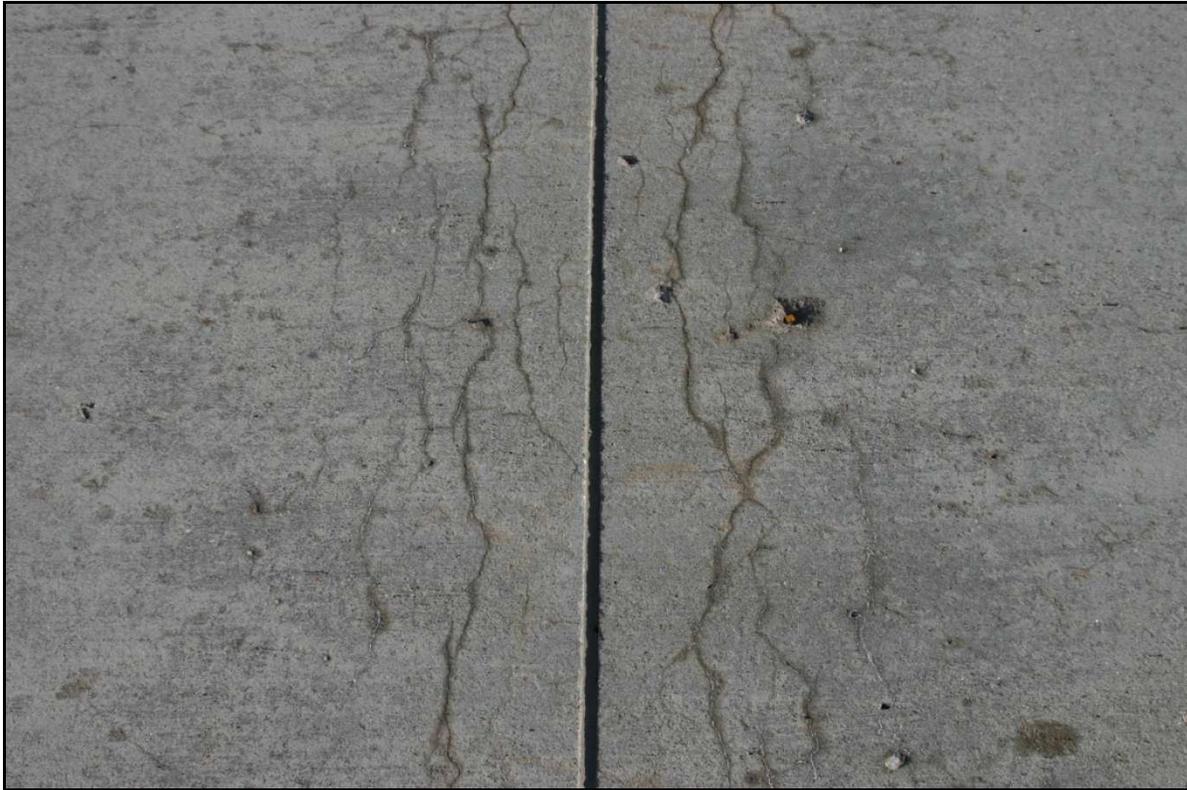
Figure 18. Example 4: opened cracking along joint.

Figure 18 shows open cracking along a joint. The MRD indicators specifically applicable to this location are *E* through *H* (sliver spalling, perpendicular cracking, parallel cracking, and joint disintegration), and *I* through *K* (staining, patching, and expansion) would also be considered. The cracking present is open, running parallel to the joint, and is discolored with exudate. Therefore this is medium-severity parallel cracking (MRD Indicator *G*) and is identified as *G-M(D)*. Staining (MRD Indicator *I*) of the joint is also clearly visible, but because the parallel cracking has progressed to medium-severity, staining is not recorded. Further, popouts (MRD

Indicator C) are visible. These are not identified for a joint location; instead, the number of popouts observed over the entire slab surface is assessed and the observation is recorded for the slab interior location with severity assigned based on the overall density of popouts observed.

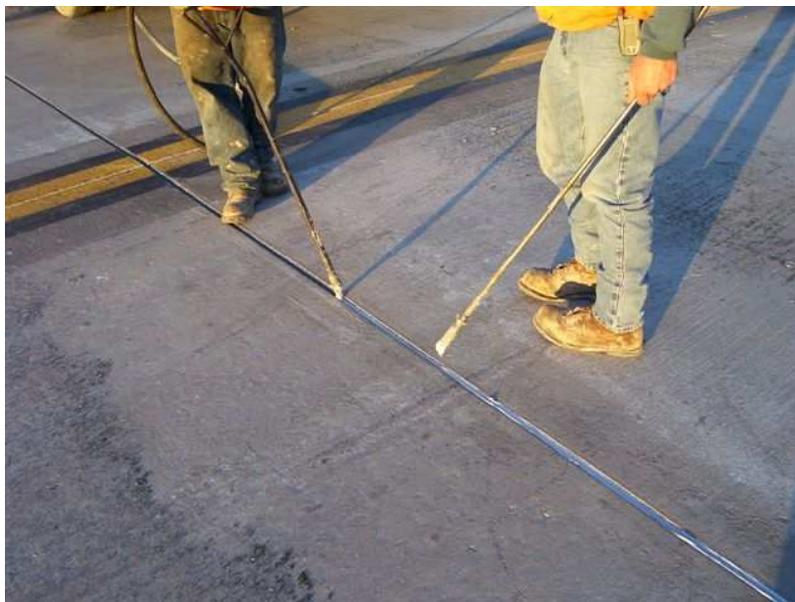
Figure 23. Joint resealing with silicone sealant (courtesy John Roberts, IGGA).

Joint and crack sealing is most effective when performed on pavements that exhibit primarily staining distress and have little to no cracking or disintegration due to MRD. Joint and crack sealing typically has a service life of 3 to 10 years, depending on the type of sealant and the quality of the installation procedures. Figure 23 shows an airport joint resealing project using a silicone sealant.

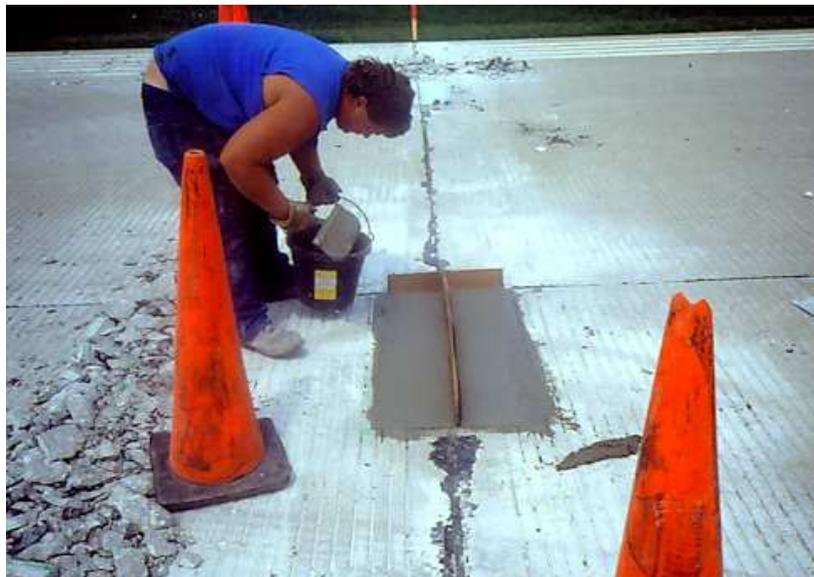
Figure 24. Partial-depth repair placement (courtesy Gary Mitchell, ACPA).

A wide variety of materials are available for use in partial-depth repairs. These include conventional cementitious materials as well as many proprietary rapid-setting and high-early strength materials designed to reduce closure times. Material selection depends on available curing time, ambient temperature, cost, and size of the repairs. Figure 24 shows the placement of a partial-depth repair on a concrete airfield pavement with both the longitudinal and transverse joint being formed through the use of inserts.

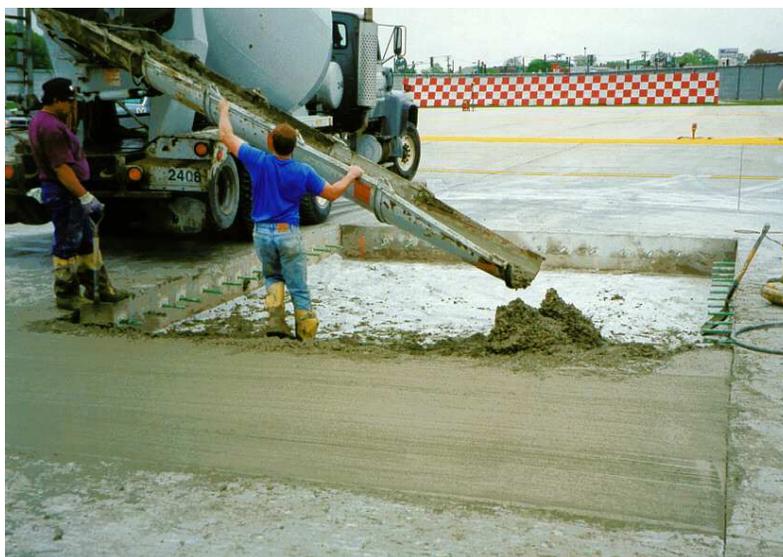
Figure 26. Conventional full-depth repair.

Some agencies have been experimenting with precast full-depth repairs. These are panels that are cast and cured off-site and then transported to the project and placed at pre-determined locations. The advantages of precast repairs include greater control over the concrete and its curing, minimal weather restrictions on placement, and reduced closures and delay times (since no on-site curing of the concrete is required). Precast panels have been used in some areas where very short work windows are available, and in some cases a cracked or damaged slab has been replaced with a precast panel in as little as 4 hours. Figure 26 shows a conventional full-depth repair operation and figure 27 illustrates the placement of precast slabs.

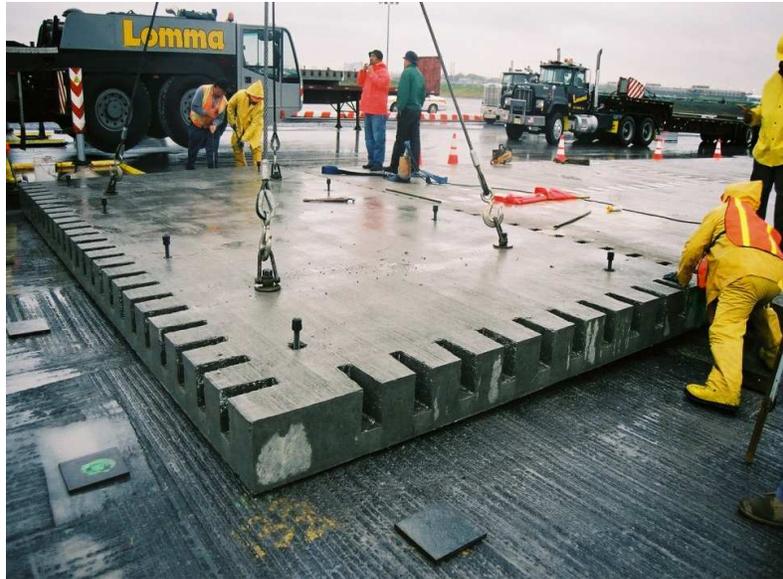
Figure 27. Precast full-depth slab replacement (courtesy Shiraz Tayabji).
